# National Transportation Safety Board

HWY23MH015

## **HIGHWAY FACTORS**

Group Chair's Factual Report

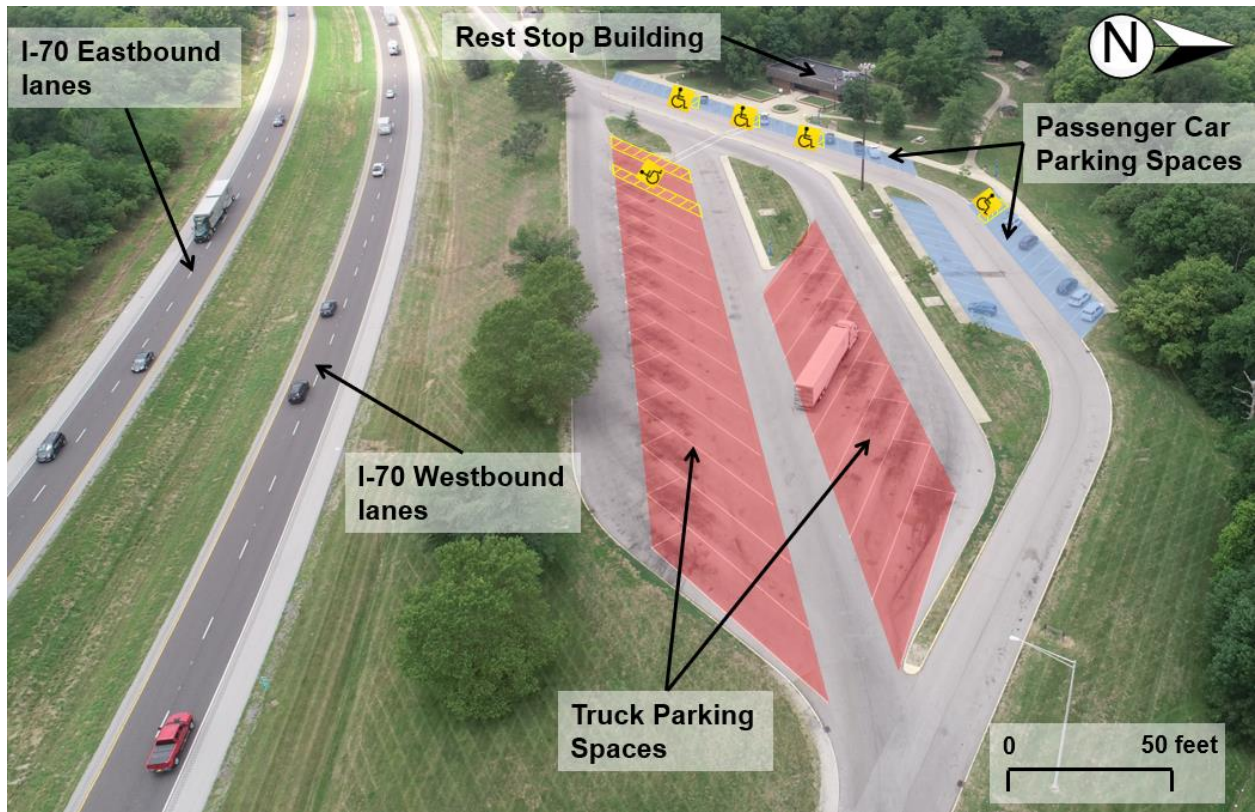
**Figure 2** is an aerial view of what the westbound Silver Lake rest stop looked like after the crash. The areas highlighted in red identify the truck parking spaces, including the truck handicap parking space. The areas highlighted in blue identify the passenger car parking spaces, including the passenger car handicap parking spaces.

**Figure 2:** Aerial view of what the westbound Silver Lake rest stop looked like after the crash, truck parking spaces are highlighted in red, while passenger car parking spaces are highlighted in blue.

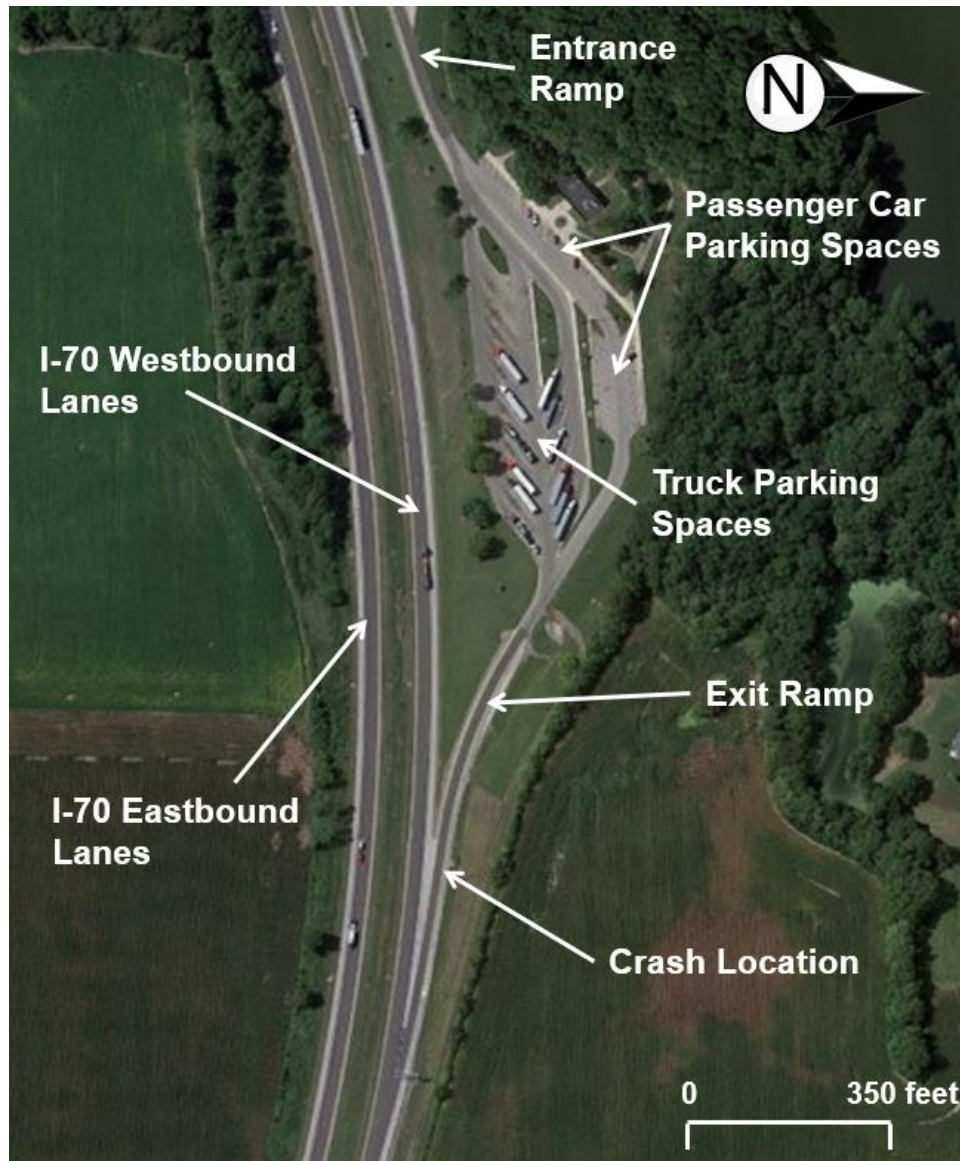
**Figure 3** is an expanded aerial view of the westbound Silver Lake rest stop illustrating the truck parking spaces, passenger car parking spaces, exit and entrance ramps, and crash location relative to I-70.

**Figure 3:** Expanded aerial view of the westbound Silver Lake rest stop illustrating the truck parking spaces, passenger car parking spaces, exit and entrance ramps, and crash location relative to I-70. (Source: Google Earth revised)

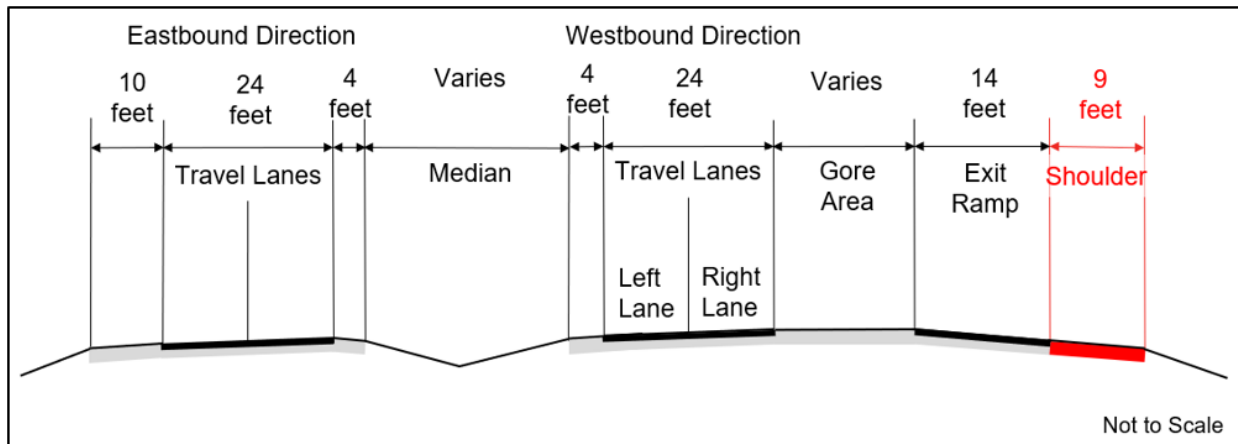
**Figure 4** illustrates the typical section for the I-70 travel lanes and exit ramp in the vicinity of the crash location. I-70 consisted of two westbound travel lanes and two eastbound travel lanes, separated by a median. The total width of the travel lanes in each direction was approximately 24-feet. A gore area separated the westbound travel lanes from the exit ramp.<sup>8</sup> The exit ramp was approximately 14-feet wide. The crash occurred on the right shoulder of the exit ramp denoted by the red highlighted text. The right shoulder of the exit ramp was approximately 9-feet wide.

**Figure 4:** Typical section for the I-70 travel lanes and exit ramp in the vicinity of the crash location.

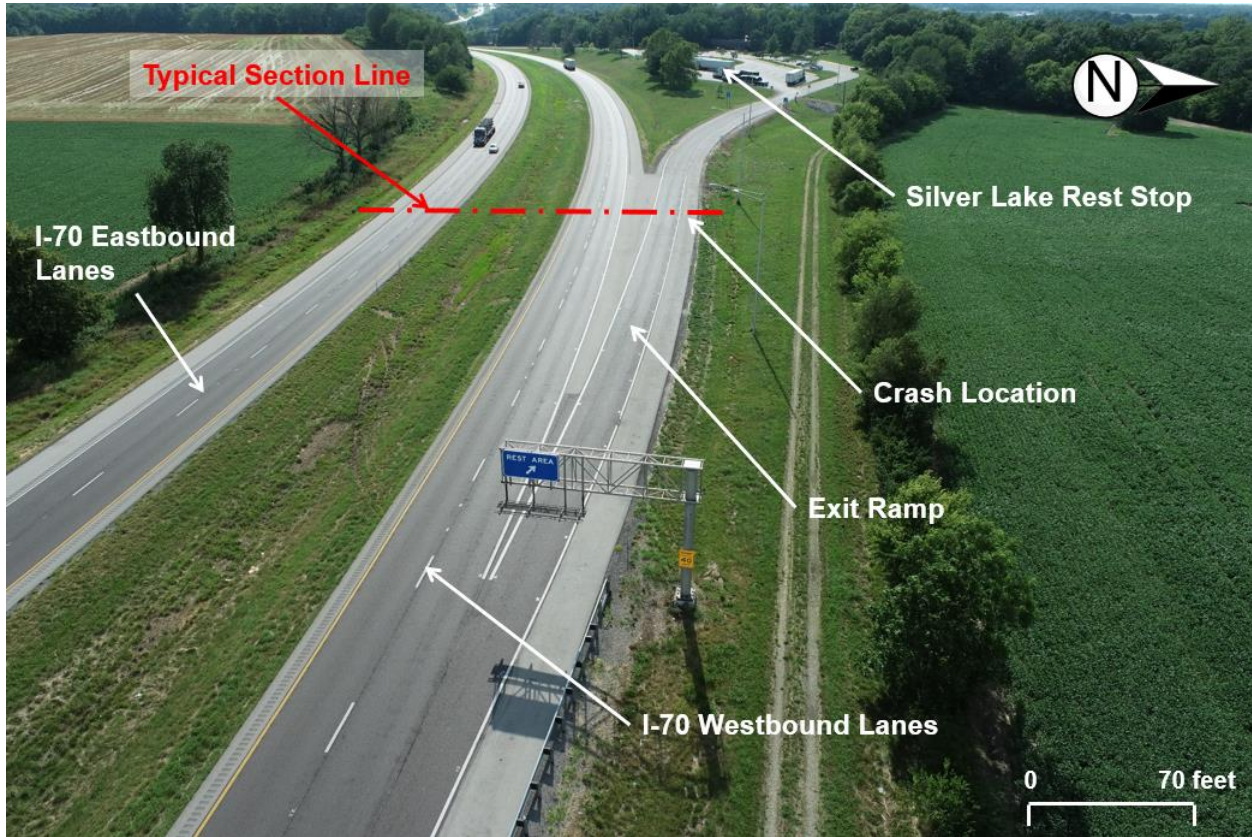
**Figure 5** illustrates the crash location from an aerial view looking to the west with a line depicting the location in which the typical section was drawn as shown in **Figure 4**.

**Figure 5:** Crash location from an aerial view looking to the west with a line depicting the location in which the typical section was drawn. (Source: IDOT Division of Aeronautics revised)

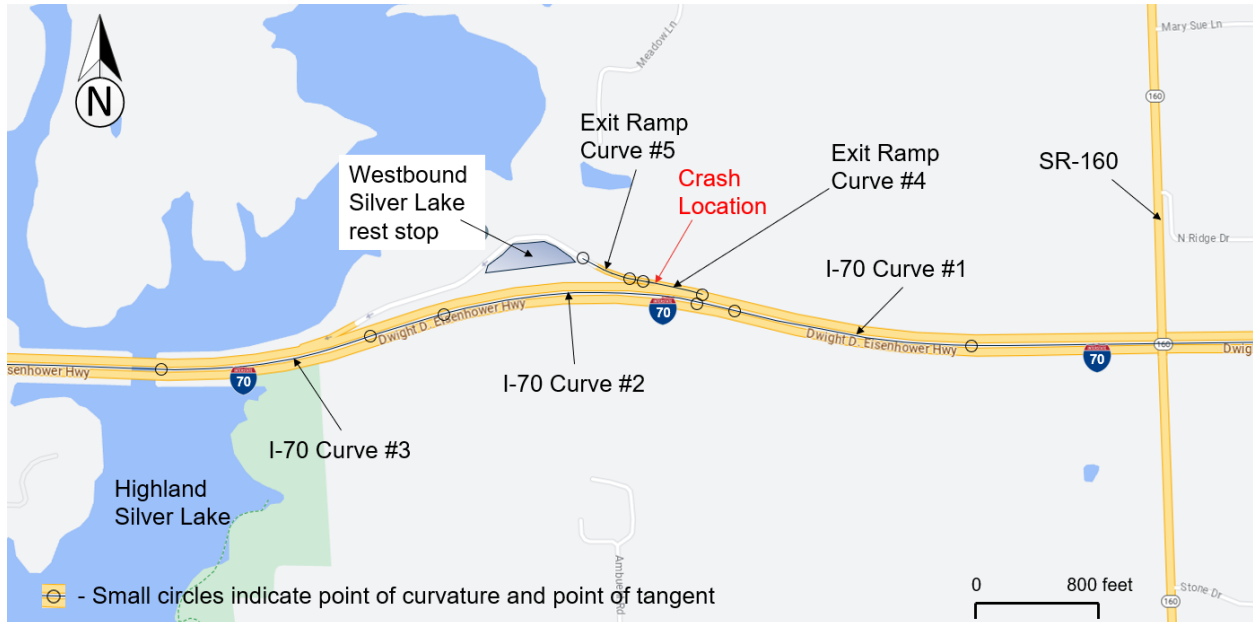
**Figure 6** illustrates the horizontal alignment immediately before and after the crash location. The horizontal curves are identified on I-70 and the exit ramp to the westbound Silver Lake rest stop.

**Figure 6:** Horizontal curves identified on I-70 and the exit ramp to the westbound Silver Lake rest stop before and after the crash location. (Source: Google Maps revised)

**Table 3** summarizes the data for each horizontal curve shown in **Figure 6**.

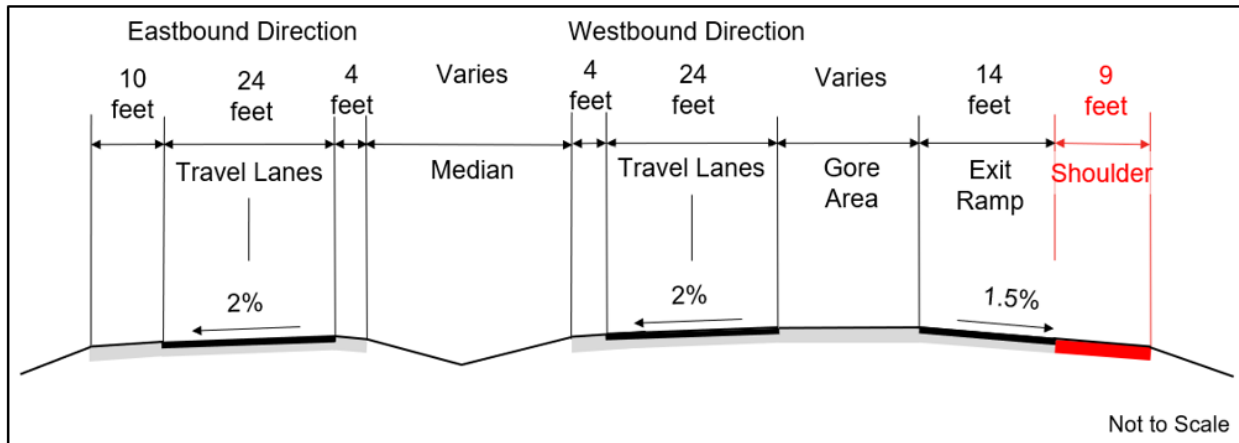
**Figure 7** illustrates the superelevation for the I-70 travel lanes and exit ramp in the vicinity of the crash location.<sup>10</sup> The superelevation for the I-70 travel lanes in the westbound and eastbound direction sloped downward to the south at an approximate 2 percent slope. The superelevation for the exit ramp to the westbound Silver Lake rest stop sloped downward to the north at an approximate 1.5 percent slope.

**Figure 7:** Superelevation for the I-70 travel lanes and exit ramp in the vicinity of the crash location.

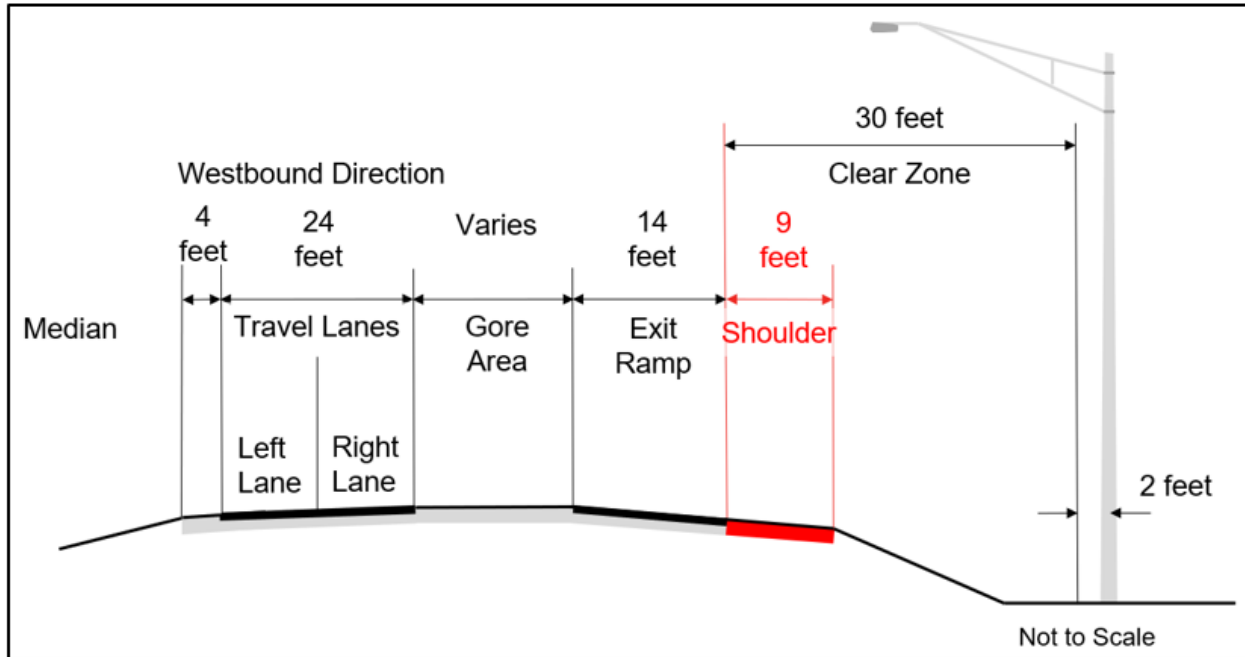
The three truck-tractor semi-trailer combination units parked on the right shoulder of the exit ramp to the westbound Silver Lake rest stop on Wednesday, July 12, 2023, at 1:48 a.m. were located closer than 30-feet from the traveled way of the exit ramp.

**Figure 8** illustrates the typical section for the I-70 westbound travel lanes and exit ramp in the vicinity of the crash location with the 30 feet clear zone.

**Figure 8:** Typical section for the I-70 westbound travel lanes and exit ramp in the vicinity of the crash location with the 30 feet clear zone.

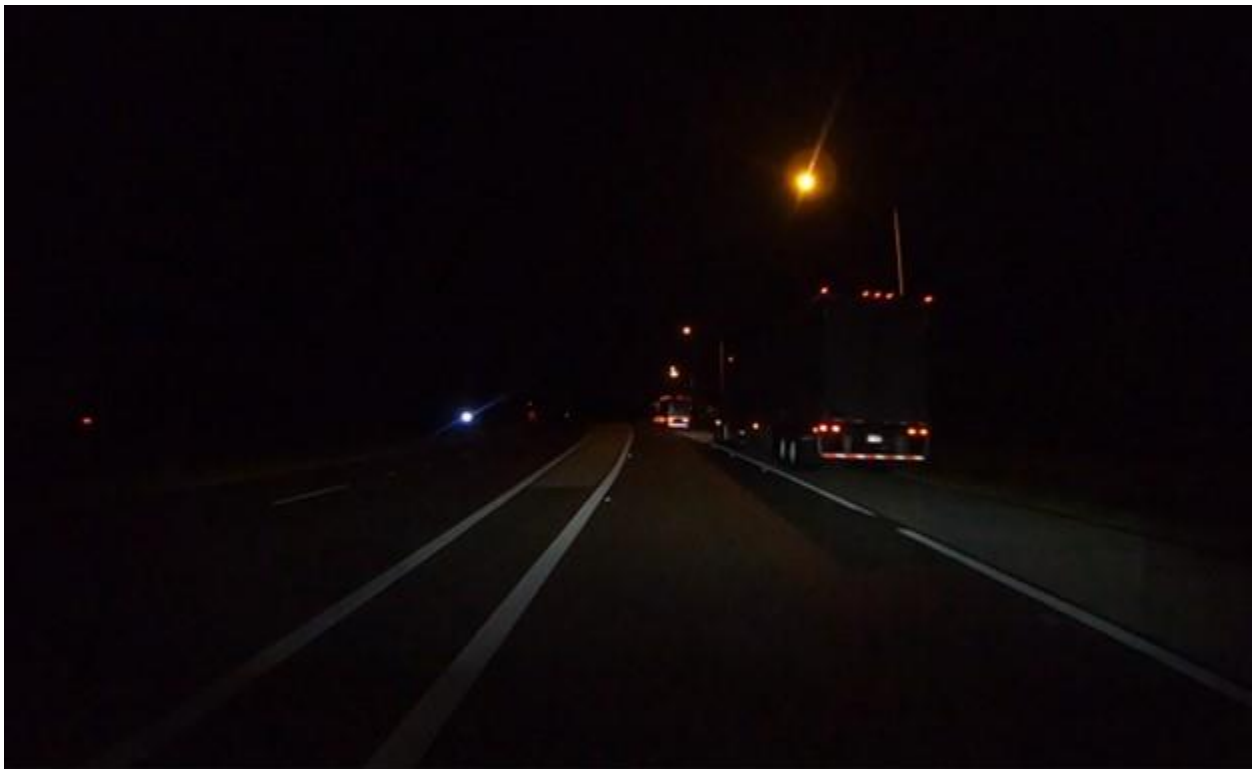
NTSB investigators conducted a nighttime scene drive-through of the crash location in the westbound direction of I-70 on July 15, 2023, three days after the crash. **Figure 9** illustrates a screenshot of two of the five truck-tractor semi-trailer combination units parked on the exit ramp shoulder to the westbound Silver Lake rest stop taken on Saturday, July 15, 2023, at approximately 9:30 p.m.

**Figure 9:** Screenshot of two of the five truck-tractor semi-trailer combination units parked on the exit ramp shoulder to the westbound Silver Lake rest stop taken on Saturday, July 15, 2023, at approximately 9:30 p.m.

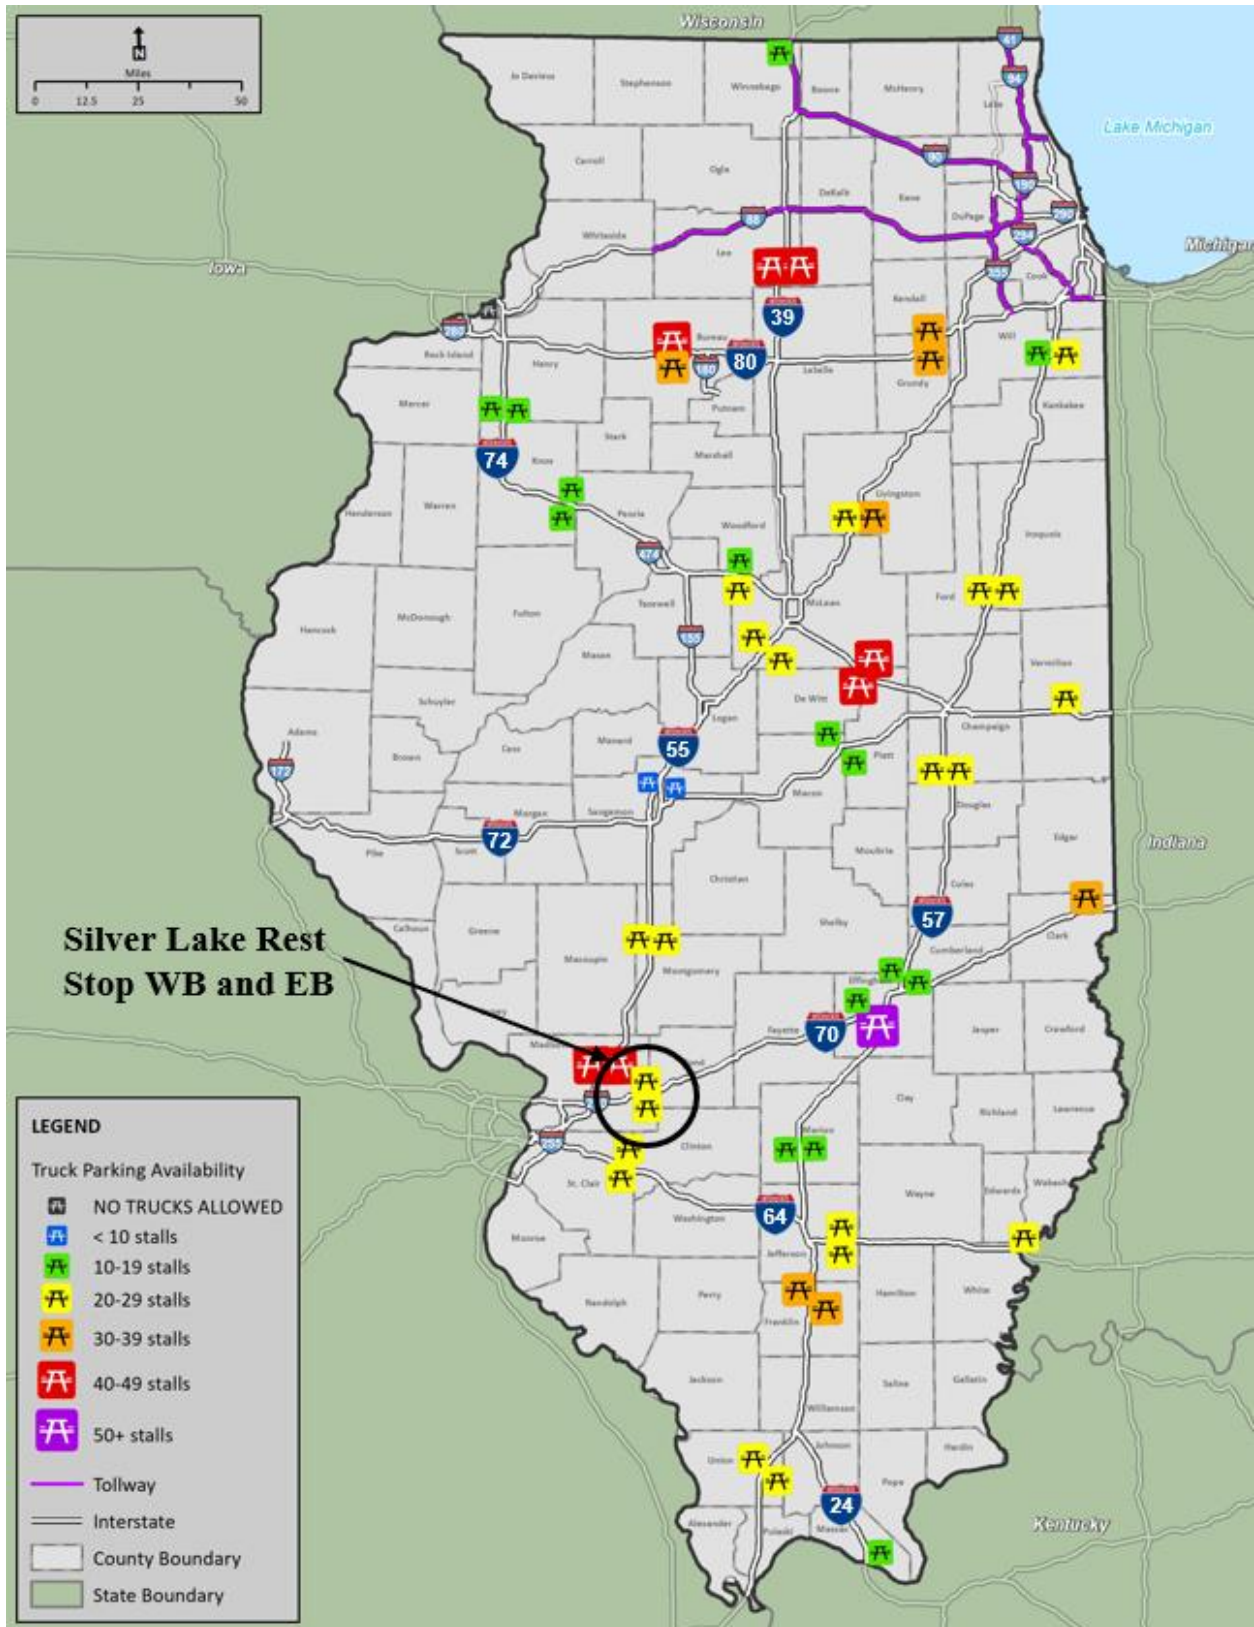
**Figure 10** illustrates the truck parking availability at each public rest stop in Illinois. As shown in **Figure 10**, the Silver Lake rest stop in the westbound and eastbound directions highlighted in yellow, fell into the category of truck parking availability that ranged from 20 to 29 stalls.<sup>16</sup>

**Figure 10:** Truck parking availability at each public rest stop in Illinois. (Source: IDOT 2018 Rest Area Study revised)

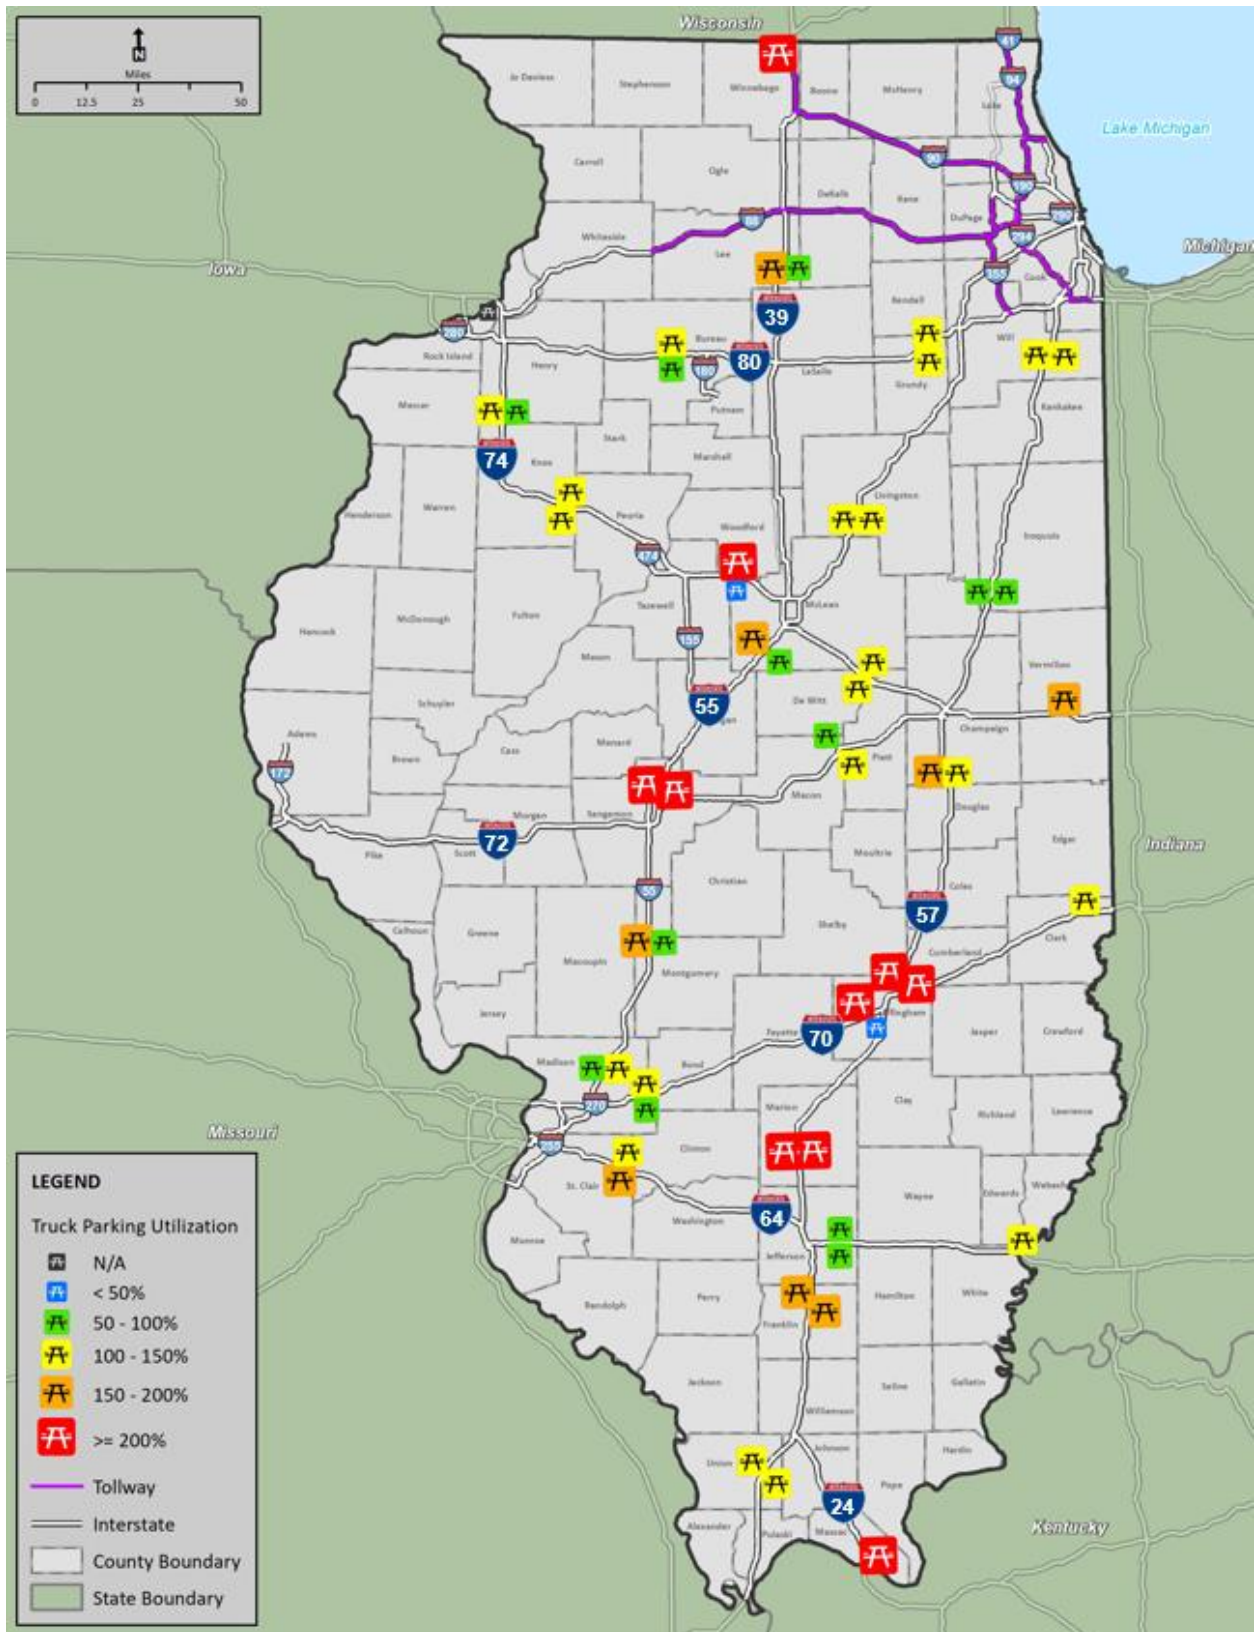
**Figure 11** illustrates the truck parking utilization at each public rest stop in Illinois. As shown in **Figure 11**, the public rest stops highlighted in red had truck parking utilization of greater than or equal to 200%. The average volume of truck shoulder parking was highest on I-55 and I-57.<sup>17</sup>

**Figure 11:** Truck parking utilization at each public rest stop in Illinois. (Source: IDOT 2018 Rest Area Study)

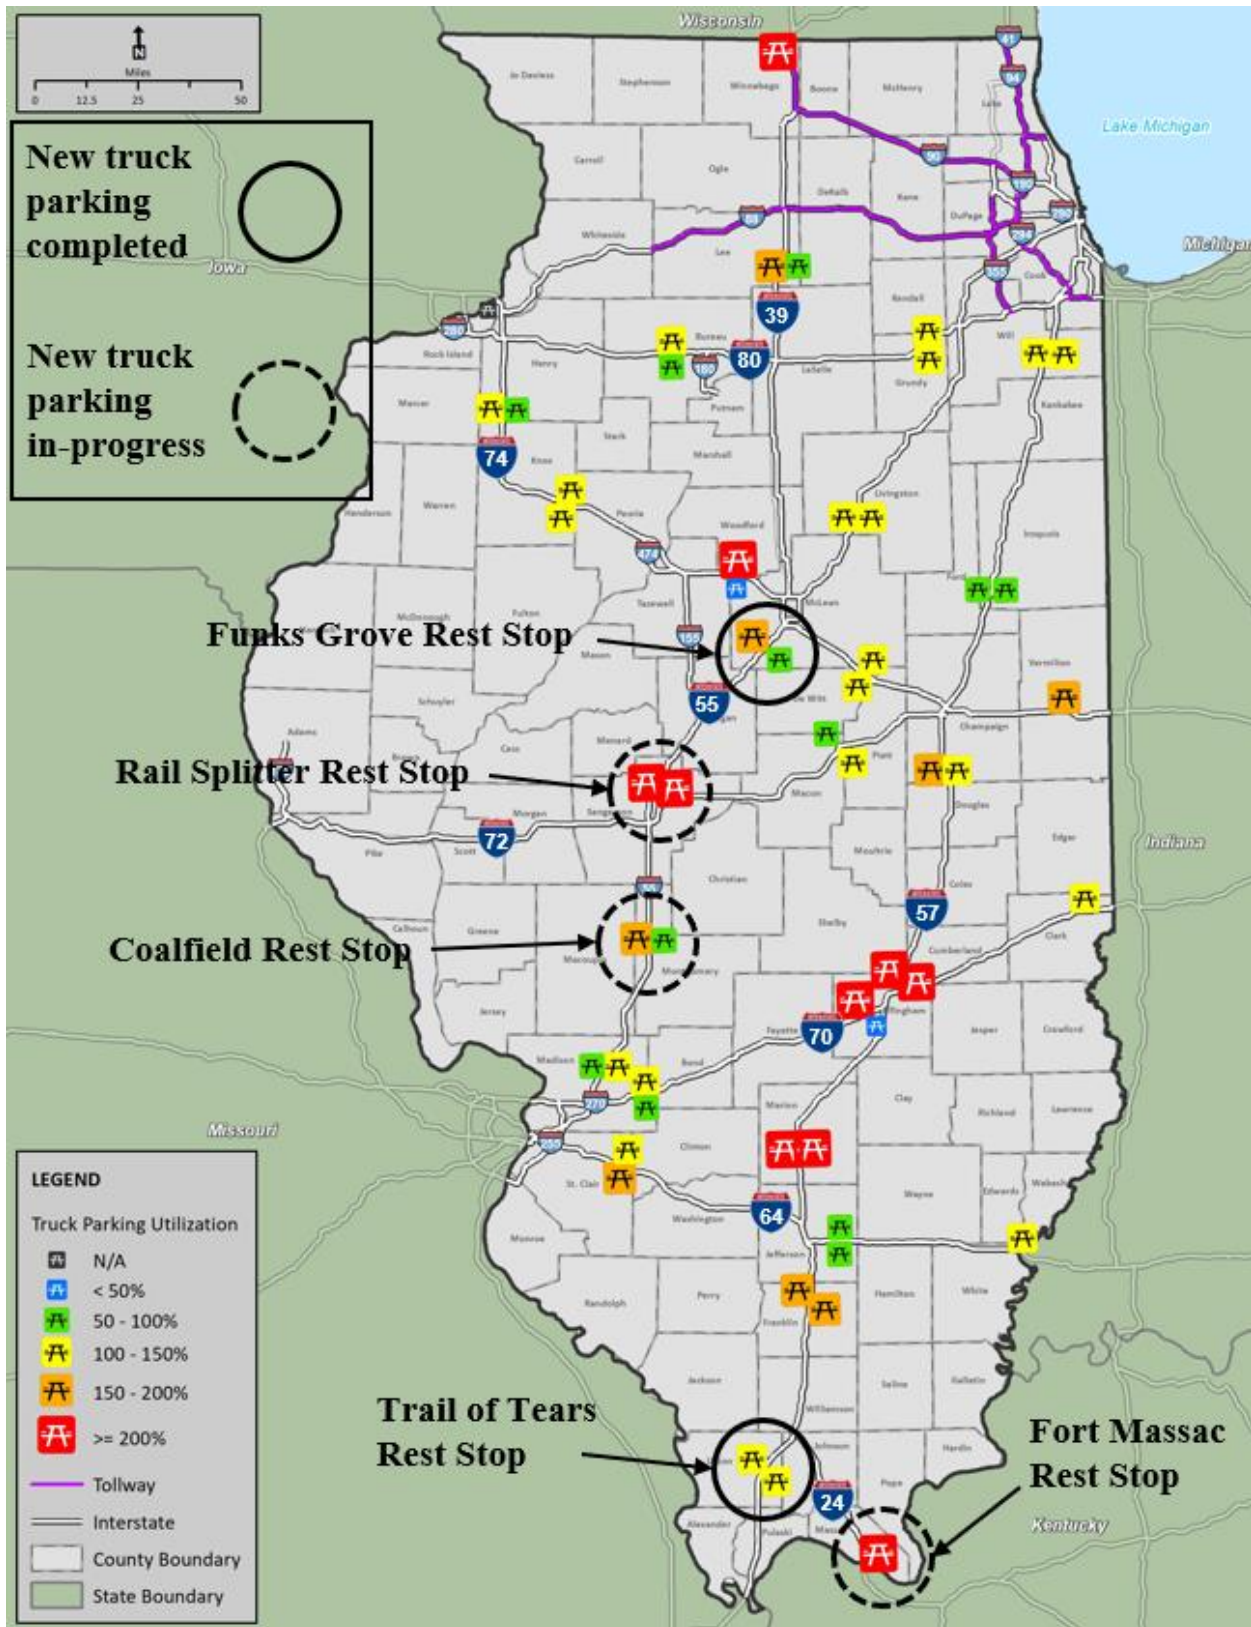
IDOT had identified 218 new truck parking spaces as completed or in-progress at five rest stops located on I-55, I-57, and I-24 in a \$53 million investment.<sup>18</sup> **Figure 12** illustrates the locations of the five rest stops overlaid on the truck parking utilization map. The new truck parking spaces completed are located at the Funks Grove and Trail of Tears rest stops. The new truck parking spaces in-progress are located at the Rail Splitter, Coalfield, and Fort Massac rest stops.

**Figure 12:** Locations of the five rest stops identified for new truck parking spaces in Illinois. (Source: IDOT 2018 Rest Area Study revised)
