National Transportation Safety Board

HWY23MH015

TECHNICAL RECONSTRUCTION

Group Chair's Factual Report

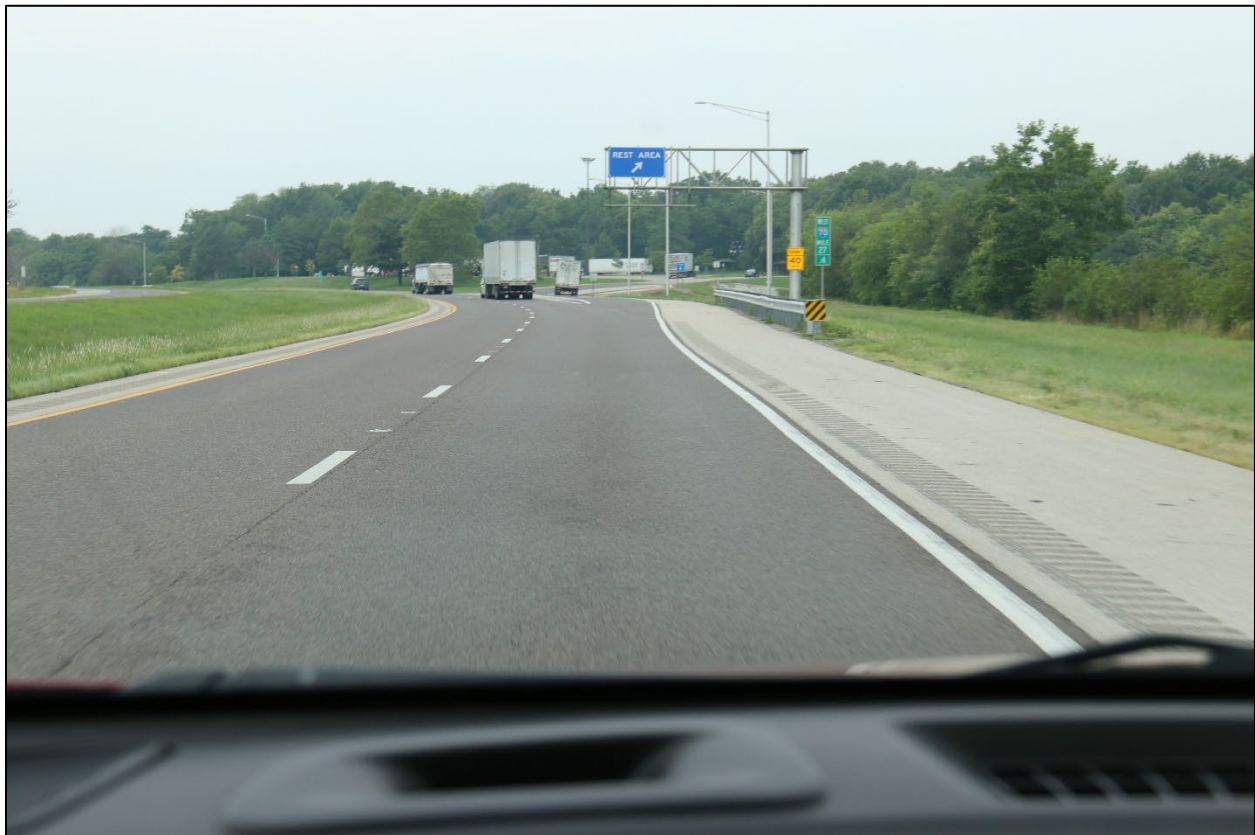
The westbound approach to the rest area and I-70 exit ramp exhibits a consistent (near tangent) west-east orientation for about 2.3 miles before the first sweeping curve (highway plans denote an actual tangent segment of about 1,204 feet before the point of curvature).¹ The first curve encountered is a 1,510-foot-long rightward horizontal curve having an approximate radius of 5,730 feet. A 272-foot tangent segment follows this curve after which the highway transitions into a 2,189-foot-long leftward horizontal curve having an approximate radius of 3,820 feet.² The rest area exit ramp begins about 10 feet before the onset of the leftward curve.³ From a westbound travel heading perspective, the rest area exit ramp visually appears as a continuation of the short tangent segment between the two curves. **Figure 2** depicts a photograph of the approach to the exit ramp. Furthermore, the exit ramp and roadway pavement striping were clear and well delineated.

Figure 2: Photograph depicting the westbound approach to the rest area exit ramp.

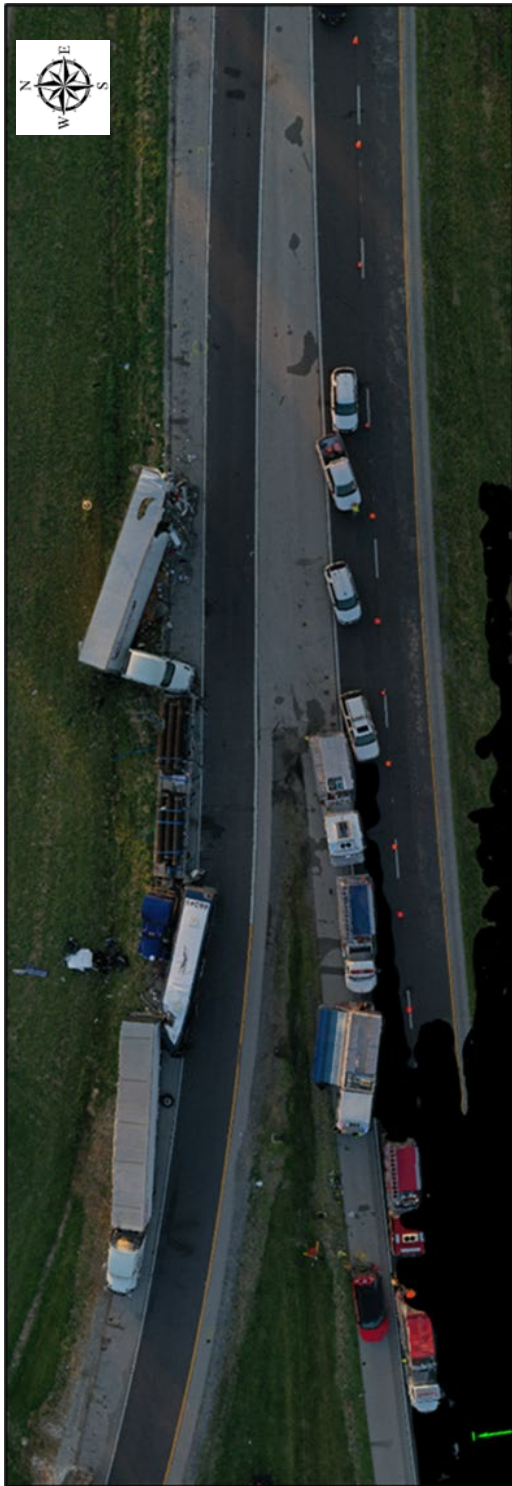
Figure 4: Selected portion of the orthomosaic image from ISP sUAS project.

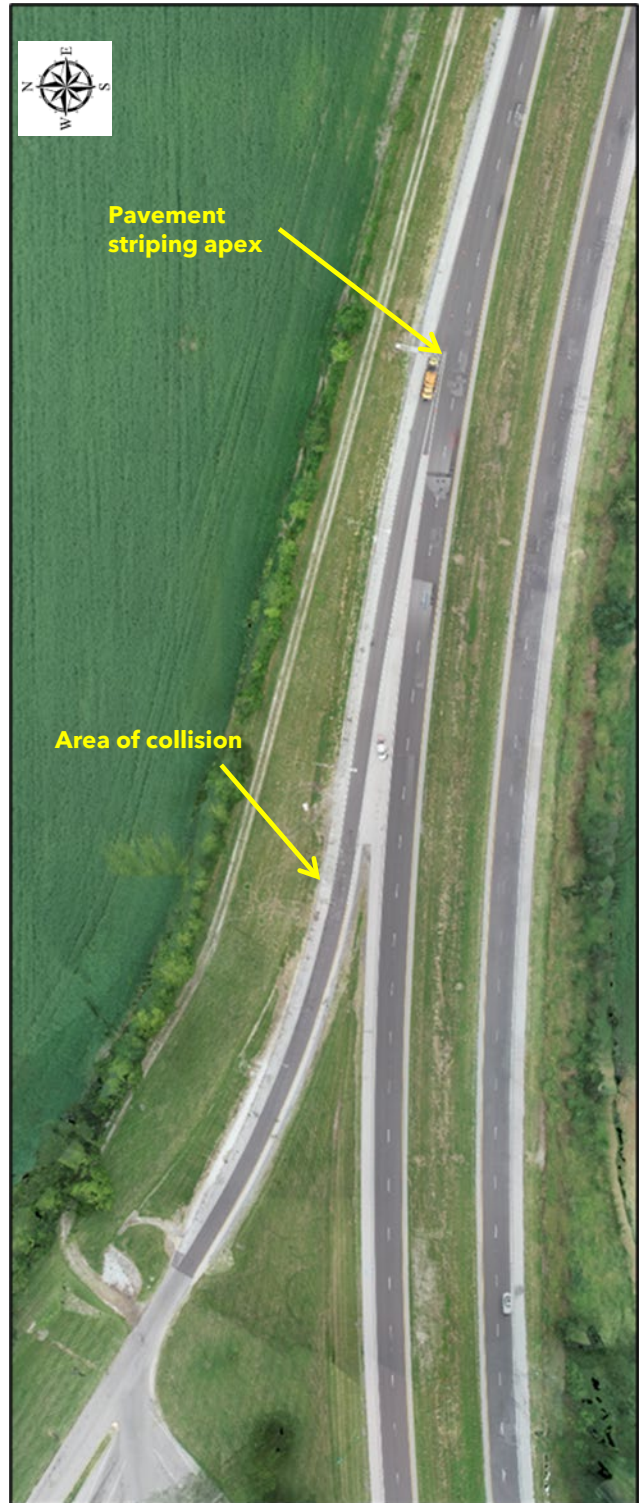
scanning about the identified area of impact for additional analytic reference.⁶ Two-dimensional orthomosaic images of the scene are depicted in **Figures 3 and 4**.

The area of impact was established at a location where the Prevost made contact with the Freightliner combination - the first vehicle struck and the last of those stopped on the ramp shoulder. At this location, a prominent tire friction mark consistent with vertical tire loading (exhibiting edge and tread rib deflection) and pavement slip characteristics of an impact was identified. The mark was located on the shoulder and centered approximately 1.4 feet offset from the edge line and 465 feet west of the start of the ramp (~309 feet from the apex of the pavement striped gore). A near parallel mark is observable in terrestrial photographs positioned closer to the pavement edge (this mark was not discernible in sUAS photographs).

Figure 3: Selected portion of orthomosaic image from the NTSB sUAS project.

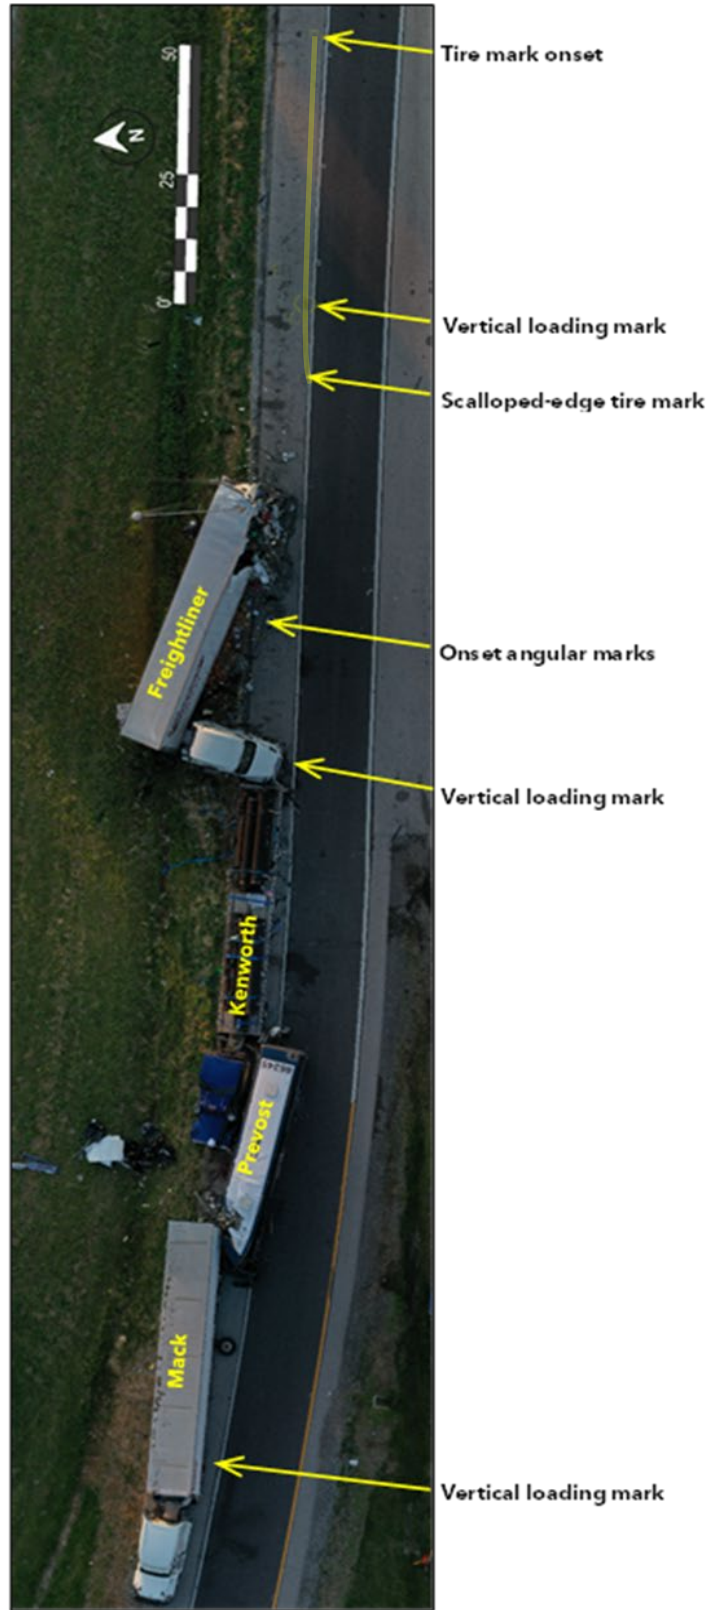
Beginning approximately 50 feet west of the first area of impact a series of prominent tire friction marks angled from the shoulder toward the right roadside. These marks were most prominent from about the middle of the ramp shoulder extending to the pavement edge. Very light pavement surface scratches and other tire friction marks were observed on the shoulder between the area of impact and these angled marks. These angled marks were consistent with the off-pavement location of the Freightliner's drive axle wheels.

Further westward surface scrapes and additional tire friction marks were observed with nearly all roadway evidence confined to the ramp shoulder. Additional, more prominent tire friction marks characteristic of vertical loading appeared about 86 and 220 feet west of the first area of impact. Examination of ISP on-scene photographs placed these loading marks in proximity to the Kenworth and Mack combination vehicles, respectively. The more prominent tire friction marks are highlighted in **Figure 5**.

Figure 5: Image depicting vehicle post-collision positions of rest relative to certain roadway evidence (additional highlight added to tire mark).

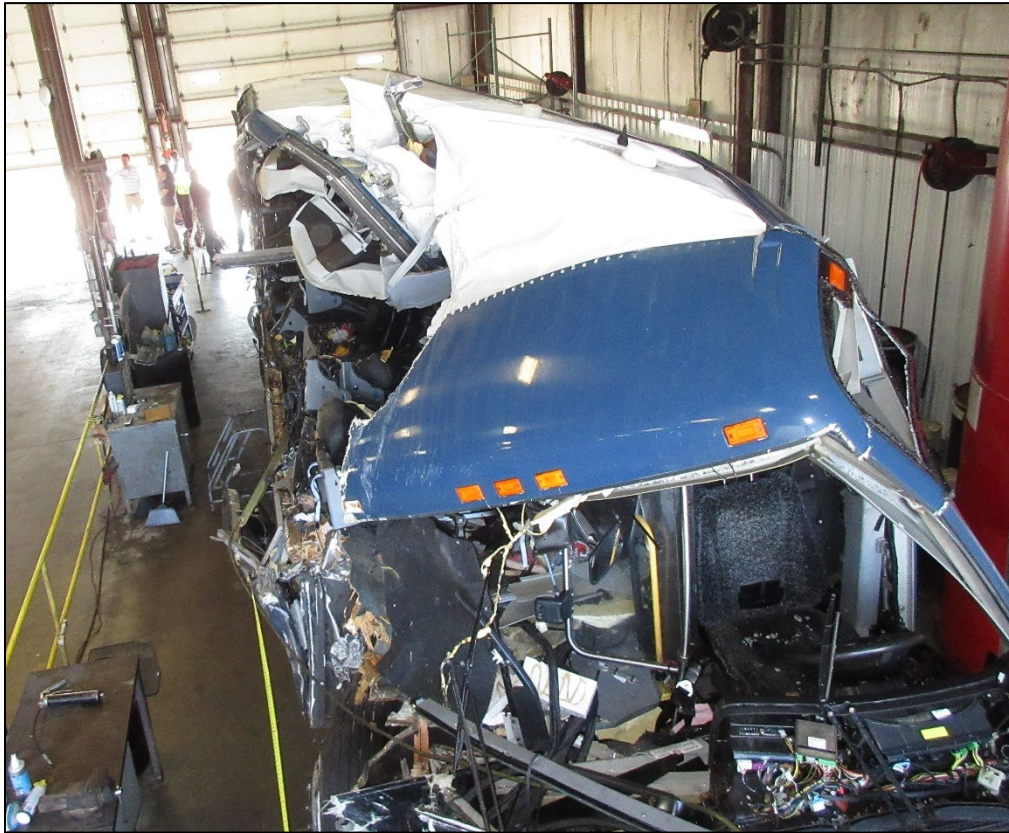
The passenger side of the motorcoach sustained extensive damage that exhibited evidence of overlapping areas of contact forward of the front axle. Intrusion and separation of the passenger side occupant compartment sidewall continued rearward from the frontal impact area. ISP scene photographs depict significant overlap of the contact area between impact with the Freightliner combination and Mack combination. Evidence of direct contact was observed at passenger side and extended inboard about 21-23 inches (indirect and recovery damage extended further inboard of the right side). The forward structure was displaced rearward into the passenger stairwell. As depicted in **Figure 6**, the passenger side A-pillar was displaced, and the roof panel disfigured rearward along the passenger side approximately 14 feet.

Figure 6: Photograph depicting damage to motorcoach roof.

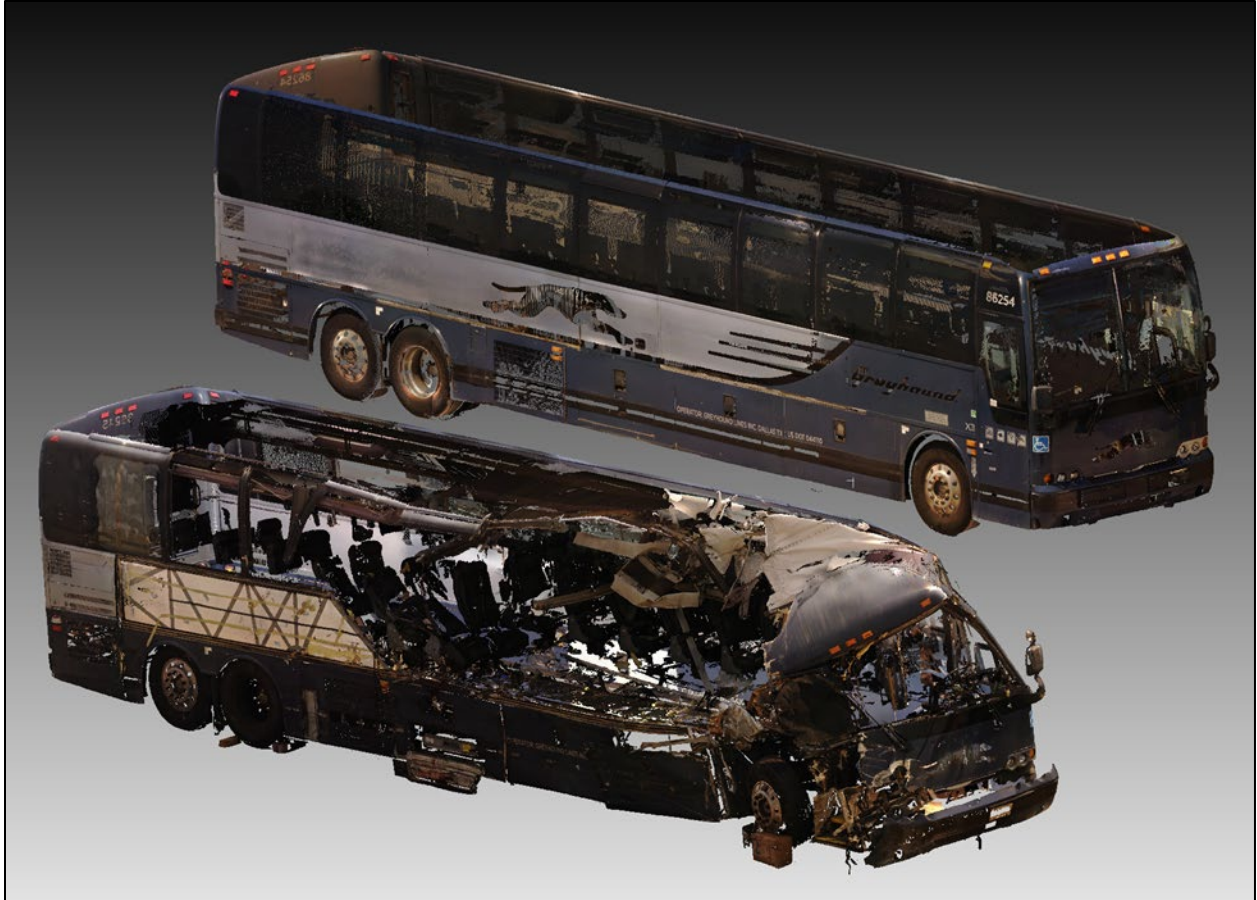
Figure 7 depicts a screen capture of an oblique view of point clouds created from 3D scans of the involved motorcoach and an exemplar motorcoach provided by the carrier.

At final rest, the Prevost was engaged with the driver side rear of the semitrailer in the Mack combination. Post-collision damage examination indicated that the lateral intrusion from the trailer extended inboard from the passenger side of the motorcoach no further than about 21-23 inches and rearward no further than the rear of front tire fender, about 9.5 feet rearward from the vehicle front.

Figure 7: Three-dimensional point cloud images of the involved motorcoach and an exemplar vehicle.

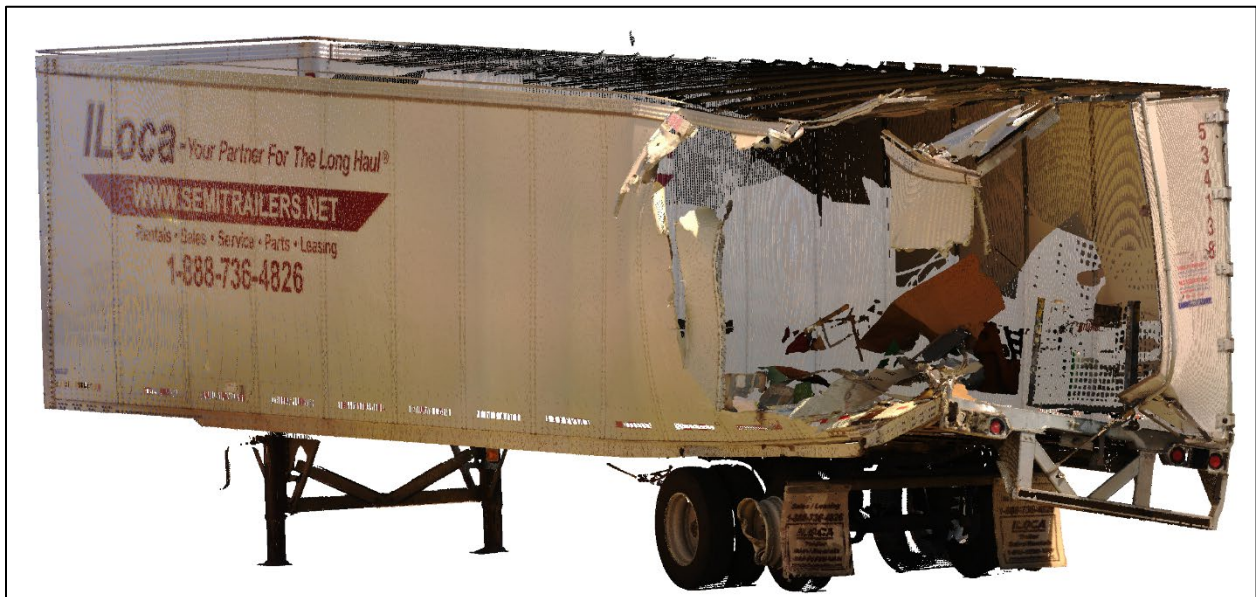
The Vanguard semitrailer exhibited contact damage at the driver side rear with related damage continuing forward. At time of examination, the driver side rear loading door was missing, the left side rear vertical support and a portion of the left sidewall were missing. The missing sidewall extended forward about 12 feet from the rear of the vehicle. The driver side rear exhibited evidence of contact damage that extended inboard about 15 inches from the sidewall. The left rear corner of the semitrailer was displaced upward about 2.5 inches. Post-crash vertical measurements with the trailer parked on its landing gear, revealed a floor height of about 45 inches and a lower sidewall rail height of about 43 inches above the ground, respectively.

Contact damage was outboard of the driver side longitudinal frame rail. The exterior underside of the floor exhibited evidence of contact damage that extended forward about 15.2 feet while angled outboard to the left side. The damage area terminated just behind the leading axle. The driver side outer tire and wheel on the trailing axle also exhibited contact damage. **Figure 8** depicts a screen capture of an oblique view of the point cloud created from 3D scans of the semitrailer.

Figure 8: Three-dimensional point cloud image of the Vanguard semitrailer.

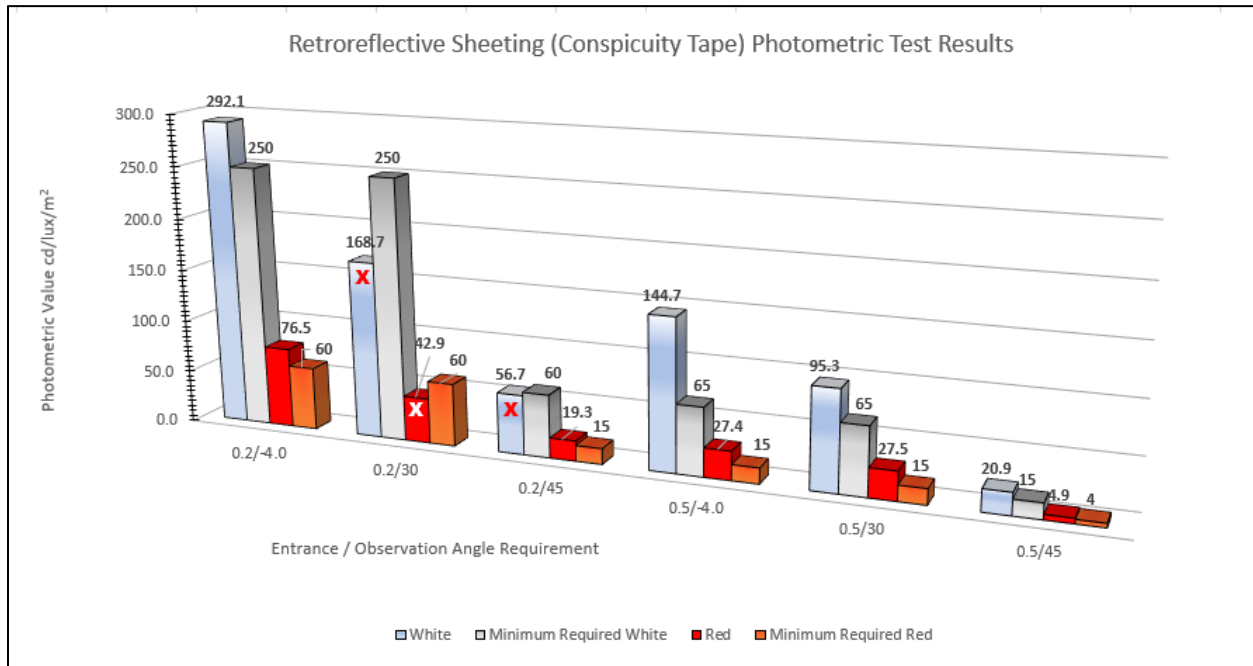
Visual examination of the conspicuity sheeting concluded that the material complied with applicable installation standards (FMVSS 108, S8.2). While photometric standards for the conspicuity sheeting specified by FMVSS 108 are applicable at the time the vehicle is manufactured, samples were acquired from the rear of the vehicle for evaluation. Although the sheeting applied to the underride guard and bottom door edges exhibited significant collision damage, an 18.5-inch-long sample was acquired from the passenger side rear door for examination. That sample contained at least one complete red and white segment. The sample exhibited no direct damage other than wear.

A RoadVista model 932 retroreflectometer was used to measure the photometric value of the samples. The measurement protocol adhered to ASTM E1709 and ASTM E2540 to evaluate the requirements of FMVSS 108, S8.2.1.7 for both red and white segments of the sheeting. The measurements were reported for entrance angles of -4, 15, and 30 degrees in combination with observation angles at 0.2, and 0.5 degrees. Measurements were taken at several points on each color segment of each sample. Other than brushing off visible dirt, the surfaces were not altered. FMVSS 108 Table XVI-c cites the threshold values for new applications. Appendix 2 provides additional reference to FMVSS 108 requirements for retroreflective sheeting. **Figure 9** is a photograph of the sheeting samples. The photometric results are cited and graphically conveyed in **Figure 10**.

Figure 10: Photometric examination results from sample of Vanguard conspicuity sheeting on rear of vehicle.

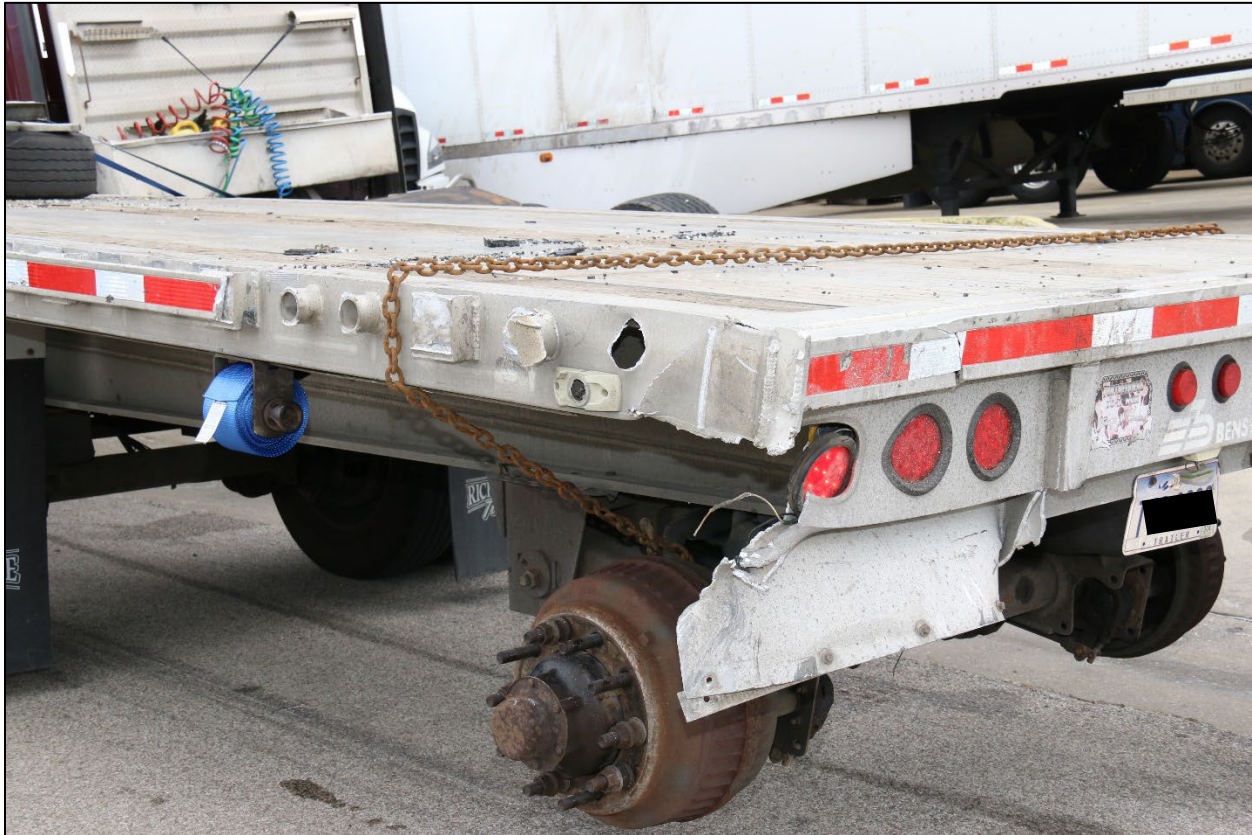
The driver-side rear corner of the semitrailer exhibited contact damage (**Figure 11**). A segment of the rub rail and the trailing axle outer wheel and tire at the end of

the trailer were displaced or substantially damaged. The outer tires and wheels on the driver side of the semitrailer and truck tractor likewise exhibited contact damage as did the truck tractor's left-side fuel tank, entry step and front fender.

Figure 11: Photograph depicting area of first contact at the driver side rear of the Benson semitrailer (Kenworth combination).

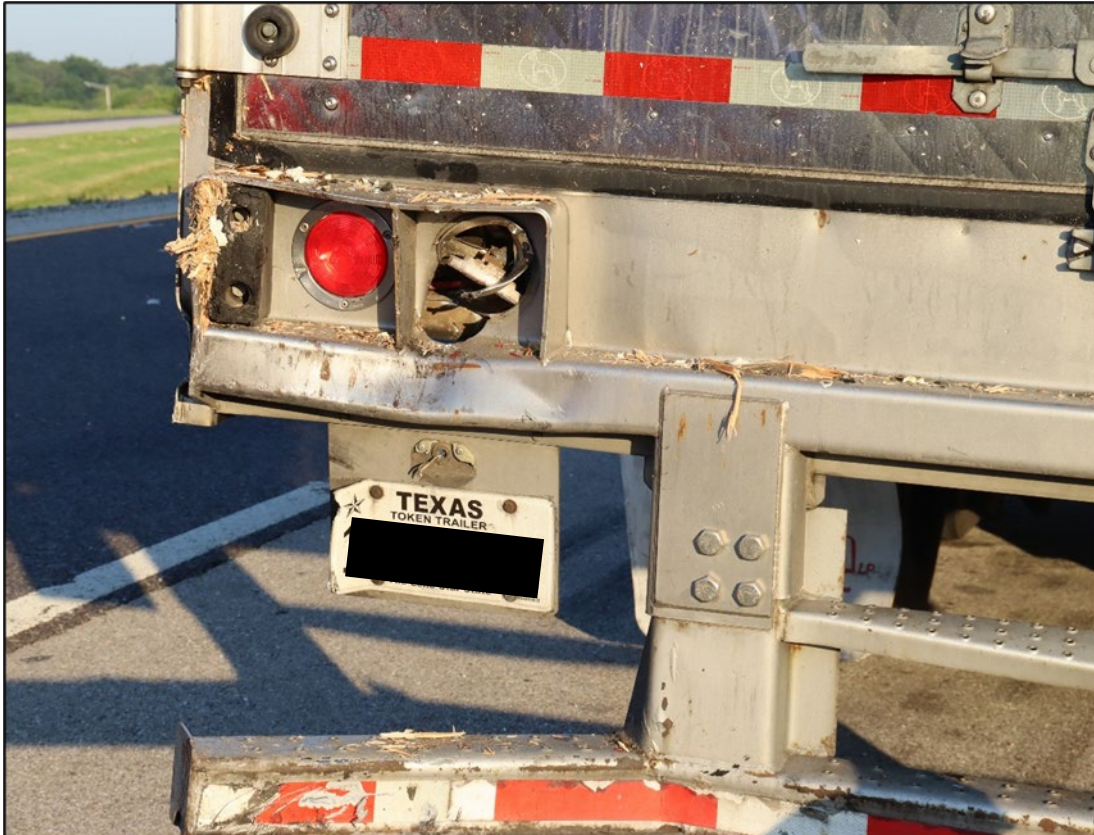
As depicted in ISP site photographs, the semitrailer exhibited contact damage at the driver side rear corner, outboard of the vertical support for the rear underride guard (**Figure 12**). Scene photographs depict the rear of the semitrailer as having intruded into the motorcoach and overlapped the area of initial contact with the Vanguard semitrailer. Photographs depict the semitrailer deck as having overridden the motorcoach front tire and come to rest around the trailing end of the wheel well, an overall distance of about 9.5 feet from the front of the motorcoach.

Figure 12: Photograph depicting impact damage to the driver side rear of the Great Dane semitrailer (Mack combination courtesy of ISP).

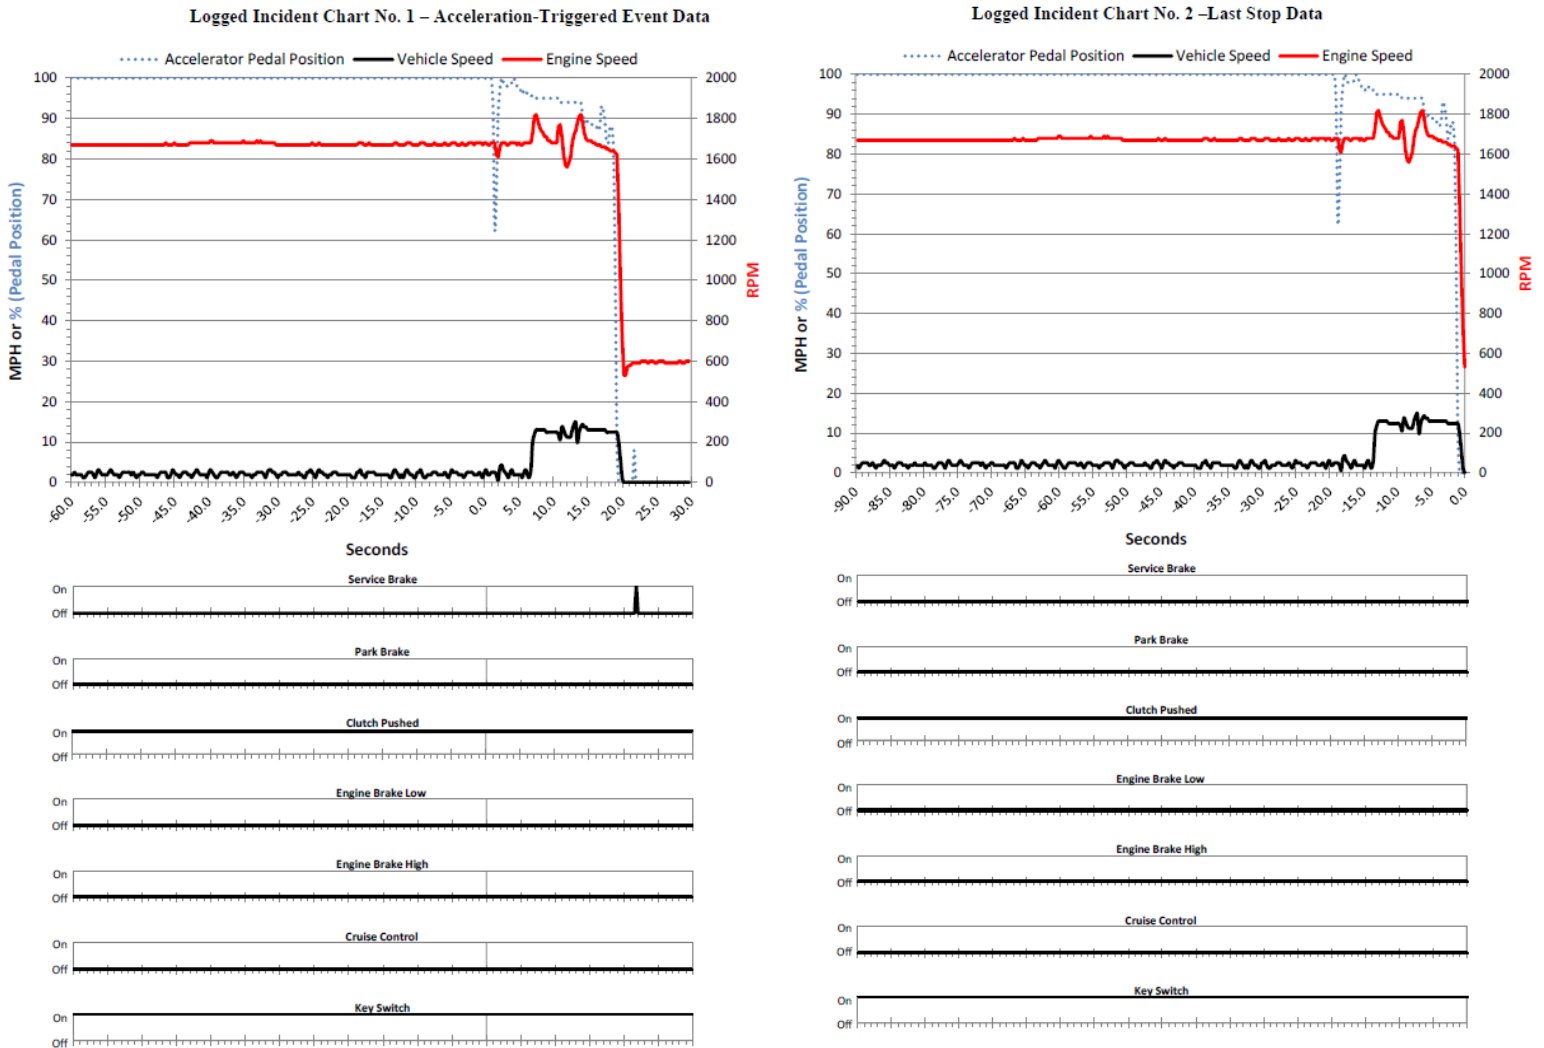
The data imaging revealed two records or “logged incidents,” one titled “acceleration-triggered event” and the second “last stop”. The event dates and times were recorded as 07/12/2023 at 05:48:32 and 05:48:52 UTC, (20 seconds apart) respectively. Although the crash occurred in the U.S. Central Time zone, these times would correlate with Eastern Standard Time for the approximate time of the crash if the ECM were initially set to EST as many are. Information provided by other investigators approximated the time of the crash 01:48 hours CDT. While typical time validation can be accomplished by comparing the current ECM time with the download computer time (i.e., identify ECM clock drift), a difference of more than 58 hours was observed.¹¹ Interpretation of a diagnostic trouble code (DTC) time stamp in the data indicated that the ECM clock apparently stopped at some point - potentially the crash incident - and then restarted when powered-up for the imaging.

The parameters in each of the data records were populated and the two records exhibited some overlap where the data could be aligned. While certain parameters exhibited consistency, others such as vehicle speed did not. The data did not indicate

a brake application. Graphs from the individual records produced from the imaged data and provided to NTSB investigators are provided in **Figure 13**.

Figure 13: Graphs depicting data from the two logged events as provided to NTSB investigators following imaging of the Prevost engine ECM.

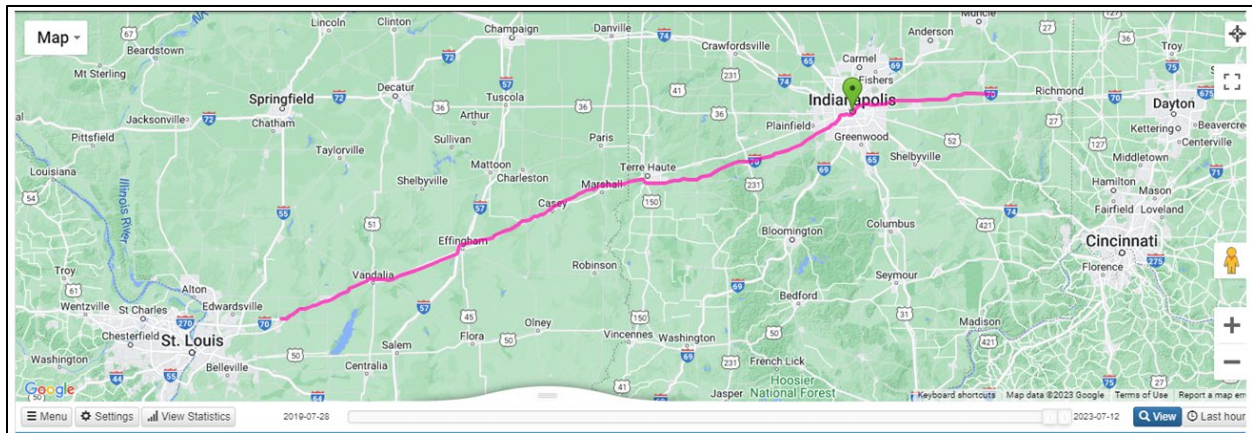
Figure 14: Map image provided by motorcoach carrier depicting vehicle position (route) as derived from the Icomera mobile wi-fi system.

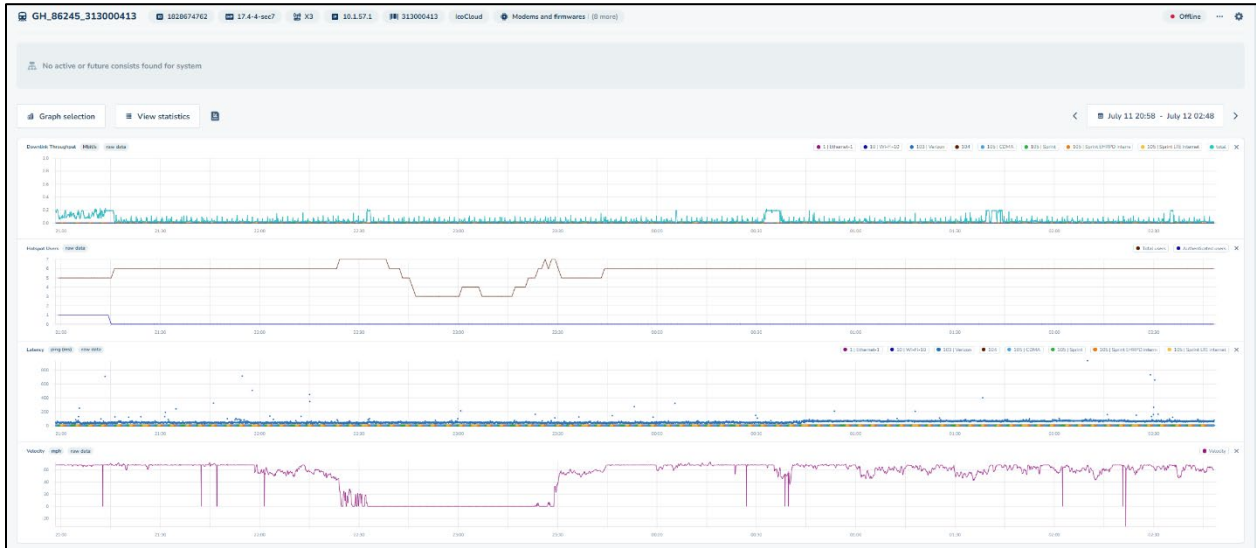
Figure 15: Graphical data image provided by motorcoach carrier depicting certain data from the Icomera mobile wi-fi system.

The motor carrier described the data images as representing the last data feed from the motorcoach before the crash event. The time scale depicted runs from just before 21:00 (9:00 p.m.) to just after 02:45 (2:45 a.m.). While the time zone (likely a programmed aspect rather than a unit location aspect) is not indicated, it would be consistent with Eastern Daylight Time in the context of the crash. The underlying data for the velocity graph were not provided.
