National Transportation Safety Board

HWY23MH015

SURVIVAL FACTORS

Group Chair's Factual Report

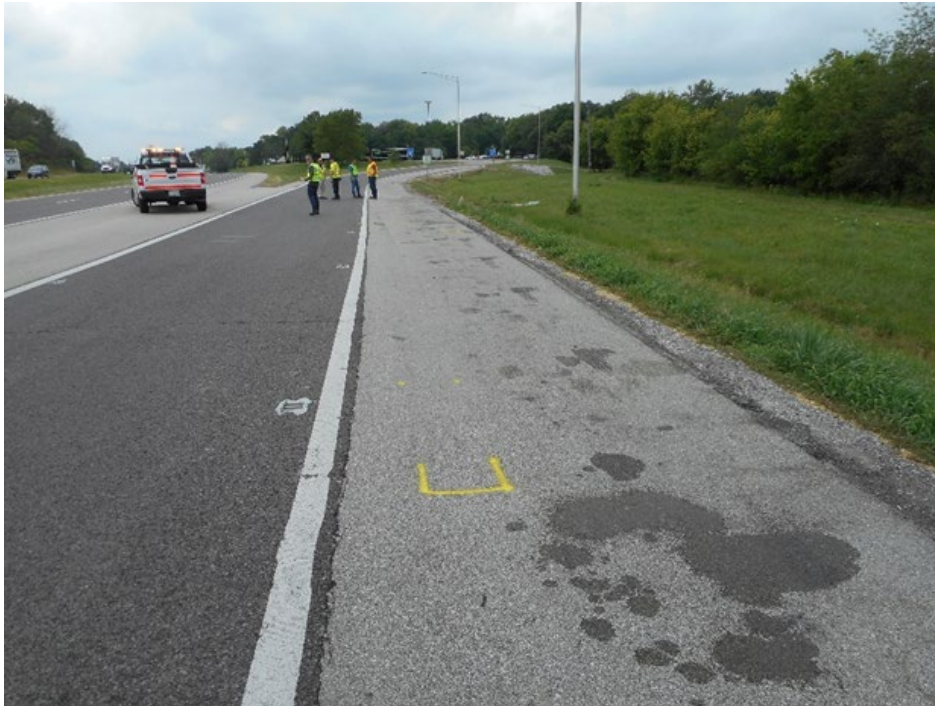
Figure 1. Post-crash view of scene showing start of tire mark from motorcoach.

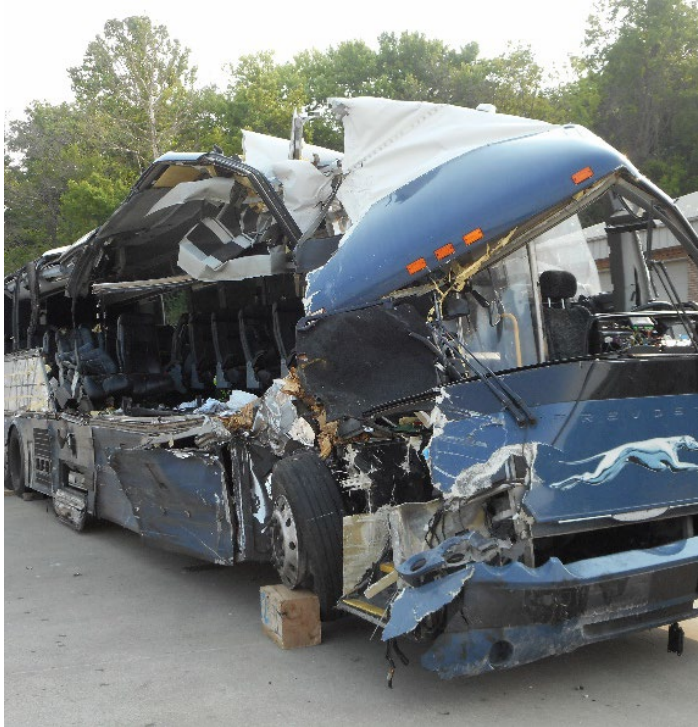
The motorcoach’s impact with three tractor-trailer combination units resulted in catastrophic damage to the motorcoach’s front end with the deformation extending down the right (passenger) side approximately 292 inches. Contact damage to the front bumper was 27 inches wide. The narrow front-end engagement resulted in the right sidewall and the first six rows of seats on the right side being sheared from the floor anchorage, as shown in **Figures 2-3**. The windshield was shattered and completely displaced. The right A-pillar, roof header and loading door frame were torn away with contact damage to the privacy panel at the entry stairwell. The impact with the parked trailers resulted in a loss of passenger occupant compartment integrity down the right side of the passenger seating compartment leaving an opening over 24 feet wide and 6 feet high. The roof’s side rail and vertical window frames were sheared away and severely deformed, and the entire roof sustained a combination of contact

Figure 2. Front angle view of damage to motorcoach.

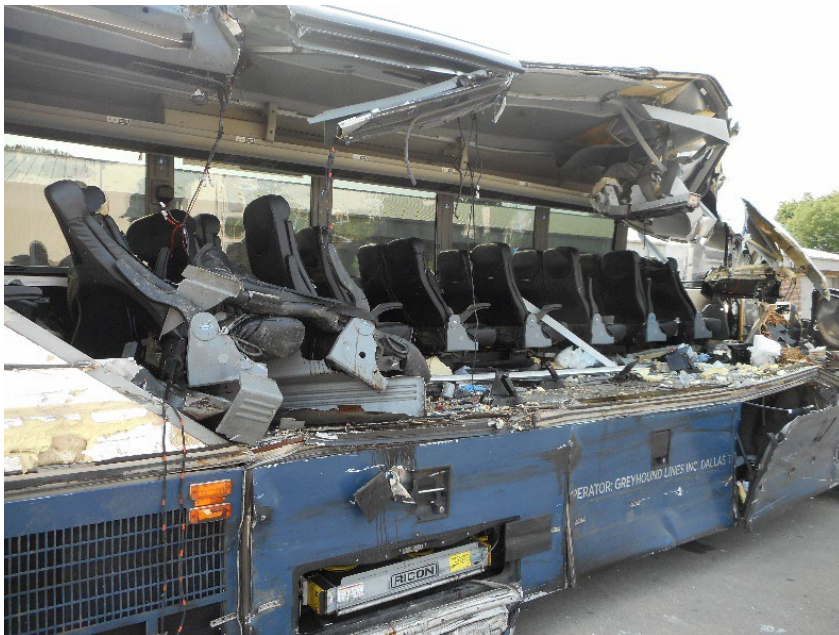
Figure 3. Right side view of damage to motorcoach.

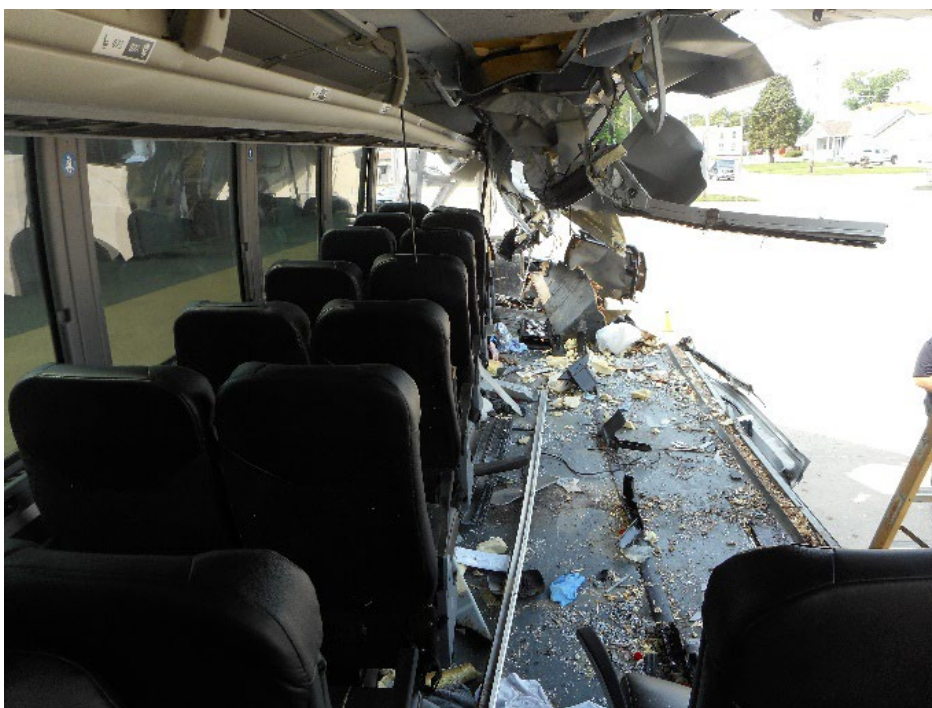
The motorcoach sustained catastrophic interior damage along the right side starting from the windshield back to Row 8. The front corner of the windshield header and A-pillar was bent under and folded back into the right-side passenger seating area extending to Row 3, resulting in approximately 30 inches of vertical intrusion. Examination of the interior of the motorcoach also revealed catastrophic lateral intrusion primarily along the right sidewall back to Row 7. The first six rows of seats were sheared away at the base of the frames. The extent of interior deformation and intrusion are shown in **Figure 4**. Firefighters stated that they did not cut out any of the right-side seats. Contact damage from striking the other trucks and trailers extended to the seatback in Row 8 on the right side as shown in **Figure 5**. Examination to the motorcoach driver's lap and shoulder belt found the driver's latchplate still inserted into the driver's seat belt buckle and the webbing for the lap and shoulder belt portions cut as shown in **Figure 6**.

Figure 4. View of interior deformation and six missing seat rows on right side.

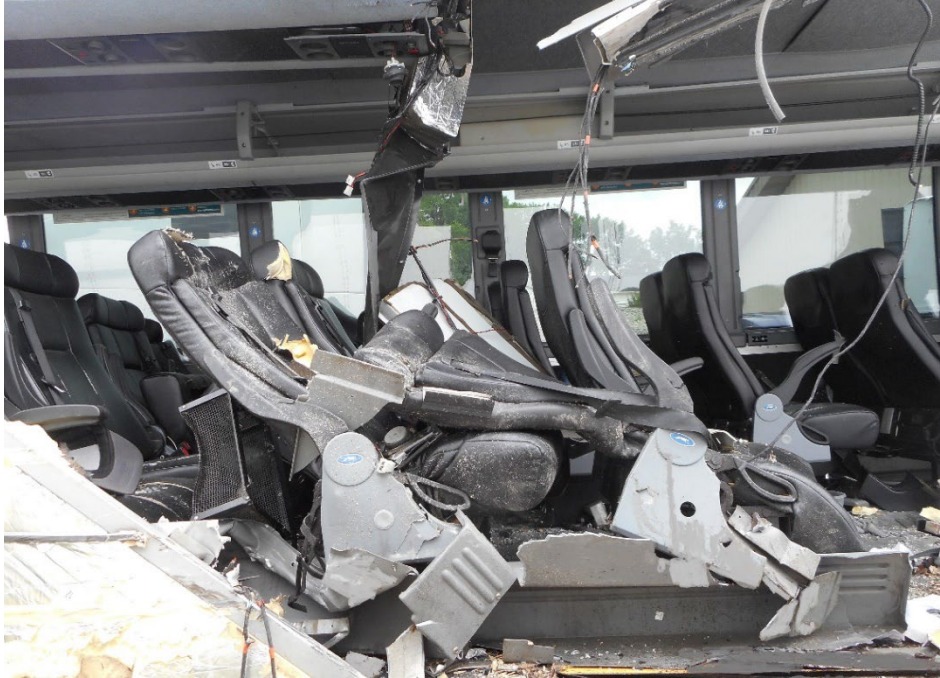
Figure 5. View of deformed seats at Rows 7-8 on right side.

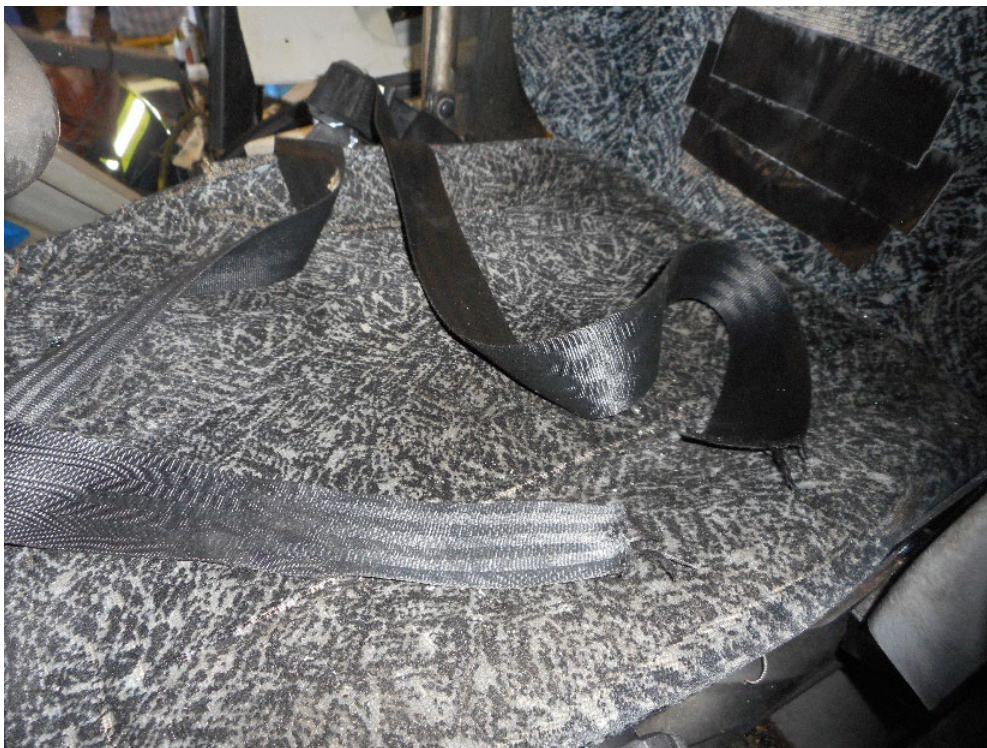
Figure 6. View of motorcoach driver's seat belt latchplate still buckled with webbing cut.

The driver's seat belt was a Type 2 lap/shoulder belt.⁵ The webbing of the driver's lap and shoulder belt were cut near the buckle and the lap belt webbing showed evidence of loading with cupping and striations to the webbing in the area his latchplate location would have been.

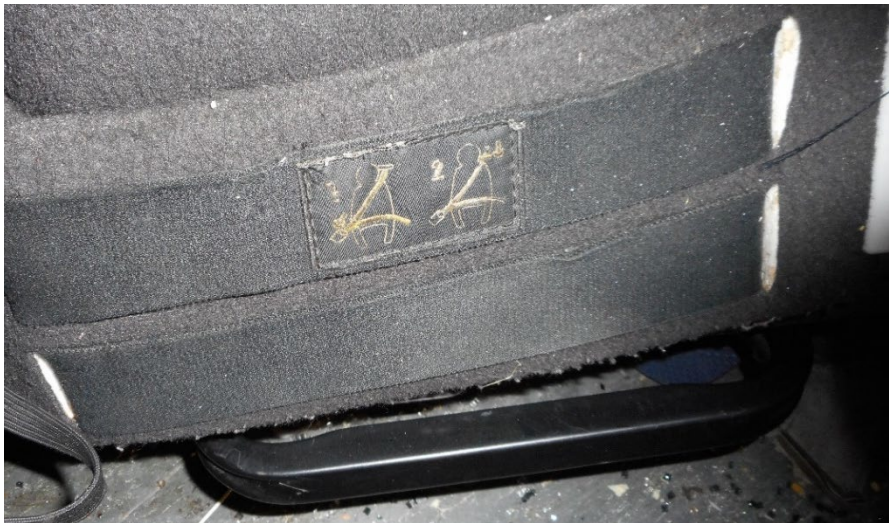
Figure 7. View of stitched in seat belt reminder to base of seatback.

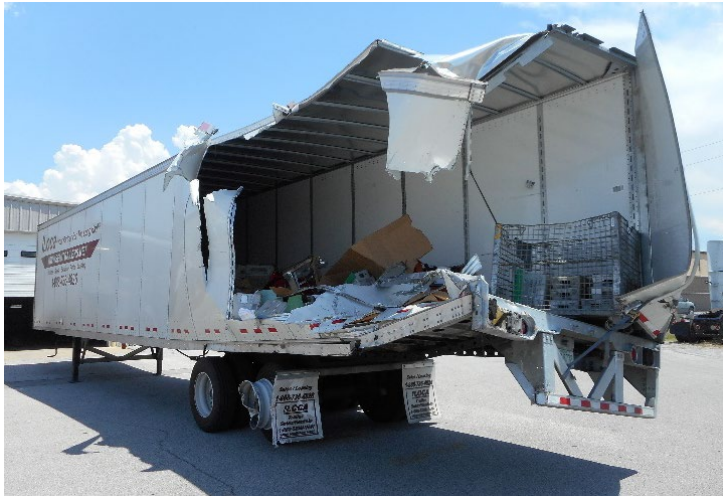
The Freightliner truck-tractor in combination with a 2024 Vanguard semi-trailer was the first parked combination vehicle struck by the motorcoach. The Vanguard trailer sustained extensive deformation as a result of the impact as shown in **Figure 8**. The combination vehicle was pushed forward into the back of the Kenworth truck-tractor combination and subsequently jackknifed off the shoulder into the grass. As shown in **Figure 9**, the front end of the truck sustained moderate damage and was towed from the scene.

Figure 8. View of damage to Vanguard trailer.

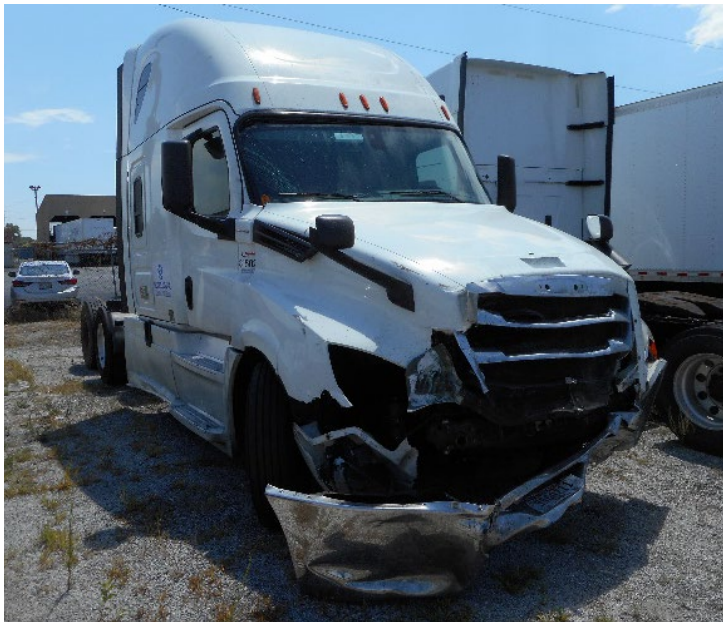
Figure 9. Frontal view of damage to Freightliner.

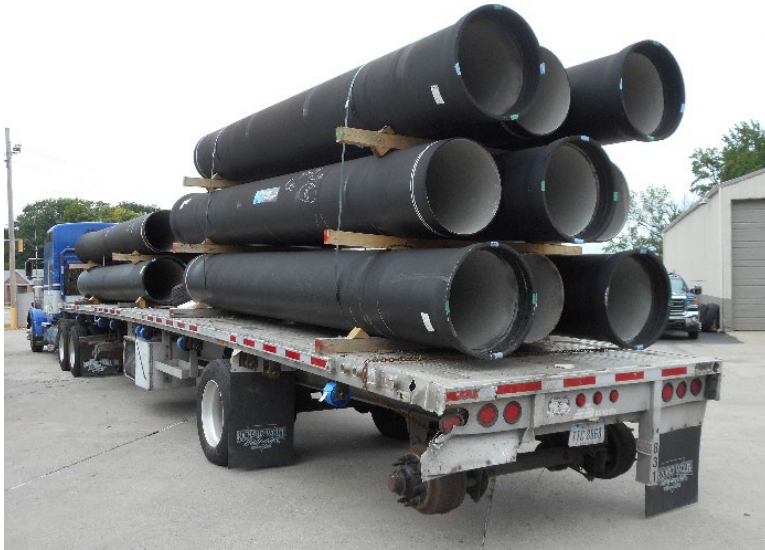
The 2000 Kenworth truck-tractor in combination with a 2007 Benson semi-trailer was the second parked combination vehicle struck by the motorcoach. The Benson flatbed trailer sustained minor deformation as a result of the impact as shown in **Figure 10**. The truck-tractor sustained minor sideswipe type damage as shown in **Figure 11**.

Figure 10. Left rear angle view of damage to trailer.

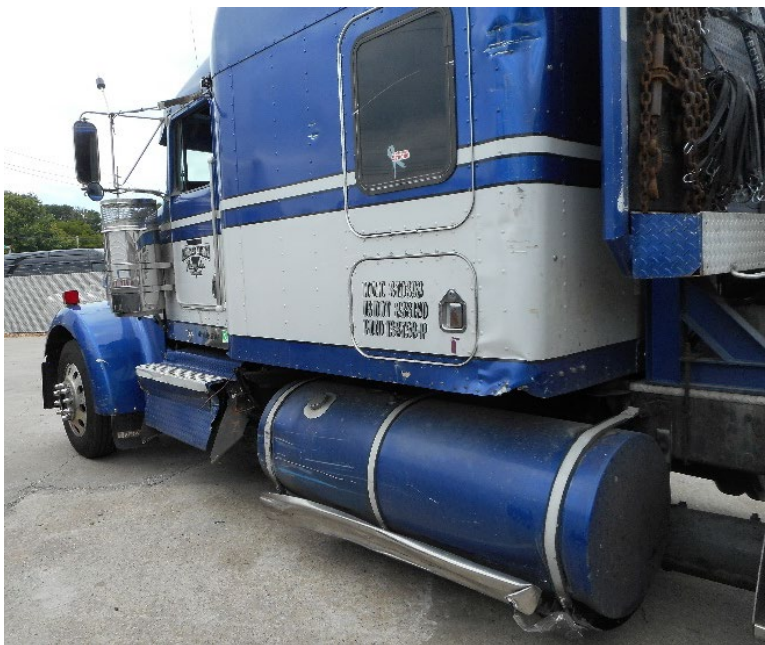
Figure 11. View of damage to left side of Kenworth.
