National Transportation Safety Board

HWY23MH015

VEHICLE FACTORS

Group Chair's Factual Report

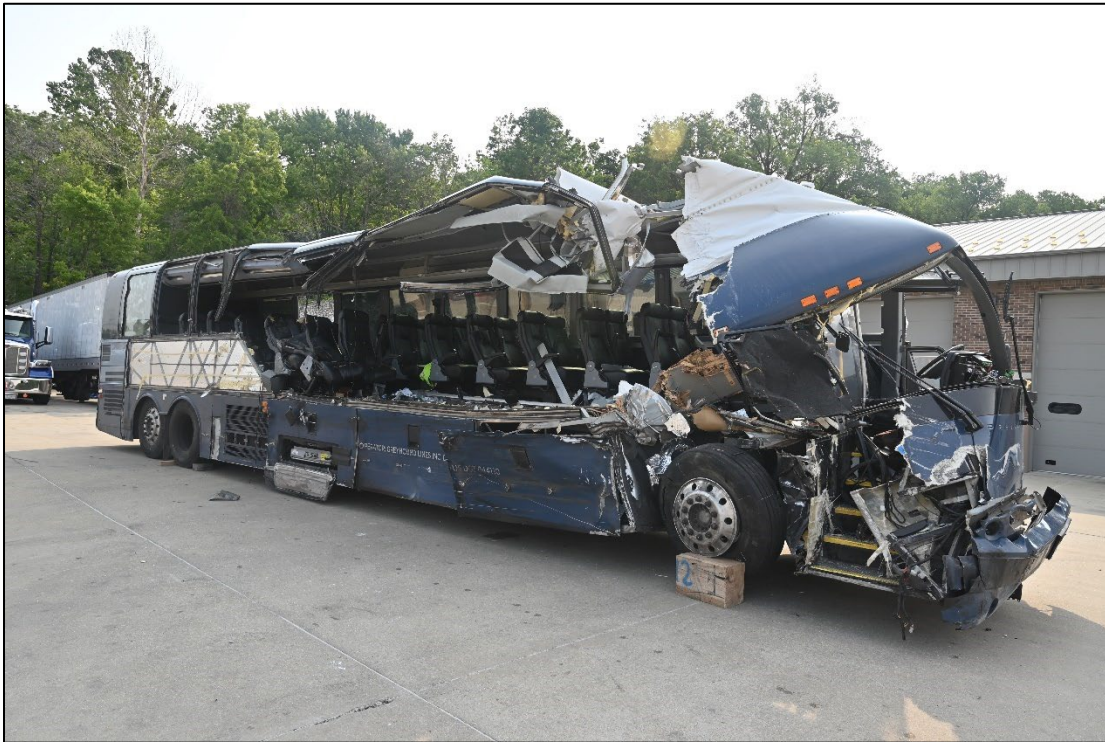
Figure 1: Motorcoach - Front-left Damage Overview

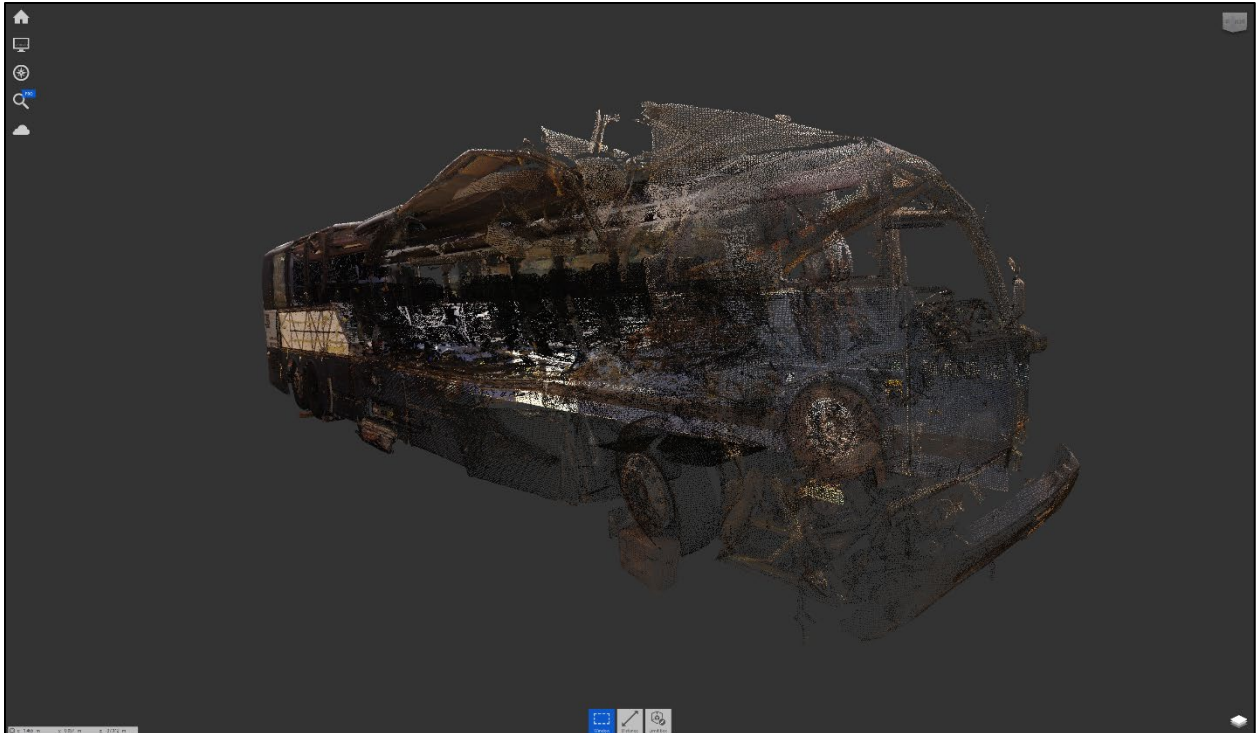
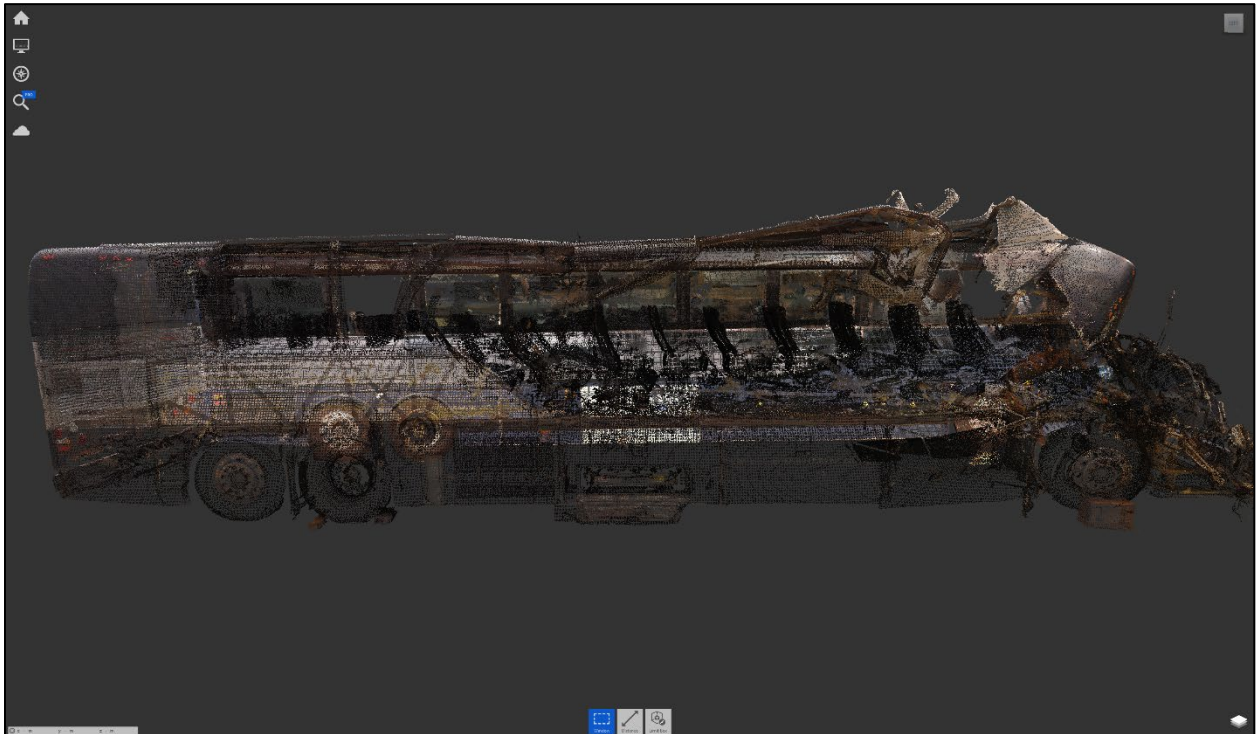
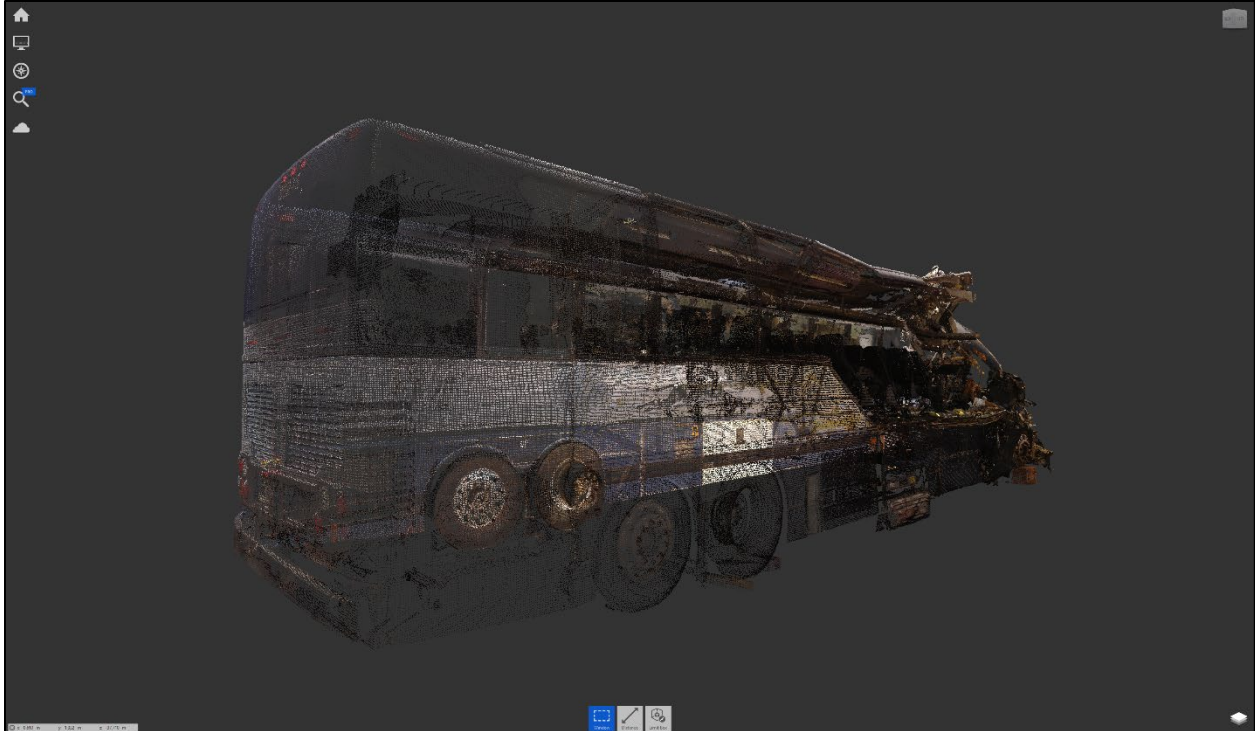
A sampling of images of the resulting point cloud for the damaged subject motorcoach can be observed below in Figure 5, Figure 6, and Figure 7.

Figure 5: Motorcoach - Subject Point Cloud - Front-Right

Figure 6: Motorcoach - Subject Point Cloud - Right-Side

Figure 7: Motorcoach - Subject Point Cloud - Rear-Right

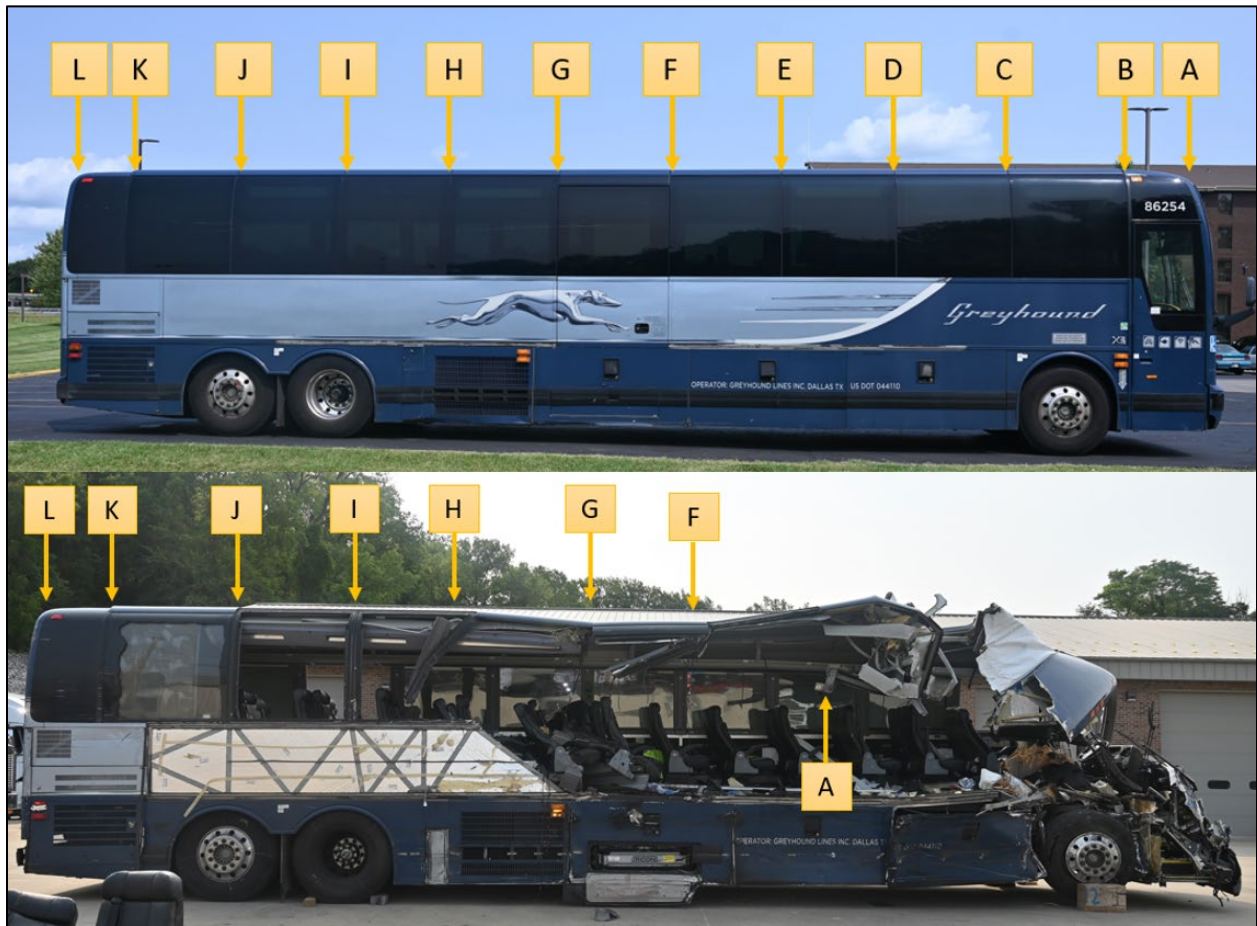
The top of the front bumper was rotated forward, and the right side was pushed rearward. The right headlight assembly was damaged. The entrance door was sheared off and missing. The front of the motorcoach’s right skirt rail was damaged and pushed rearward. The right side-rail was damaged and pushed rearward from the front of the motorcoach to Row 2. Damage to the side-rail continued rearward to approximately Row 9. The right waist⁶/window rail was missing from the front of the motorcoach to Row 9. The right A-pillar was detached from the base and was pushed rearward to row 5. There was induced damage to the left A-pillar, and it was bent rightward while still attached to the roof support. Right-side pillars B, C, D, E, and G were missing, pillars F and H were severed and pushed rearward, and pillars I, J, K, and L remained intact, as observed in Figure 8.

Figure 8: Motorcoach - Pillar Damage Comparison - Exemplar and Subject⁷

⁷ Lower image: "G" denotes the location that Pillar G previously resided.

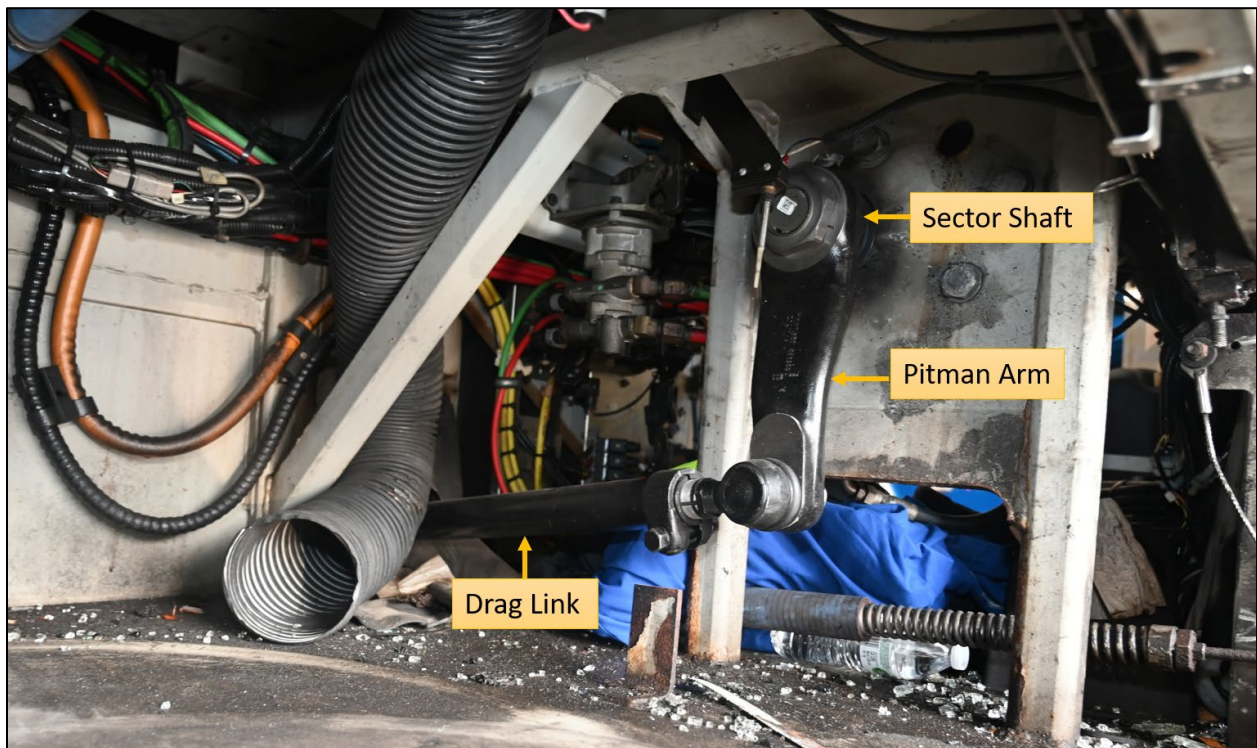
The steering system was intact and functional. The steering gearbox, pitman arm, drag link, steering knuckles, and tie rod were examined (Figure 13). There was crash-related downward deformation observed at the center of the tie rod which caused the tie rod to be in contact with suspension components, as observed in Figure 14. All securement pinch bolts were examined and found to be tight. According to maintenance records obtained from Greyhound Lines, Inc., the steering gearbox, pitman arm, drag link, tie rod, and ball joint ends were replaced on June 29, 2023. The tie rod did not have any visible part number attached or stamped onto it but did have an affixed label that stated "Kit IS18091". The steering was checked for looseness at the sector shaft, pitman arm, drag link, and the ball joints. There was no looseness observed. The steering system was manually rotated from the left stop to the right stop and vice versa, via the steering wheel, with no other issues observed.

Figure 13: Motorcoach - Steering Components

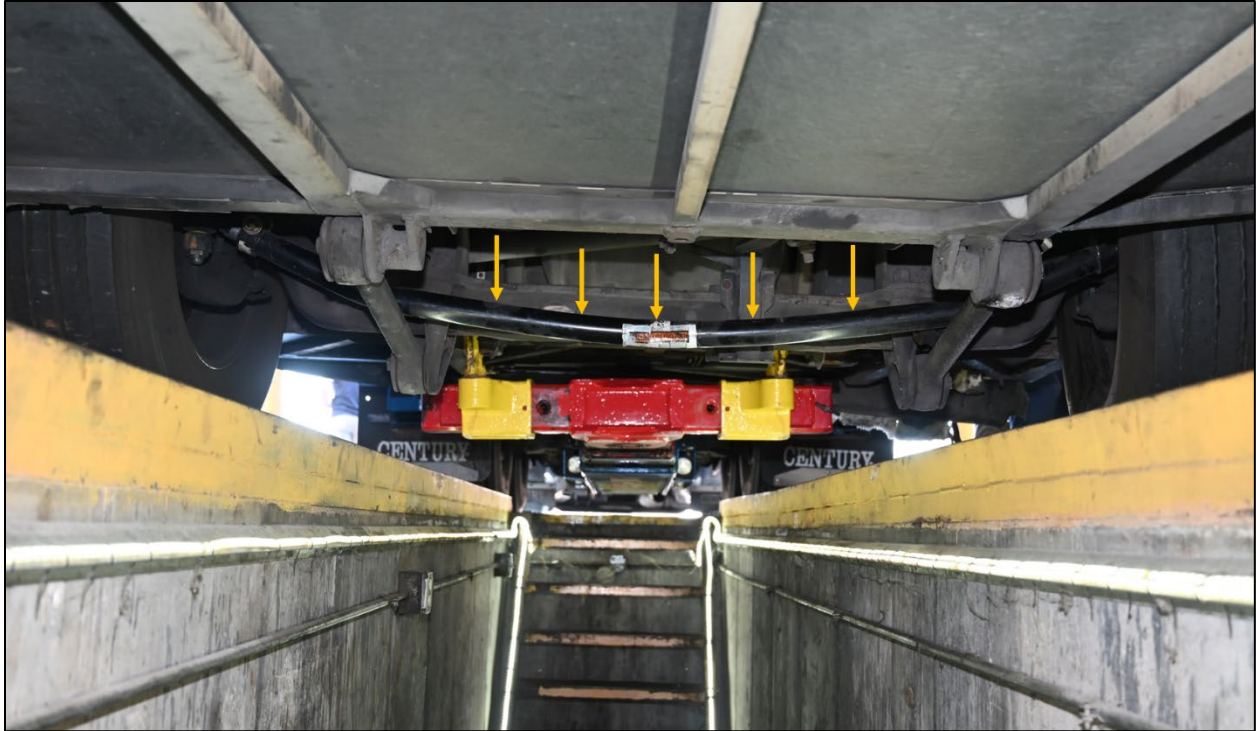
Figure 14: Motorcoach - Deformed Tie Rod

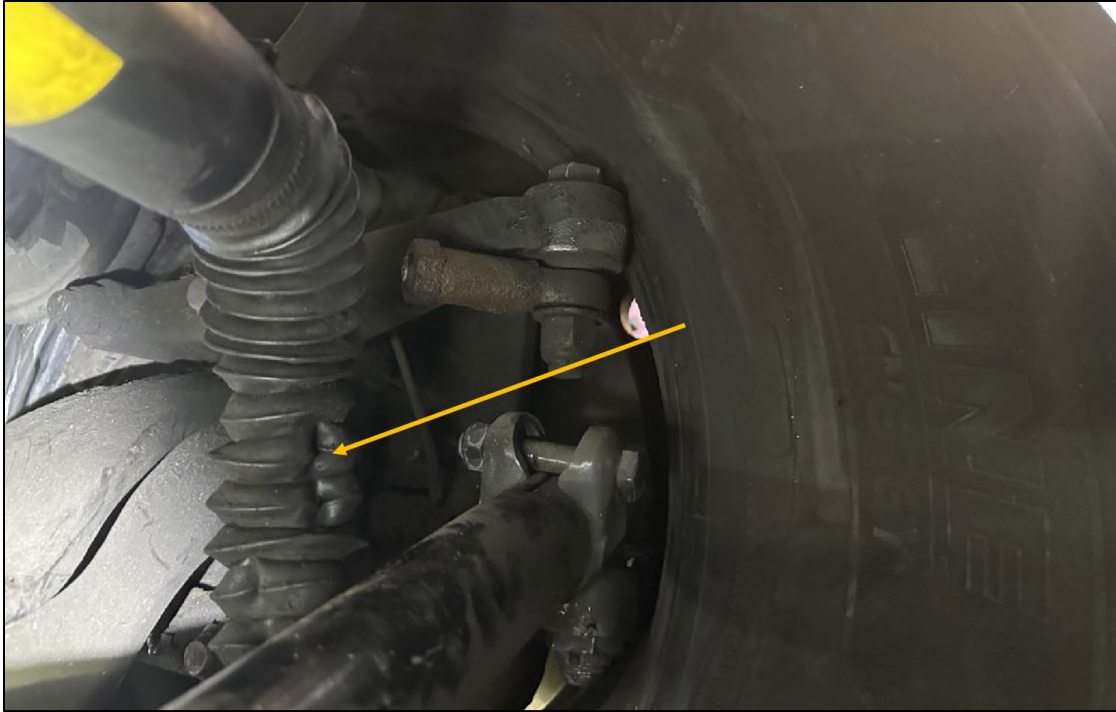
A steering damper was mounted on the right side of the steering axle (axle 1). The piston rod separated from the damper pressure tube and was broken away from the steering knuckle connection and exited through a tear that was observed in the damper boot, as observed in Figure 15.

Figure 15: Motorcoach - Tear in Damper Boot and Missing Component

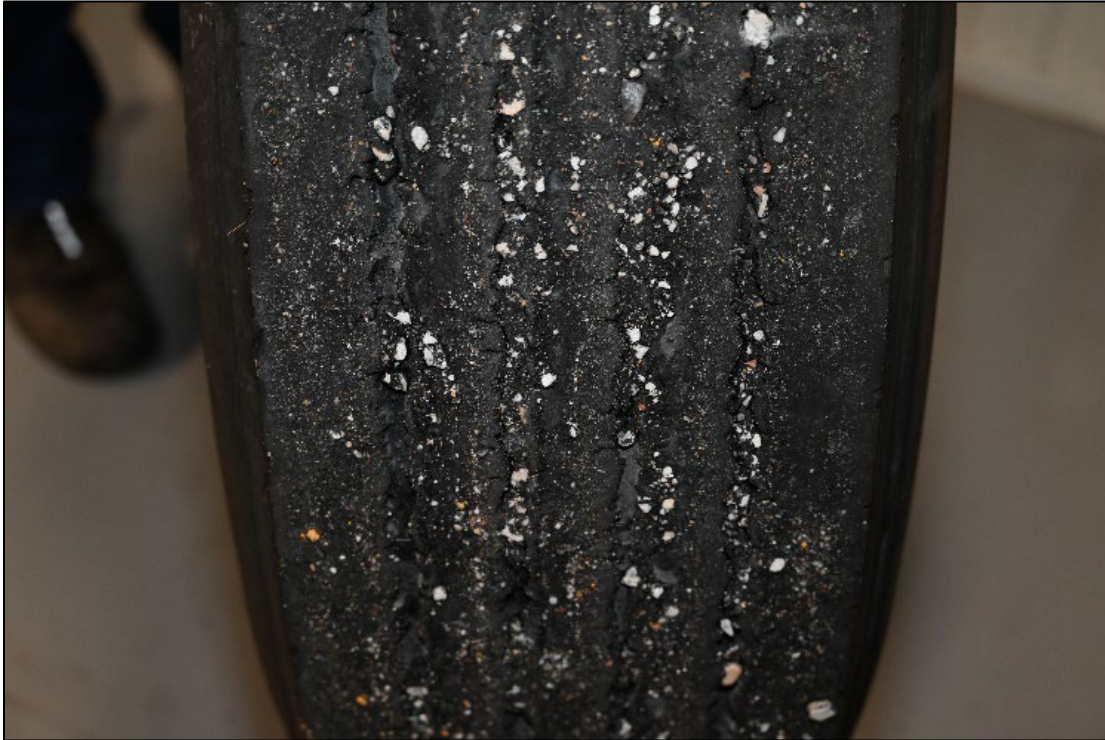
related defects. Tire pressure measurements were taken using a commercial grade tire pressure gauge. The outboard side of axle-1-right's tire had an approximate 16-inch tear, an approximate five-inch tear, several small tears, and several gouges to the sidewall. The inboard portion of the tire had a dark transfer and abrasion that ran circular around 360 degrees of the tire and was located in the inside portion near the inboard portion of the wheel. The outboard side of the wheel contained multiple scrapes and black-colored transfer marks. The tread belonging to axle-2-left-inside's tire was melted and sticky to the touch, as observed in Figure 16.

Figure 16: Motorcoach - Tire - Axle-2-Left-Inside

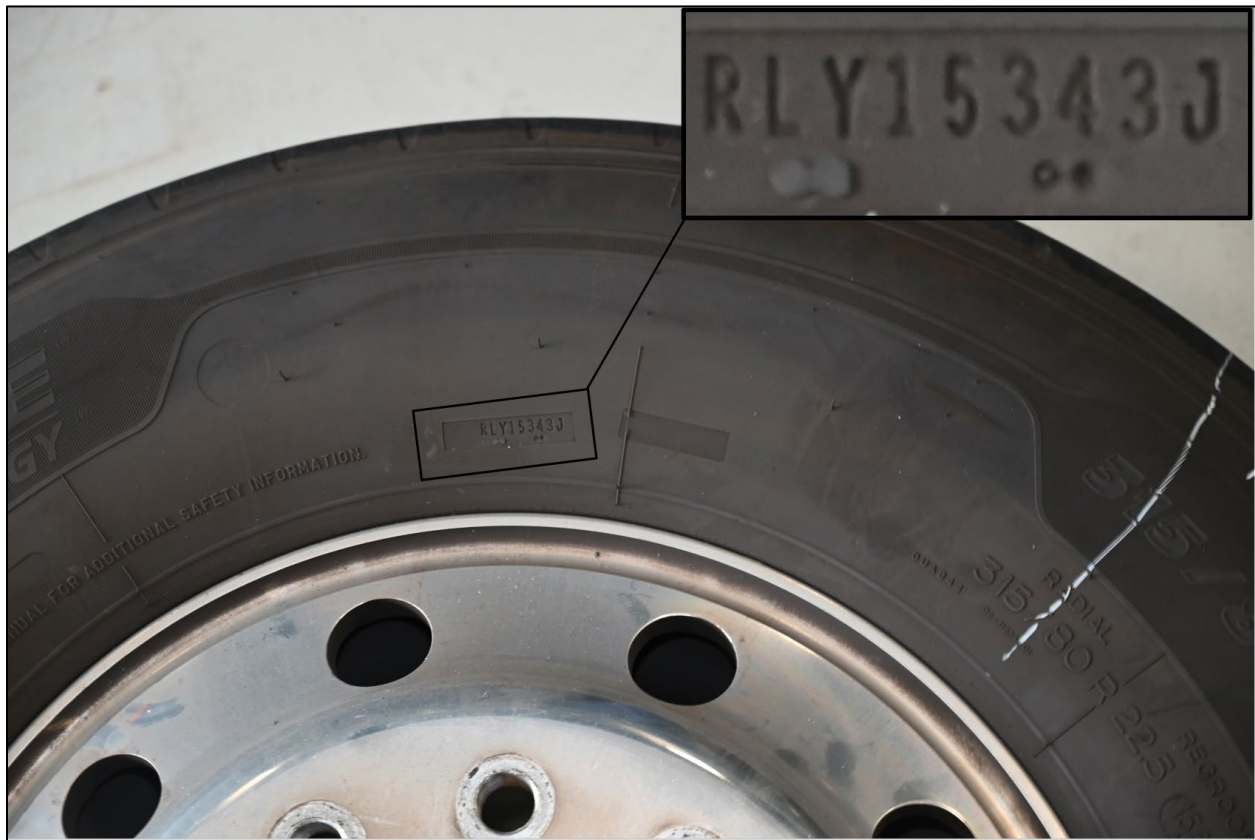
During the tire inspection, an unknown stamp was located on both steer axle tire sidewalls. Axle-1-left had a branded stamp located on the sidewall that stated "RLY15343J" (Figure 17) and axle-1-right was also branded with a sidewall stamp that stated "KLY12194J". The tire manufacturer, Michelin, was contacted by NTSB investigators. According to Michelin, the stamps were "matricule numbers". Typically, a Michelin tire that is produced in North America is labeled with a barcode sticker for tracking purposes. These two tires that displayed the unique stamp were produced at Michelin's Spain plant. Rather than a barcode, the Spain plant used the matricule numbers as an identification or serial number for internal tracking of the tire. Michelin

Figure 17: Motorcoach - Tire Stamp Located on Steer Axle Tire

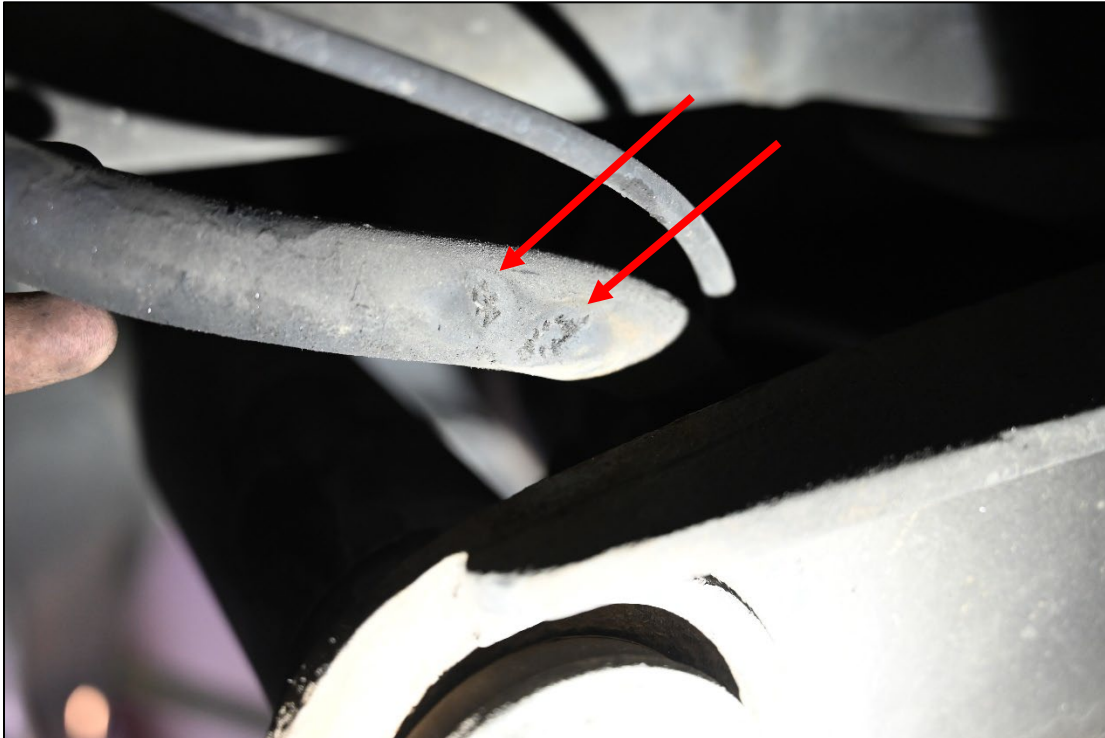
There was slight bluing¹⁴ observed to axle-2-left's rotor. Lips were observed on the rotors for axle 2-left and axle-2-right.¹⁵ The minimum rotor thickness for the subject rotors were 37mm (1.456 inches) and the thickness of brand-new rotors were 45mm (1.771 inches).¹⁶ An axle-1-right air brake hose was observed with chaffing present. The chaffing and wear extended through the braid reinforcement ply, as observed in Figure 18, in violation of 49 CFR 393.45(b)(2).¹⁷ Due to the wear extending through the reinforcement ply, an out-of-service criteria for the motorcoach was met. There were no other defects observed during the examination of the braking system.

Figure 18: Motorcoach - Axle-1-Right Out-of-Service Air Brake Hose

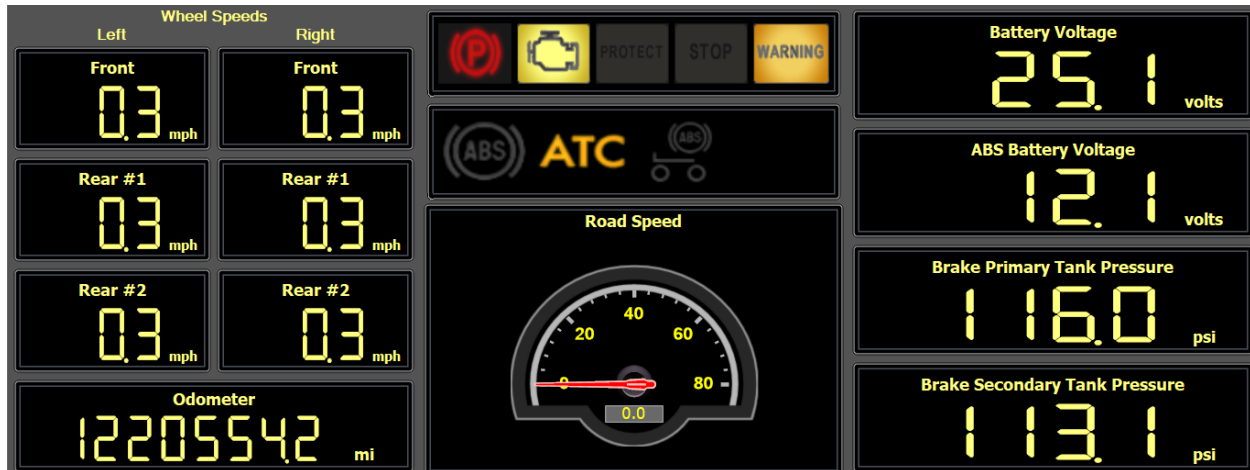
The motorcoach was equipped with air operated disc brakes. As a result, stroke length measurements typically measured with drum brakes were not applicable. During the imaging of the vehicle's modules, the motorcoach was pressurized and provided power. There were no air leaks discovered in the air system. The brake primary and secondary tank pressure were stable and recorded to be 116.0 and 113.1 psi, respectively, as observed in Figure 19.

During the vehicle examination and the imaging of the motorcoach's EDR modules, the motorcoach was powered without issue. The electrical system to the motorcoach was functional, however, power was disconnected from the motorcoach post-collision on-scene. When powering the vehicle, Bendix ACom Diagnostics was utilized to evaluate various vehicle system statuses and to extract data from vehicle modules. During the imaging of the modules, the battery voltage and the ABS battery voltage was reported to be 25.1 volts and 12.1 volts, respectively, as observed in Figure 19.

Figure 19: Motorcoach - Bendix ACom Overview

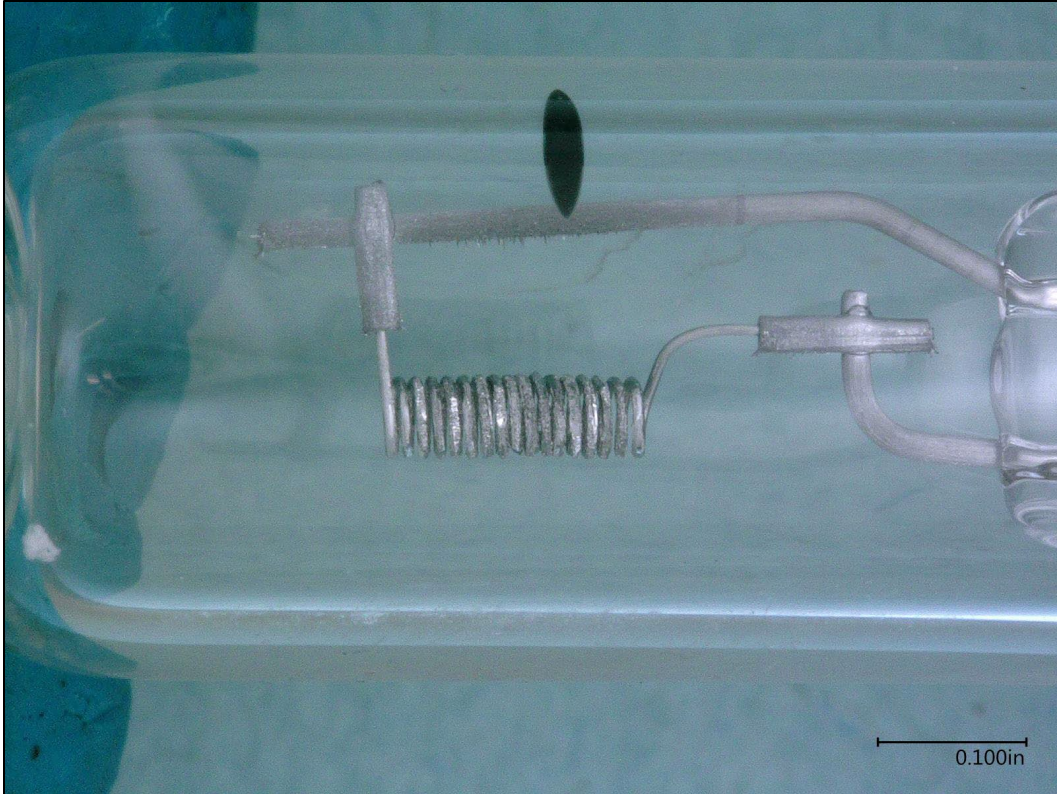
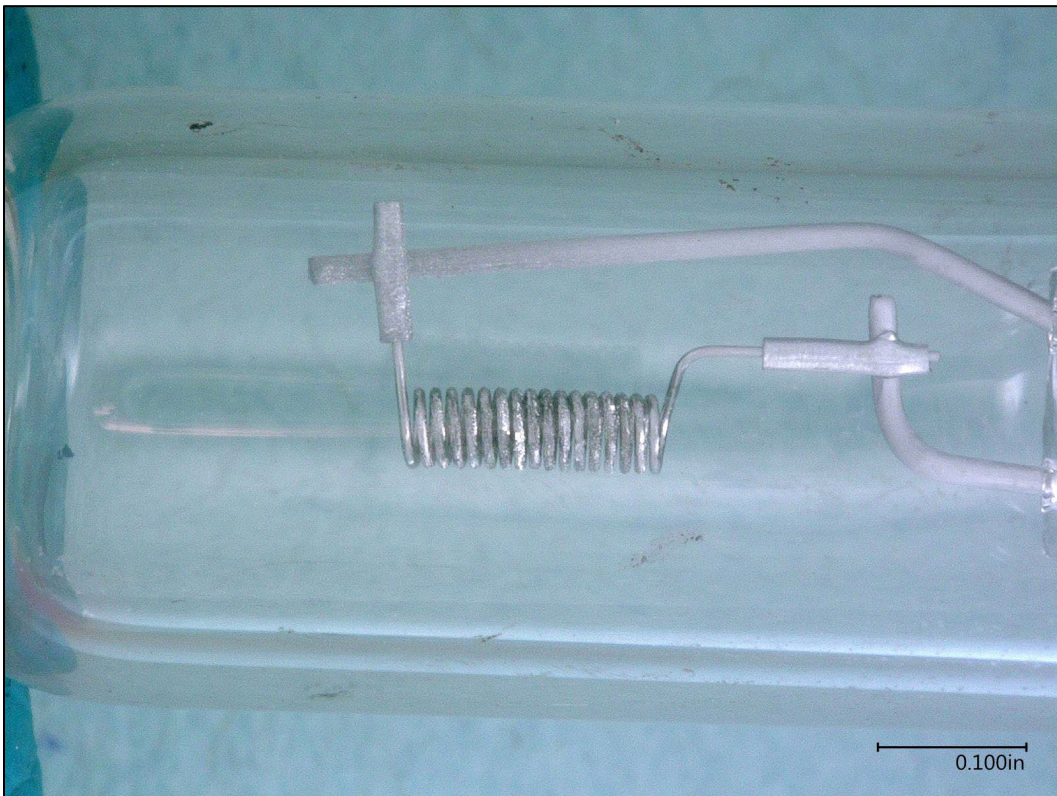
The motorcoach's lighting was tested without issue. The left headlight assembly's low and high beams, hazards, turn-signals, taillights, and brake lights were all inspected and in working condition. The right headlight assembly was damaged from the collision and the low and high beam bulbs were not recovered. The left headlight assembly's low and high beam bulbs were removed from the vehicle by NTSB investigators, secured as evidence, and submitted to the NTSB Materials Laboratory, located in Washington, DC, for further advanced imaging of the bulb filaments to facilitate further analysis. The imagery of the left headlight assembly bulbs can be observed in Figure 20 and Figure 21.

Figure 20: Motorcoach - Left Low-Beam Filament

Figure 21: Motorcoach - Left High-Beam Filament

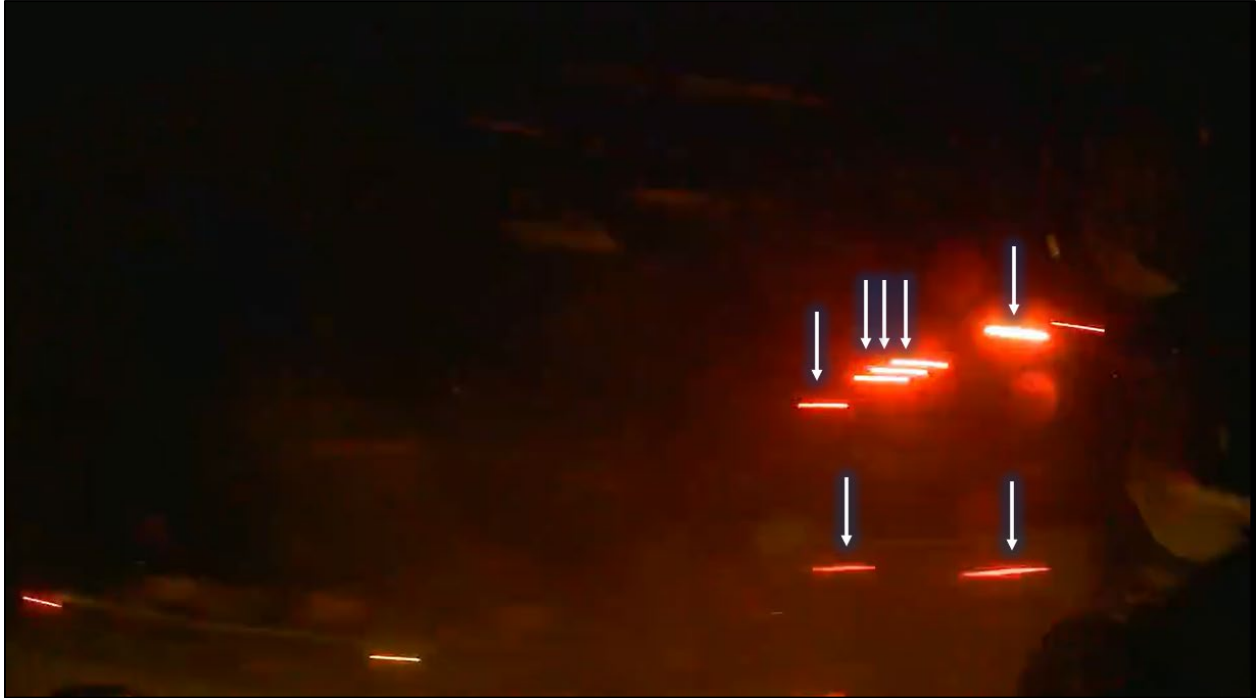
The rear of the motorcoach was captured by Freightliner's dash-cam during the collision sequence. The motorcoach's rear lights were illuminated during collision sequence, as observed in the screenshot of the video footage located in Figure 22.

Figure 22: Motorcoach - Rear Lighting During the Collision Sequence (Source: Freightliner's dash-cam)

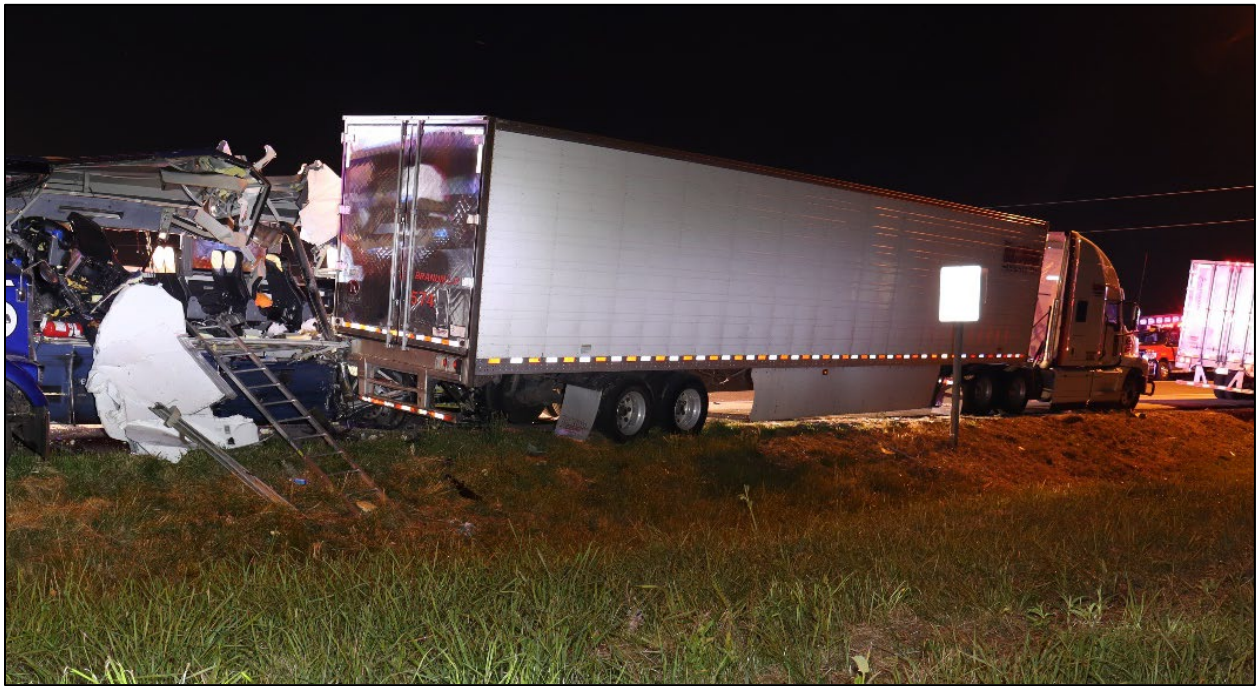
Figure 29: Tractor-Trailer 3 and Motorcoach at Final Rest (Source: ISP)

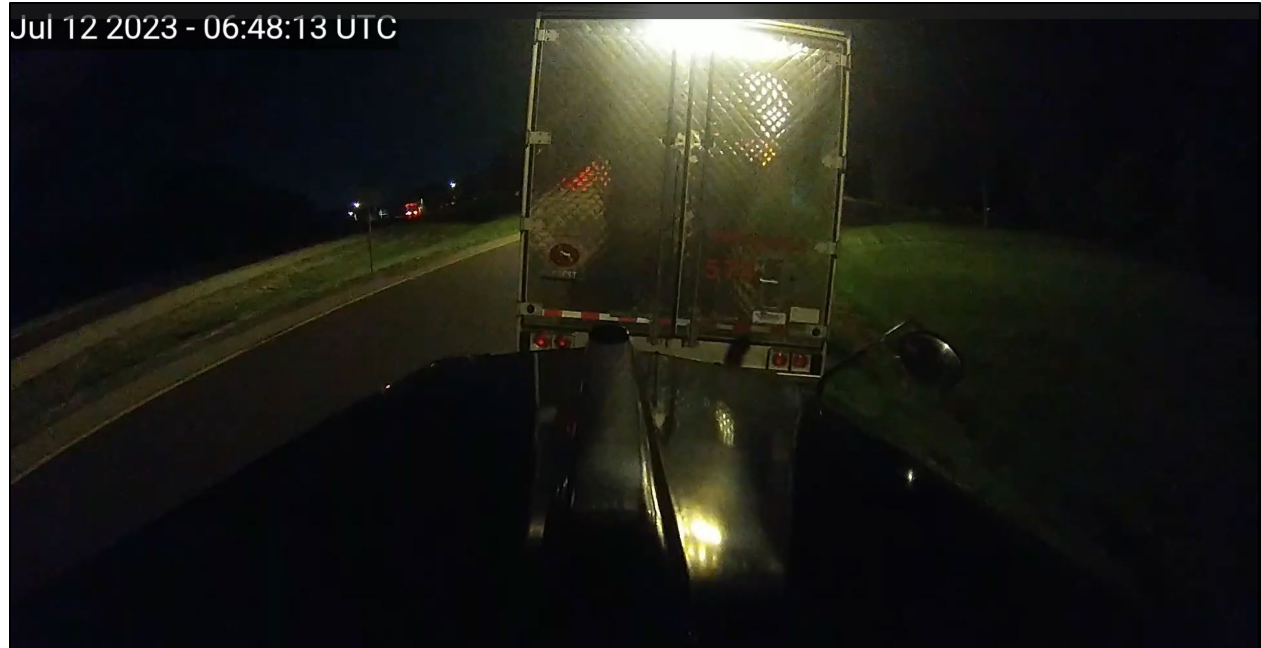
Dash-cam video footage from Tractor-Trailer 2 was obtained. The video footage shows the rear of Tractor-Trailer 3 prior to the subject collision. Tractor-Trailer 3's rear-lights and hazard lights were not activated nor illuminated prior to the subject collision, as observed in Figure 30.

Figure 30: Tractor-Trailer 3 - Rear Lighting Condition Prior to Impact (Source: Tractor-Trailer 2 dash-cam)
