National Transportation Safety Board

RRD24MR002

MECHANICAL

Group Chair's Factual Report

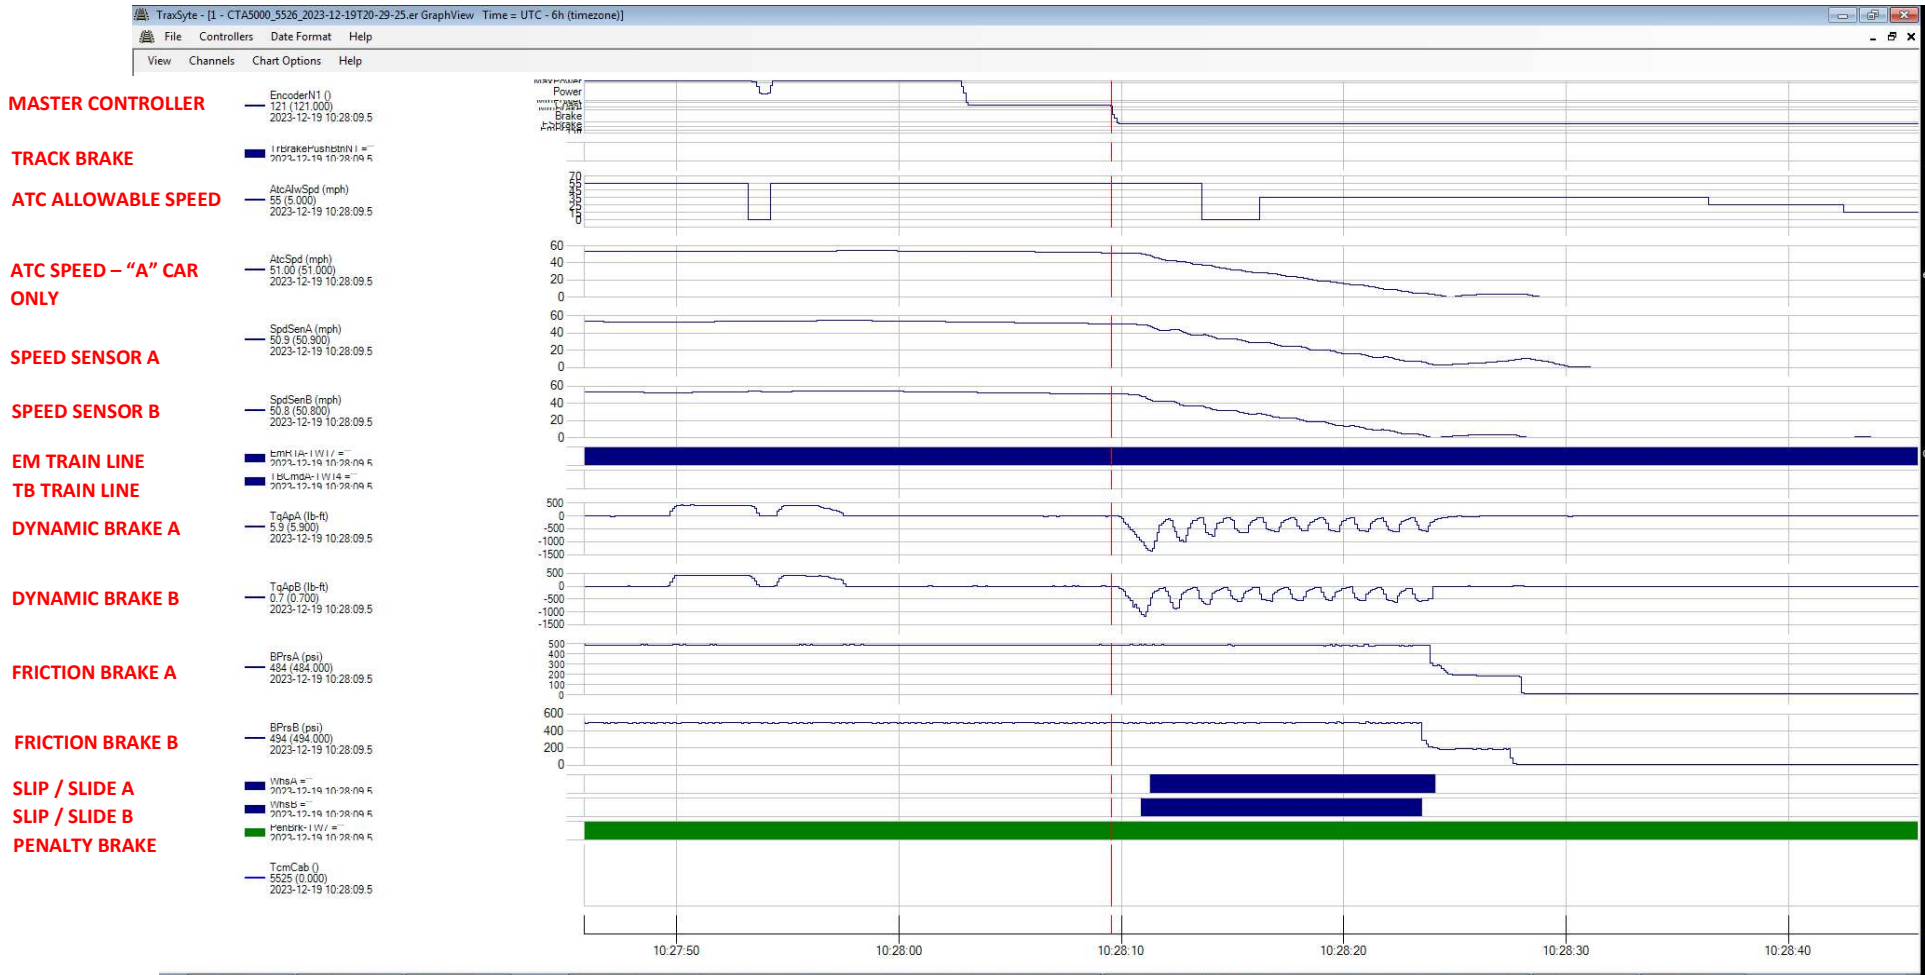
Test Run #1 ERU Event Log – Operator acts normally; full service brake at 26T bond

Run No.	Description and Expectations of Test	Notes from Event Recorder	Notes from Video
1	“Available adhesion level test” Full-service brake at 26T. Sliding wheels expected due to requesting a full-service brake rate (2.8mphps).	<ul style="list-style-type: none"> • Dynamic brakes apply at about 10:28:10 • Wheel slide detected about 1-second later • Dynamic brakes modulate • As the speed is reduced below 5mph, the friction brakes come on and the dynamic brakes fade out • 	<ul style="list-style-type: none"> • 0:37 – Movement begins • 1:45 – Passed cone for 26T Bond • Wheel slide protection system evident until: • 2:06 – Wheels lock, friction brakes likely applied at this point • 2:28 – full stop
2	“Available adhesion level test” Full-service brake at 26T Sliding wheels expected due to requesting a full-service brake rate (2.8mphps).	<ul style="list-style-type: none"> • Dynamic brakes apply at about 10:41:10 • Wheel slide detected about 1-second later • As speed is sensed below 5mph, friction brakes apply and dynamic fades out. • A second wheel slide is noted at 10:42:20 • The friction brake reduced pressure until wheel slide is no longer noted. 	<ul style="list-style-type: none"> • 0:31 – Movement begins • 1:40 – passed 26T Bond • Wheel slide protection system evident until: • 1:57 – Wheels lock. • 2:01 – Some wheel rotation until the end • 2:17 – Full stop •

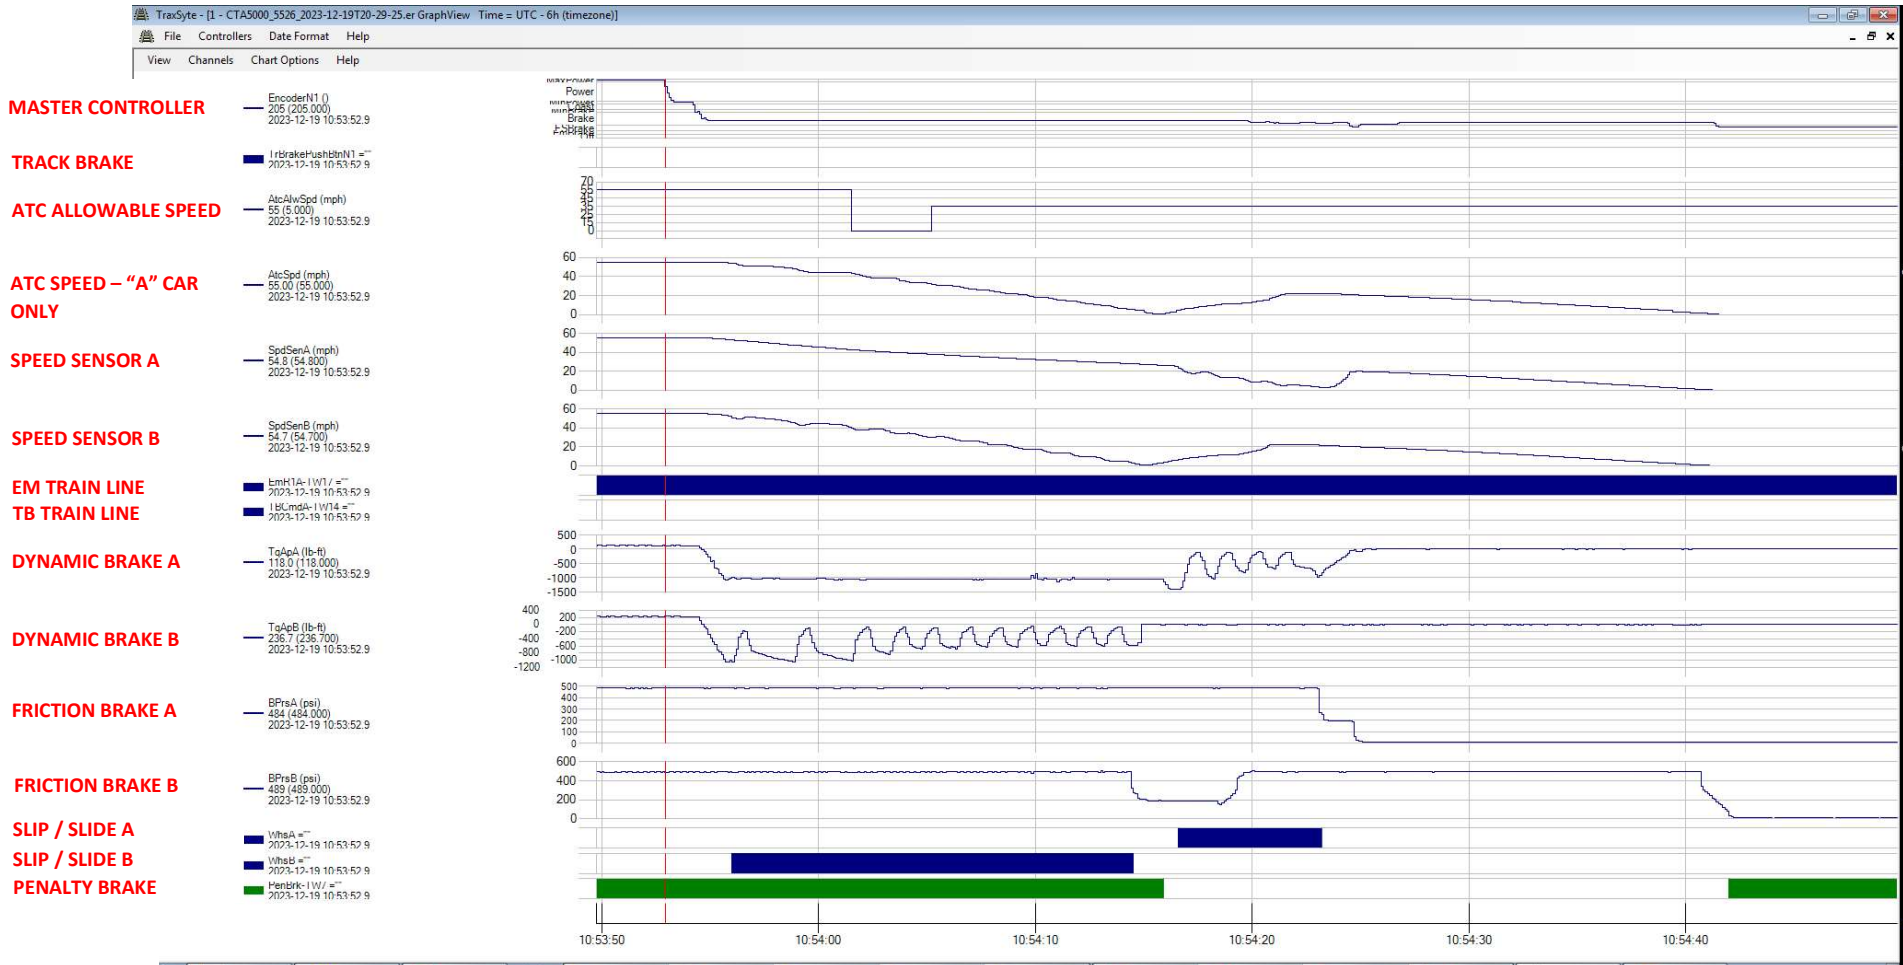
Test Run #3 ERU Event Log – ATC bypass; ~75% service brake at 26T bond

3	“Available adhesion level test” ATC Bypass ~75% Full Service Sliding wheels likely due to requesting a full-service brake rate (~75% of 2.8mphps).	<ul style="list-style-type: none"> • Dynamic brakes apply at about 10:53:56 • Dynamic brake pattern is much different under slide protection that previous runs. B does not sense a slide until 10:54:16 whereas A sense a slide immediately, but modulates differently than before. A stops slide sensing before he begins sliding • Full friction at about 10:54:23 	<ul style="list-style-type: none"> • 0:29 - Movement begins • 1:39 – Passed 26T Bond • Wheel slide protection not as evident until about 2:00 • 2:20 – Full stop
4	“Available adhesion level test” ATC Bypass ~75% Full Service Sliding wheels likely due to requesting a full-service brake rate (~75% of 2.8mphps).	<ul style="list-style-type: none"> • Dynamic brakes apply at about 11:04:59 • Both trucks sense slide almost immediately. The pattern is similar to the first runs • Friction and dynamic are blended at the end more clearly. 	<ul style="list-style-type: none"> • 0:38 – Begin movement • 1:46 – Passed 26T Bond • Slide protection isn’t clearly evident until about 1:58 • Wheels never stop rotating until full stop • 2:23 - Full stop

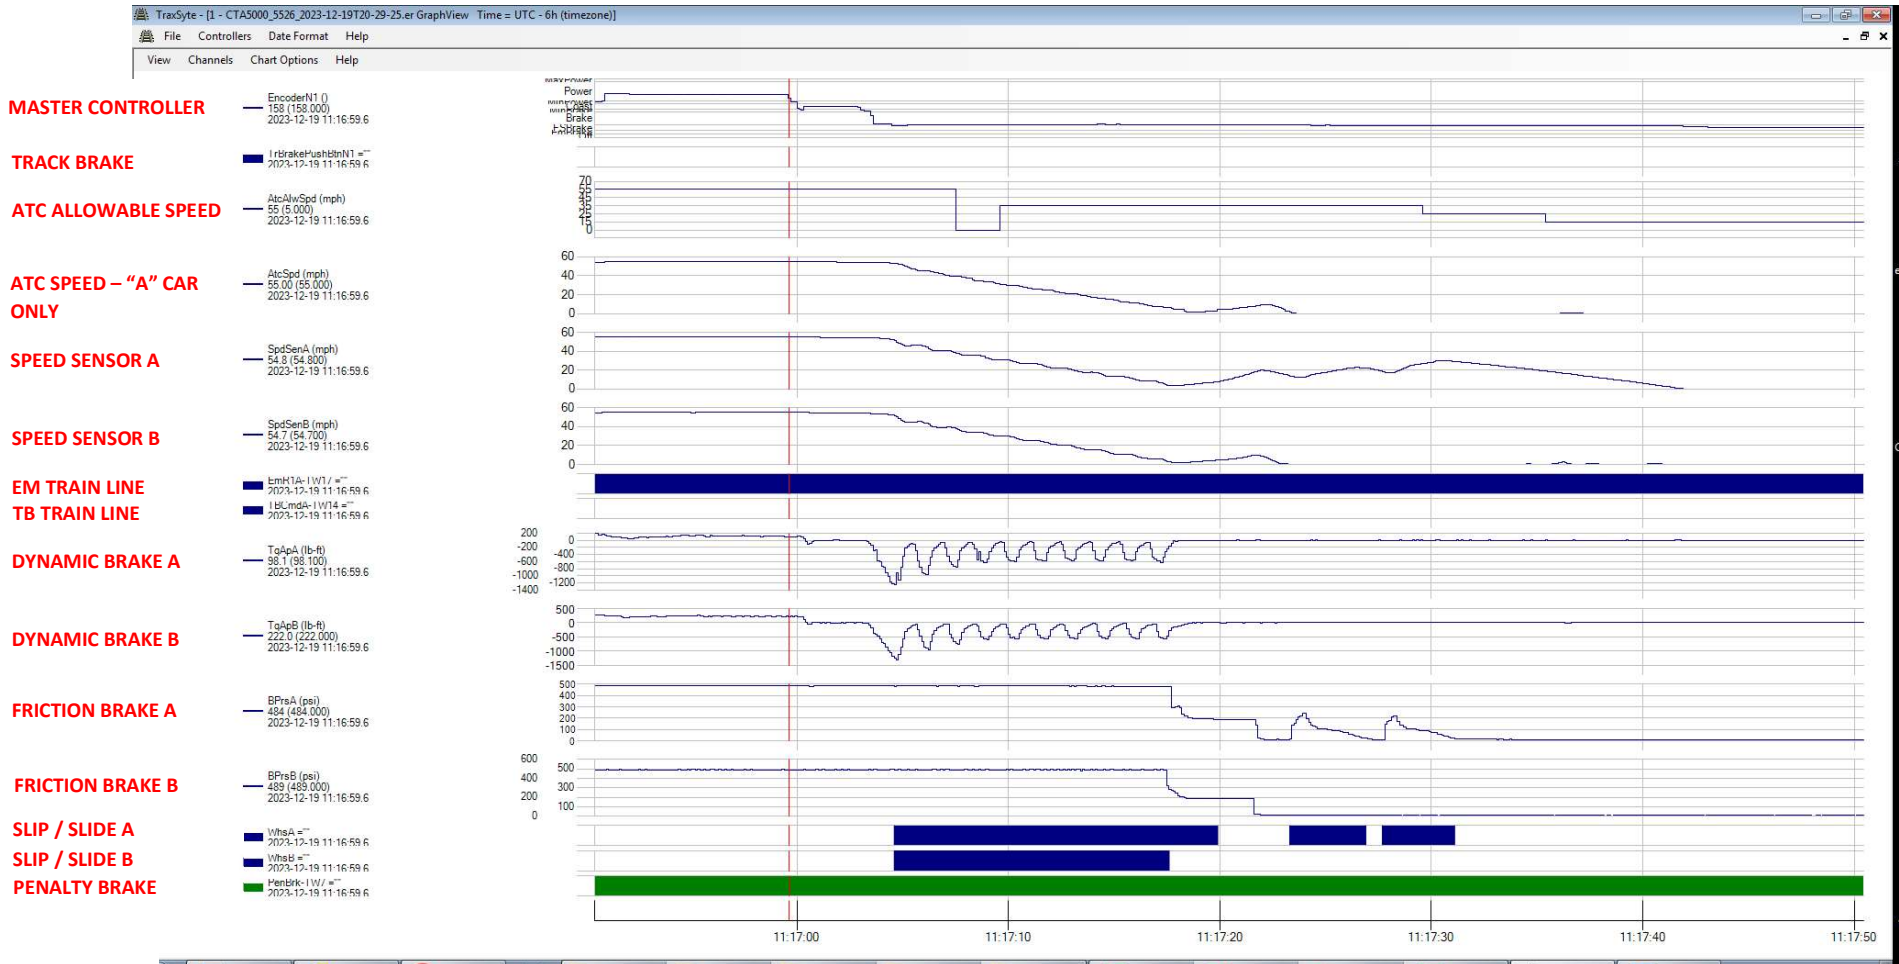
Test Run #5 ERU Event Log – ATC bypass; ~75% service brake at 26T bond

5	“Available adhesion level test” ATC Bypass ~75% Full Service Sliding wheels likely due to requesting a full-service brake rate (~75% of 2.8mphps).	<ul style="list-style-type: none"> • Dynamic brakes apply at 11:17:04 • immediately. The pattern is similar to the first runs • 	<ul style="list-style-type: none"> • 0:27 run begins • 1:37 – Passed 26T Bond • Slide protection is evident, but wheels never stop turning until full stop • 2:14 – full stop
6	“Available adhesion level test” ATC Bypass ~50% Full Service Sliding wheels possible due to requesting a full-service brake rate (~50% of 2.8mphps). (no wheel slide encountered)	<ul style="list-style-type: none"> • Dynamic brakes apply at 11:24:11 • No slip slide • Friction brakes blend in at about 11:24:47 	<ul style="list-style-type: none"> • 0:30 movement begins • 1:38 – passed 26T Bond • 2:13 – Full stop
7	“Available adhesion level test” ATC Bypass ~50% Full Service Sliding wheels possible due to requesting a full-service brake rate (~50% of 2.8mphps). (no wheel slide encountered)	<ul style="list-style-type: none"> • Dynamic brakes apply at 11:33:54 • Truck B wheel slide protection three separate times starting around 11:33:54. Dynamic brakes modulate for each. 	<ul style="list-style-type: none"> • 0:41 Movement begins • 1:49 – passed 26T Bond • 2:21 – full stop. Wheels never stopped spinning

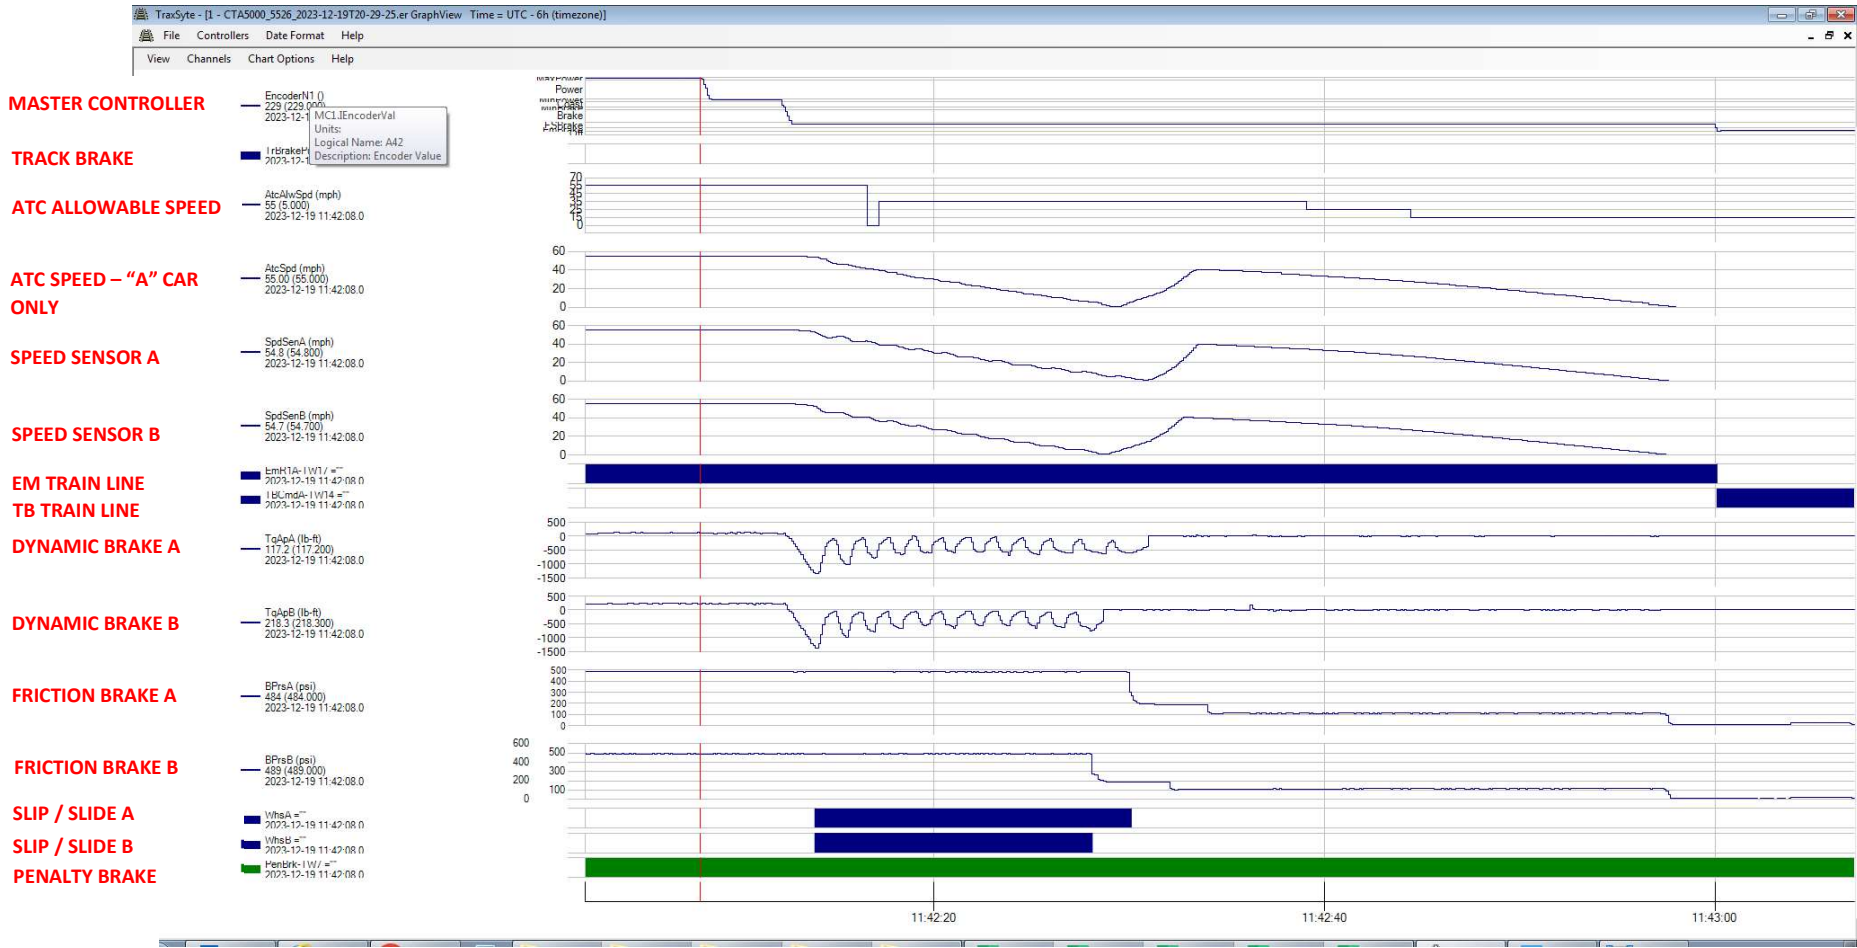
Test Run #8 ERU Event Log – Operator acts normally; full service brake at 26T bond

8	Full-service brake at 26T	<ul style="list-style-type: none"> • Dynamic Brakes apply at about 11:41:15 • Slide protection immediately engages • When speed gets below 5, the friction brakes come on, and do not release again, event though the speed shows that it increased from near zero to 40 mph prior to full stop. 	<ul style="list-style-type: none"> • 1:16 – Movement begins • 2:25 – passed 26T bond • Slide protection evident • 2:43 – Wheels nearly stop, but pick up speed quickly after that • 3:09 = full stop
9	Incident recreation	<ul style="list-style-type: none"> • Dynamic brakes apply at about 12:34:56 • Immediate slide protection system activation • Similar to run 8, when dynamics blend out, friction brakes return and the wheels pick up speed. • Two additional slide protection events. 	<ul style="list-style-type: none"> • 1:10 – movement begins • 2:21 – Passed 26 T bond • Slide protection system evident • 2:36 – Wheels nearly stop, then pick up speed. • 2:51 – Wheel slide • 2:26 – Track brake activates? •

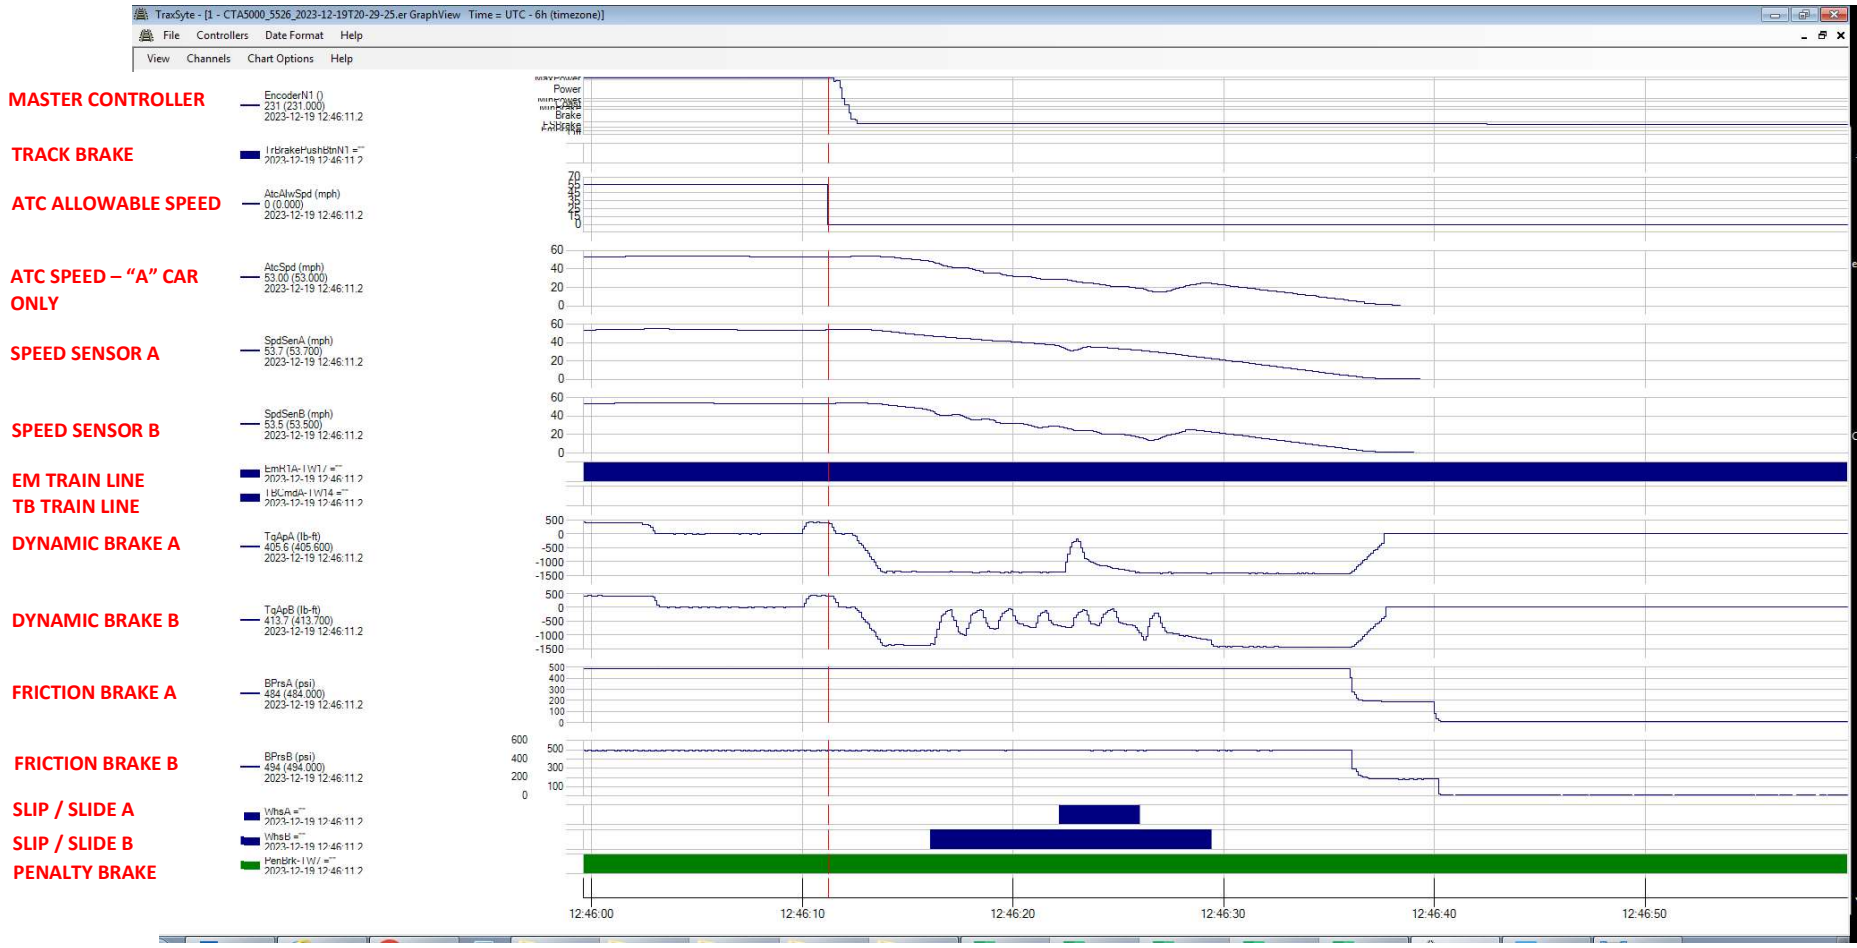
Test Run #10 ERU Event Log – Incident recreation: operator reacts to ATC; full service brake; "Emergency brake" upon sight of snow-fighter

10	Incident recreation	All tests similar to above.	
11	Incident recreation		
12	Incident recreation		
13	Emergency w/ slip-slide track brake feature “off”	By this time rail adhesion had increased to the point we were no longer getting wheel slides.	
14	Emergency w/ slip-slide track brake feature on	By this time rail adhesion had increased to the point we were no longer getting wheel slides. Track brake activation was not evident in the video.

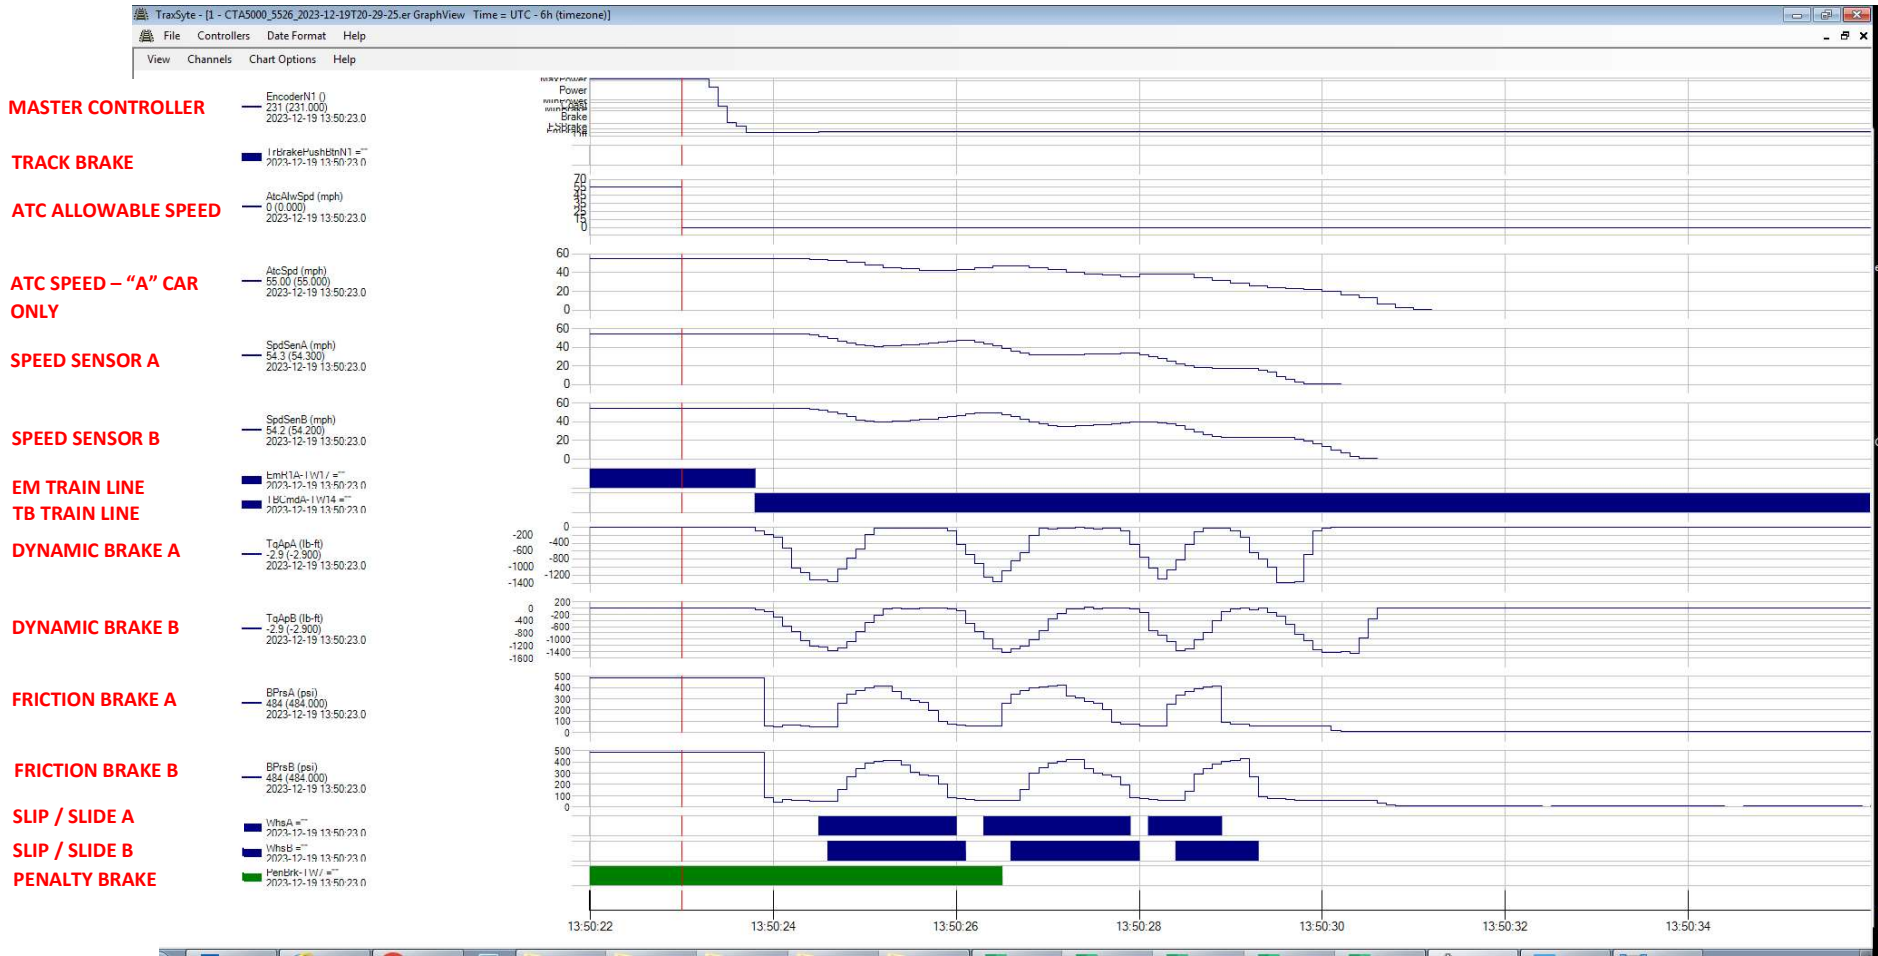
Test Run #13 ERU Event Log – Full emergency at 26T bond

The team also discussed reasons why the 13th and 14th tests resulted in short stopping distances and little difference between the two tests. It was determined that the frequency of tests and heavy braking 'cleaned' the rail, such that rail adhesion had improved by the end of the test regimen, and wheel slide was no longer a factor.
