Dan Baker
Senior Air Safety Investigator
AS-WPR

Date: December 1, 2022

Subject: WPR22LA333, N687AM Collective Stick Examination Report

The collective stick came from a Bell 407, N687AM, that was involved in an accident on September 4, 2022, near Mount Baldy, California. The total part time was reported to be 6,942 hours. Representatives from the FAA, Air Methods, and Rolls-Royce were present for the examination of the helicopter's collective stick assembly that occurred at Bell Headquarters in Fort Worth, Texas on October 19, 2022.

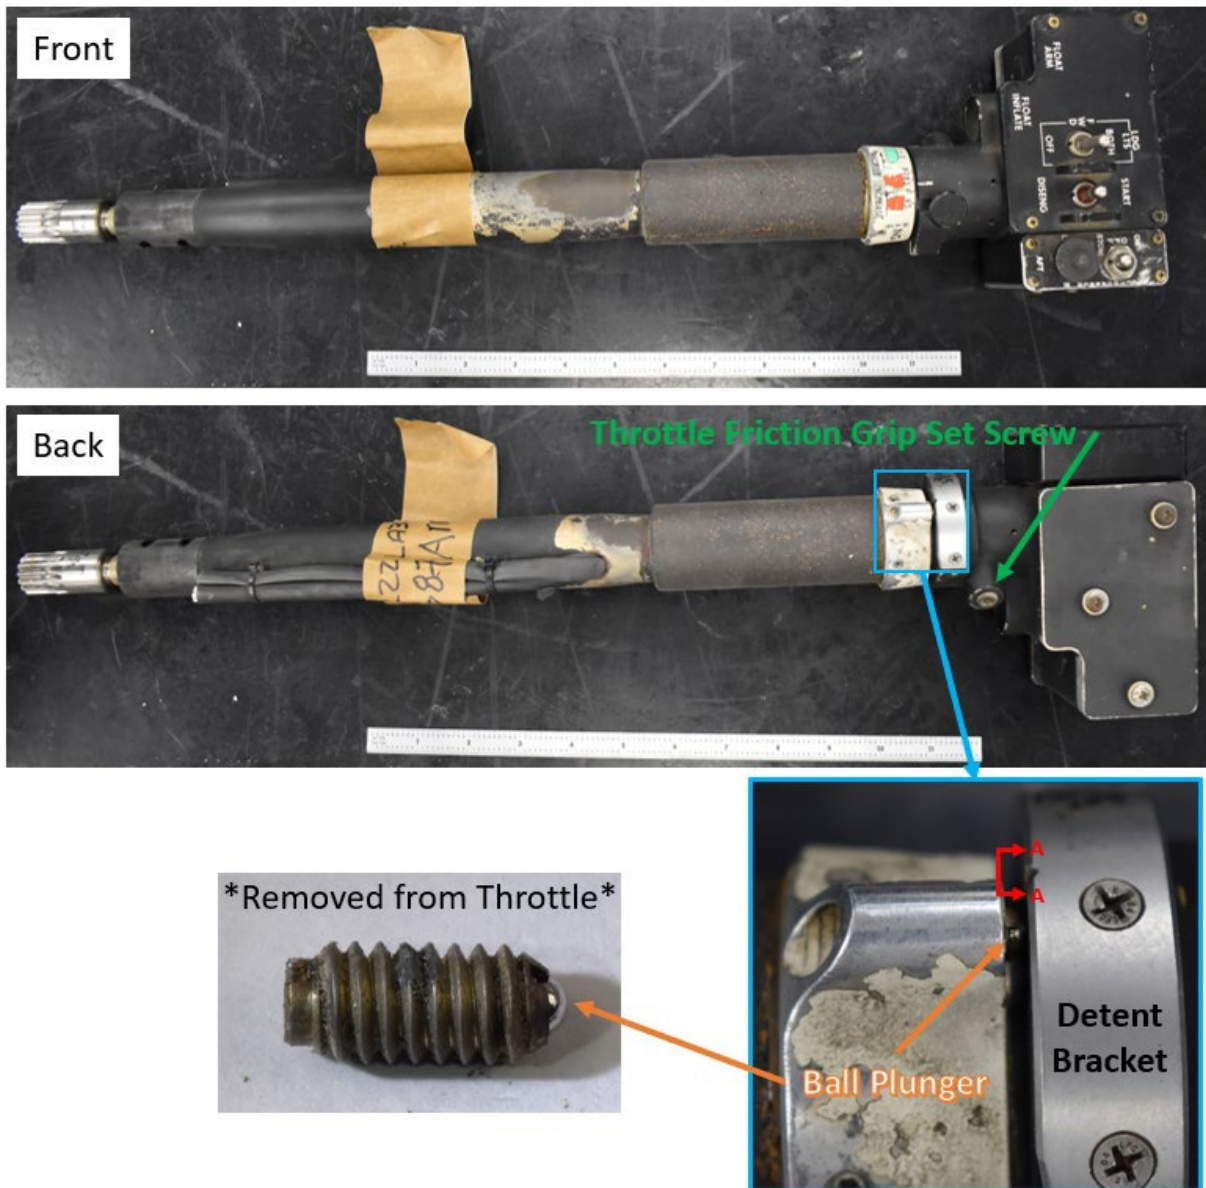
The ball plunger was removed from the accident helicopter's collective (figure 1) and the spring force was tested with a load frame. The spring met the design requirements of 4lbs \pm 25% initial force and 12 lbs \pm 25% final force that was specified by the manufacturer. Initial force is the force it takes to start compressing the spring. Final force is the force it takes the spring to compress the distance specified by the manufacturer.

Figure 1 - Collective as Received and Ball Plunger (Bell Photograph)

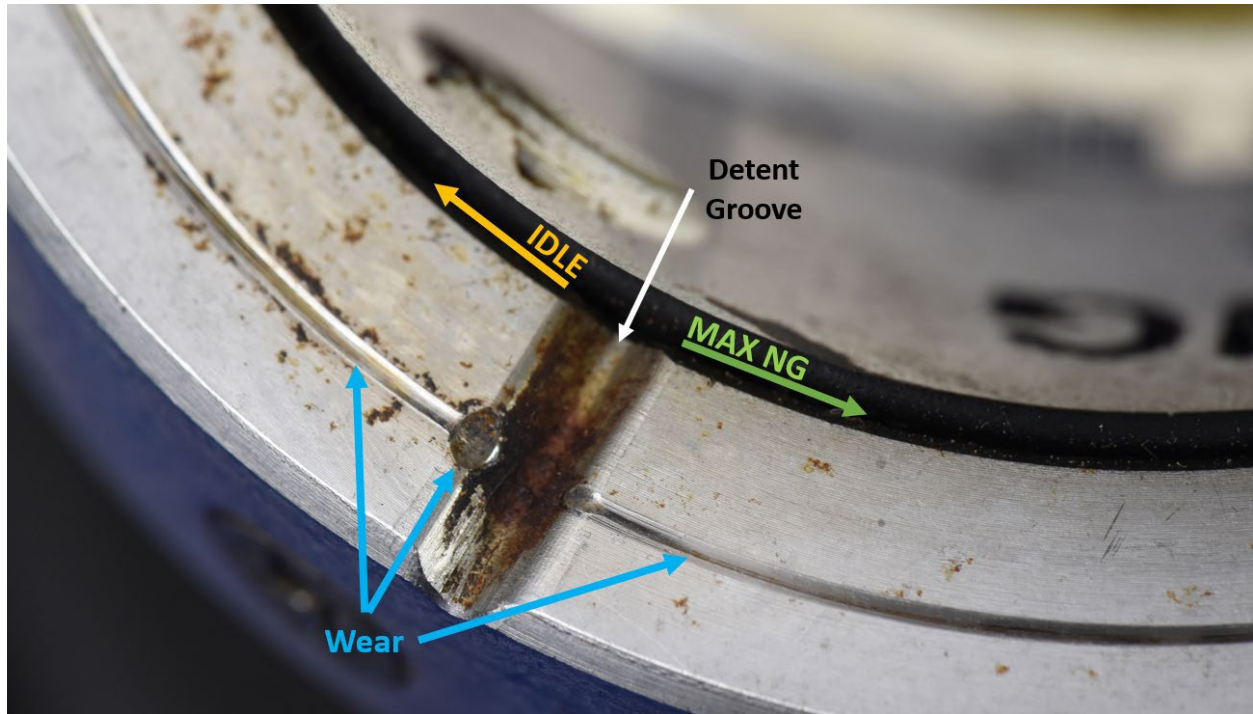
Superficial wear was observed where the ball plunger slid against the detent bracket, measuring less than 0.001 inch. A wear indentation was noted on the radius

of the detent groove, between FLY and IDLE. The indentation measured 0.055 inch in length and 0.035 inch in width. Its depth was 0.009 inch measured from the flat of the detent bracket to the bottom of the indentation. See figures 2 and 3.

Figure 2 - Collective Detent Wear (Bell Photograph)

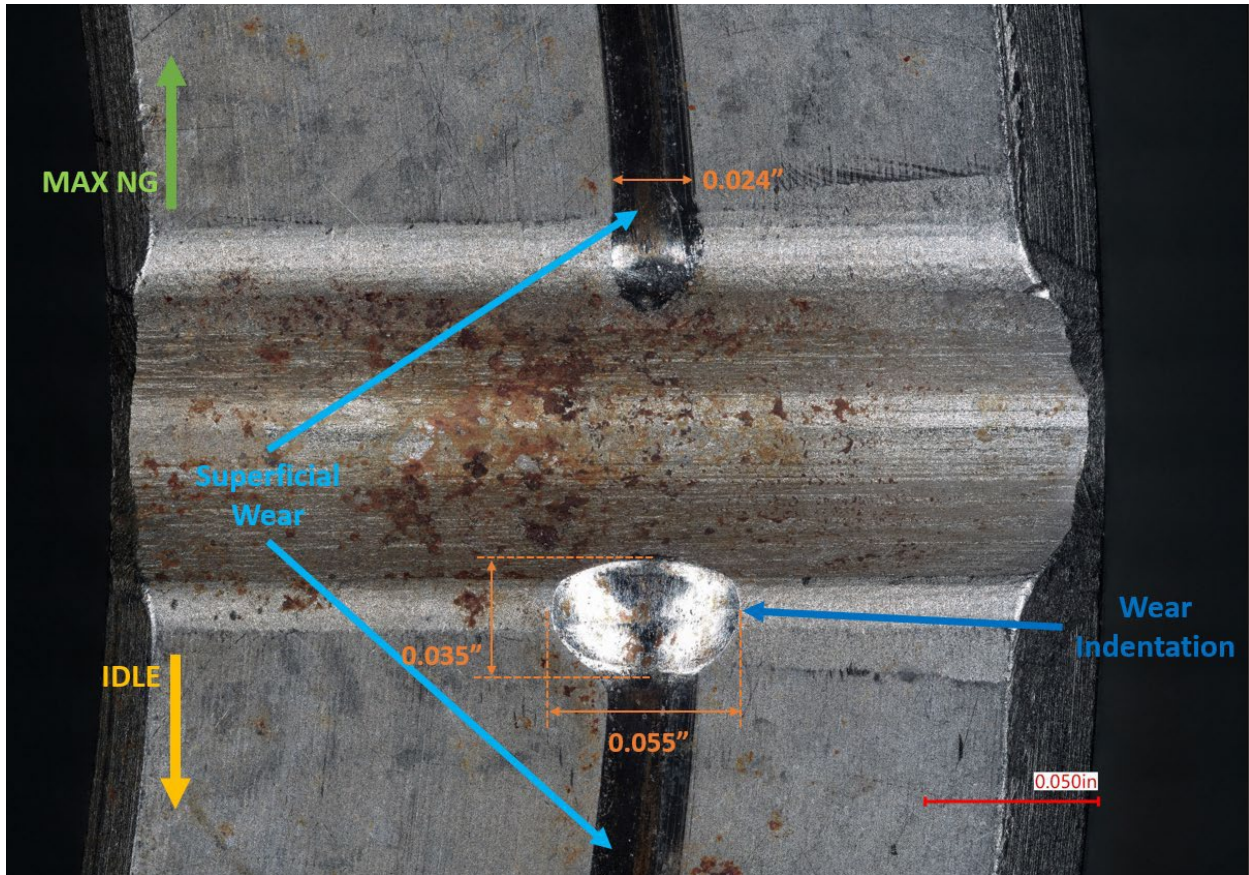
Superficial wear was observed where the ball plunger slid against the detent bracket, measuring less than 0.001 inch (figure 3). A wear indentation was noted on the radius of the detent groove, between FLY and IDLE. The indentation measured 0.055 inch in length and 0.035 inch in width. Its depth was 0.009 inch measured from the flat of the detent bracket to the bottom of the indentation.

Figure 3 -Collective Detent Wear with Measurements (Bell Photograph)
