National Transportation Safety Board

ONBOARD VIDEO RECORDER

Specialist's Factual Report

Location: Chicago, Illinois
Date: November 16, 2023
Time: 10:31 a.m. central daylight time (CDT)
Vehicle: Chicago Transit Authority (CTA) train #593

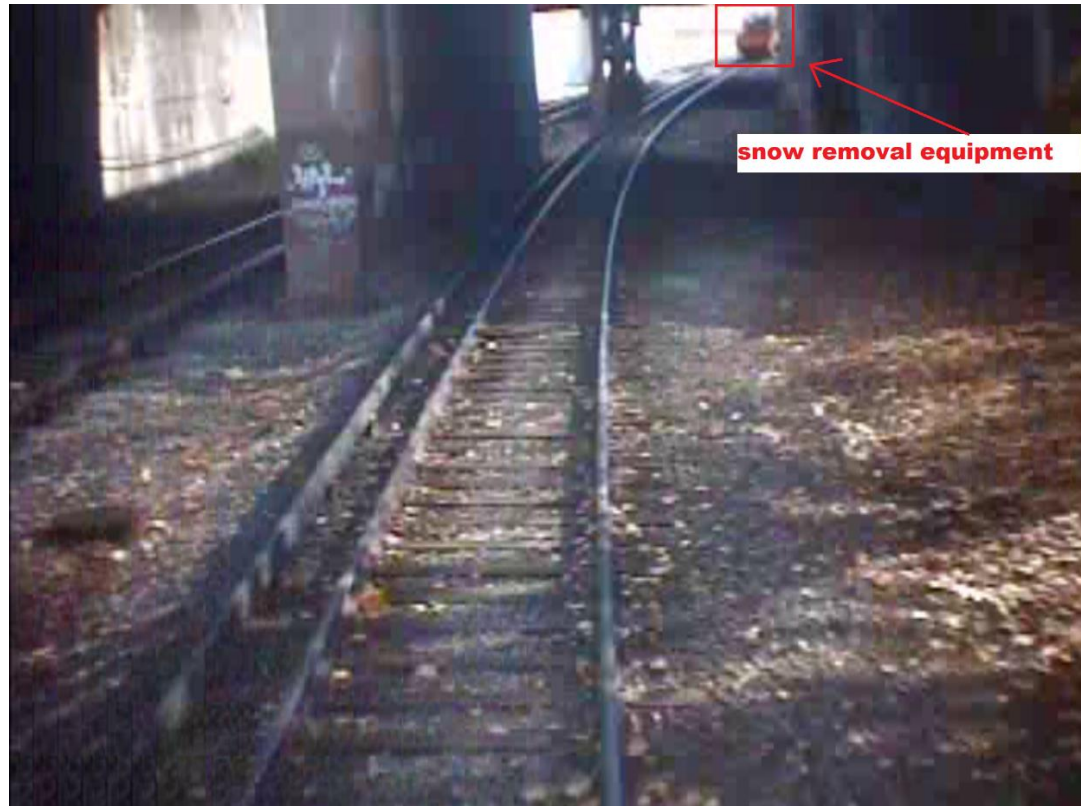
10:30:41.71	Snow removal equipment on the track appeared in the FoV. Figure 4 below shows a screenshot at this time.	The operator remained seated and looking forward. The operator's right hand was holding the control stick, and the left hand was outside of the operator's compartment and out of the camera FoV.	The operator's left hand was holding the outside wall of the operator's compartment.

Local Time (CDT)	Forward-Facing Video	Inward-Facing Cab-Right Video	Inward-Facing Cab-Left Video
10:30:50.38	Two personnel were visible on the snow removal equipment. One of them was leaning to jump out of the snow removal equipment. Prior to impact with the snow removal equipment, there were not any warning signals observed as the accident train approached.	Prior to impact with the snow removal equipment, the operator's body leaned back, with his right hand holding the control stick. The left half side of the operator's body was outside of the operator's compartment and out of the camera FoV.	Prior to impact with the snow removal equipment, the operator's left hand was holding the outside wall of the operator's compartment.

10:30:50.72	The impact occurred. The FoV of the camera changed to facing down toward the ground after the impact.	The impact occurred. The camera lost signal.	The impact occurred. The camera lost signal.

Figure 4. A screenshot at 10:30:41.71 shows the snow removal equipment became visible to the forward-facing camera.
