ERA24FA058

ONBOARD IMAGE RECORDER

Specialist's Factual Report

Location: Pulaski, Tennessee
Date: December 7, 2023
Time: 1103 central standard time (CST)
Airplane: Beech 35-C33, N5891J

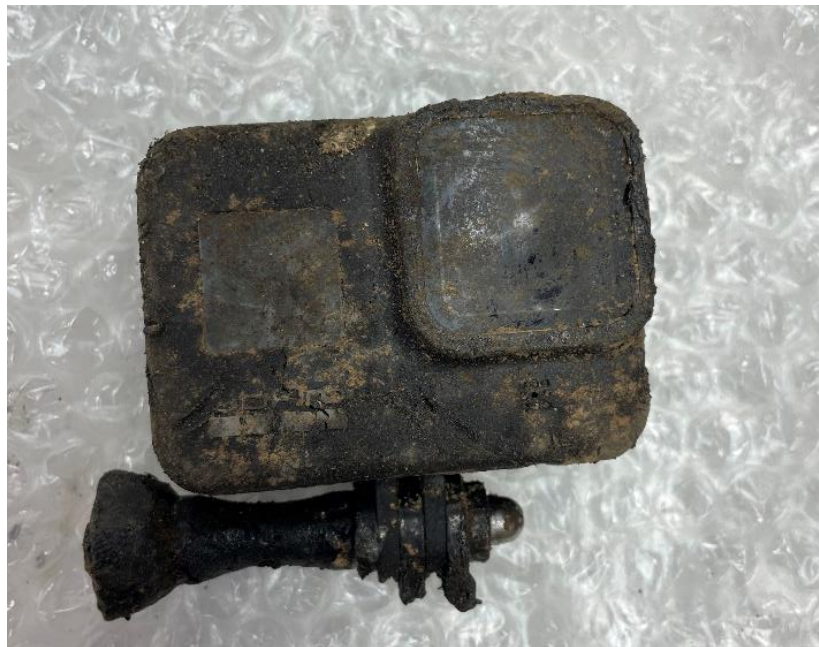
The GoPro Hero 8 Black is pictured in Figure 1, as received. The GoPro exhibited some impact damage and thermal damage. A 256 GB microSD type memory device was found seated in the memory socket location (Figure 2). A 256 GB SanDisk Ultra microSD card was extracted. The microSD card exhibited impact damage and was cracked in multiple locations. Figure 3 is an annotated stereoscopic photograph of the cracked areas of the card. Figure 4 is a magnified stereoscopic image of one of the damaged areas of the card. Figure 5 is an x-ray of a portion of the microSD card. The figure is annotated with blue arrows to show a cracked area. An overall review of x-ray images taken of the card do not reveal any obvious bond wire damage. Cracks were present in other areas of the card that were x-ray imaged, but are not included in this report.

Figure 1. Device as received by the lab.

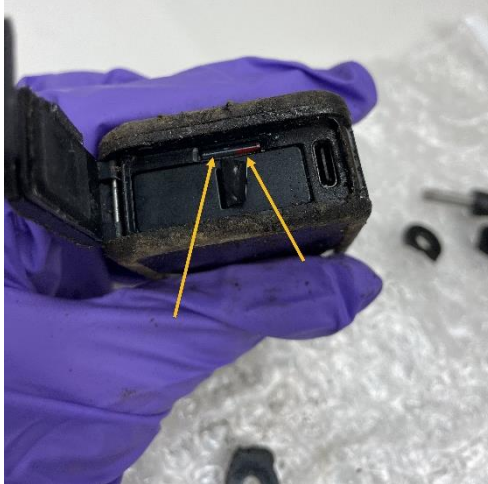
Figure 2. The microSD memory device seated in the camera's memory card chassis. The yellow arrows show the location of the seated microSD card.

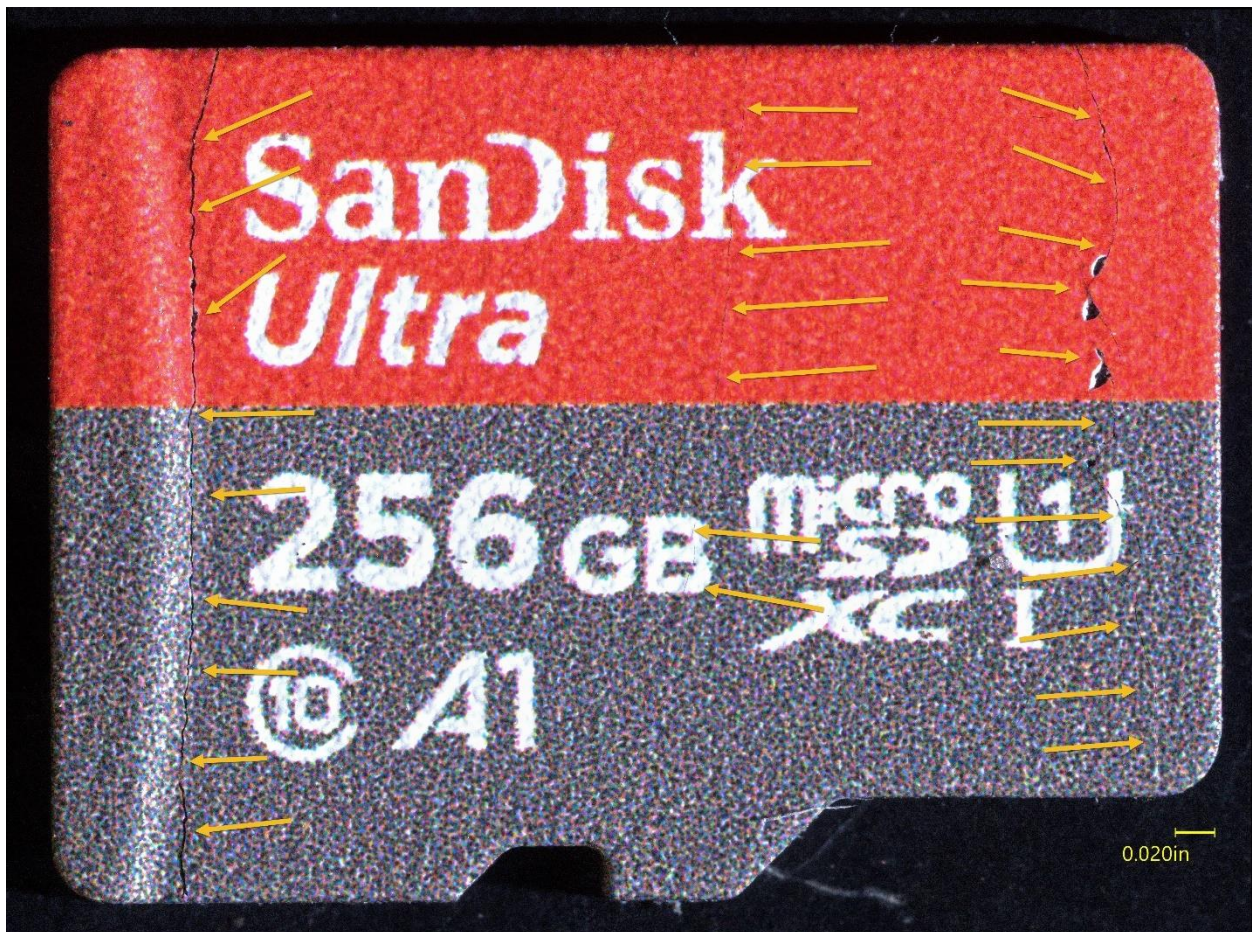
Cracks on monolithic memory devices can extend through the component's plastic packaging and into the silicon die. These cracks can also affect the bondwires that interface the silicon die to the chip's architecture as well. Bondwire damage, in some instances, can be repaired, or bypassed altogether by reading the silicon die directly using the chip's test pins. As noted above, no obvious bondwire damage was noted from the x-ray inspection. Cracks to the silicon die, however, cannot be repaired. There is no known repair method for cracked silicone dies at the time of this report's publish date.

Figure 3. Annotated image showing the cracked areas of the device's associated microSD card.

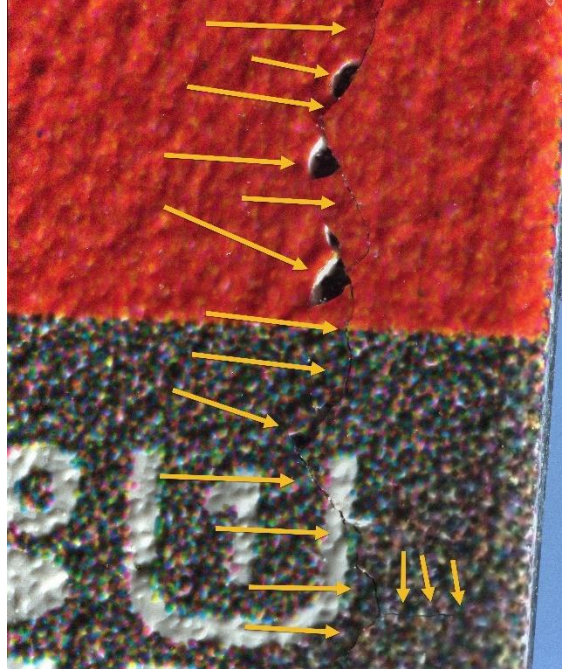
Figure 4. Magnified image of a cracked area of the device's associated microSD card.

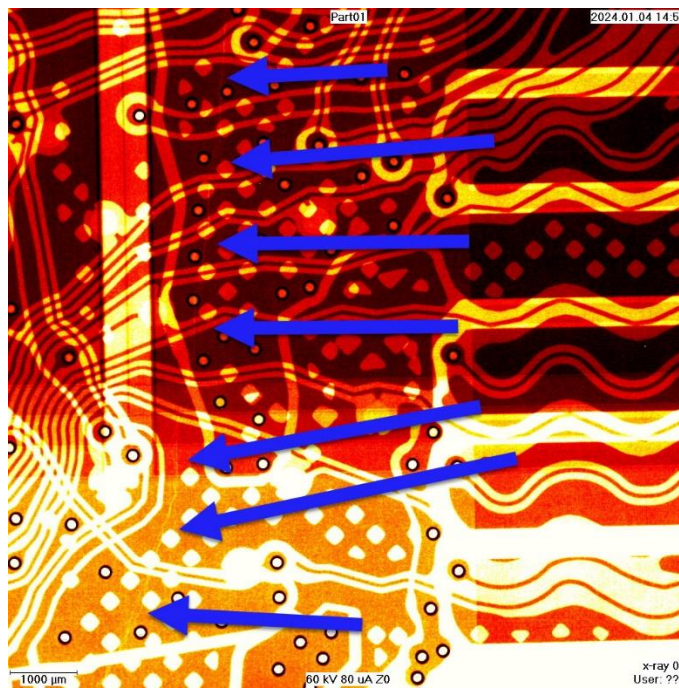
Figure 5. An x-ray image with a color filter applied showing a cracked area of the microSD card.

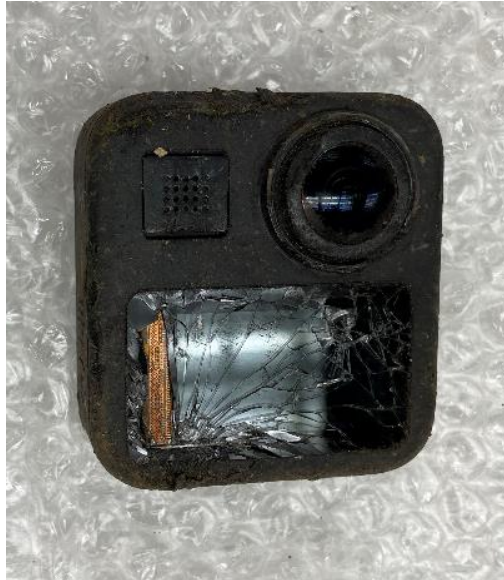
The GoPro MAX is pictured in Figure 6. The GoPro MAX exhibited some impact damage and thermal damage. A 128 GB microSD type memory device was found seated in the memory socket location (Figure 7). The microSD card was

Figure 6. GoPro MAX as received by the lab.

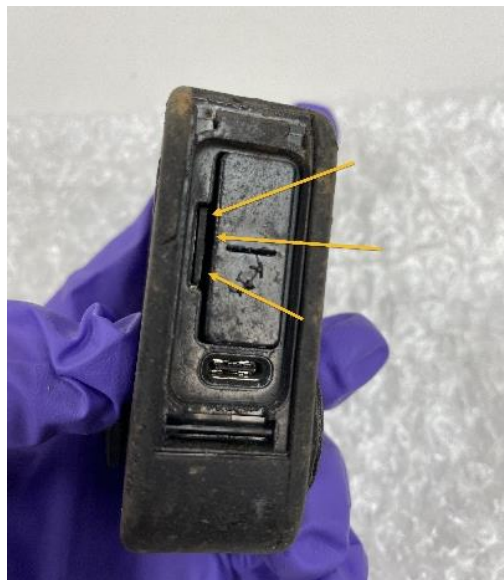
Figure 7. Memory card seated in the GoPro MAX.

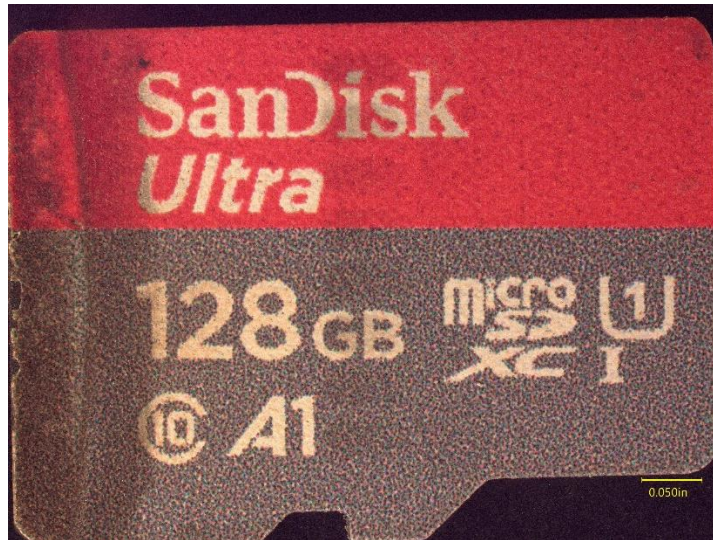
extracted. The microSD card exhibited some thermal damage but did not appear to be cracked (Figure 8).

Figure 8. Memory card recovered from the GoPro MAX.

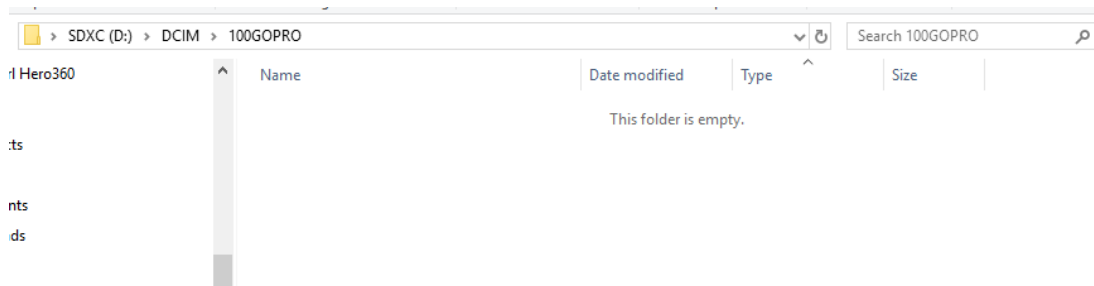
The device was read via a forensic write blocker and was able to mount as an accessible drive in a PC. The mounted drive revealed a folder structure consistent with the operation of a GoPro product. The drive contained two folders, DCIM and MISC (Figure 9). The DCIM folder which holds recordings made on the device was empty (Figure 10).

Figure 10. Empty DCIM folder from the card associated with the GoPro MAX from the accident.
