June 24, 2024

Investigative Update

Contact of Containership *Dali* with the Francis Scott Key Bridge and Subsequent Bridge Collapse (DCA24MM031)

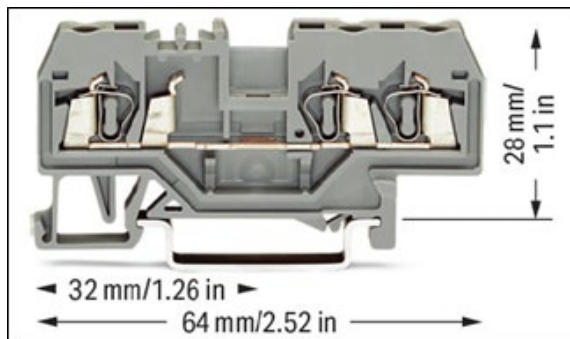
Exemplar terminal block identical to model removed from ship. (Source: WAGO)

NTSB investigators subsequently removed an electrical component (a terminal block; see figure) from the control circuit for HR1's undervoltage release.² Two portions of control wiring associated with the terminal block were also removed. We continue to examine the removed components at the NTSB Materials Laboratory. We will continue to evaluate the design and operation of the vessel's electrical power distribution system, and investigate all aspects of the accident to determine the probable cause and identify potential safety recommendations.
