National Transportation Safety Board

CEN23FA071

VIDEO FILE AND ONBOARD IMAGE, AUDIO, AND DATA RECORDER

Group Chairman's Factual Report

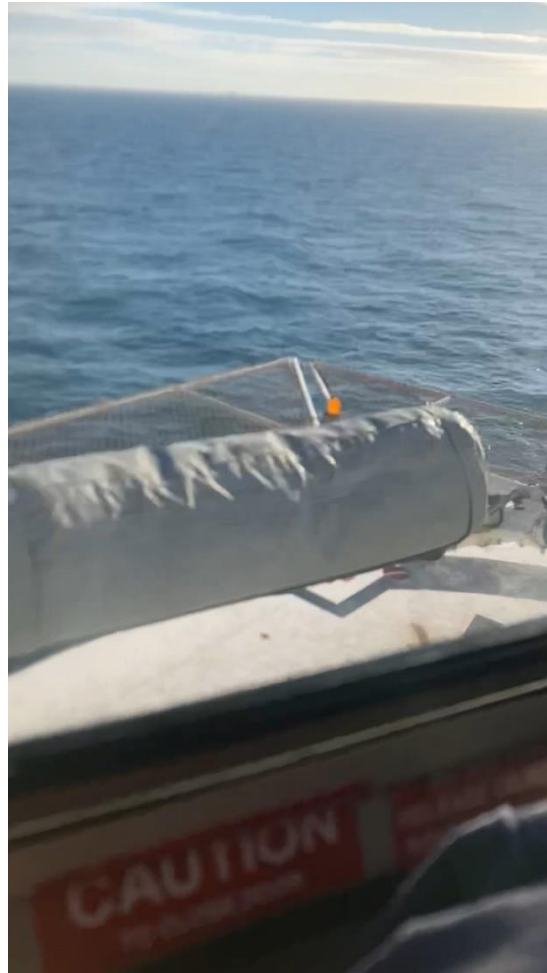
From 29:12 to 30:10, the helicopter started rolling to the right, and the recording showed the left skid started to rise. Figure 2 is a screenshot at 30:23 as the helicopter continued to roll to the right, the left skid and float is visible. An angle between the horizon and the bottom edge of the left seat window was apparent. The

time from when the helicopter began to ascend and began to roll was approximately 1.5 seconds.

Figure 2. Screenshot at 30:23, showing an angle between the horizon and the bottom edge of the left seat window while the helicopter was rolling to the right.

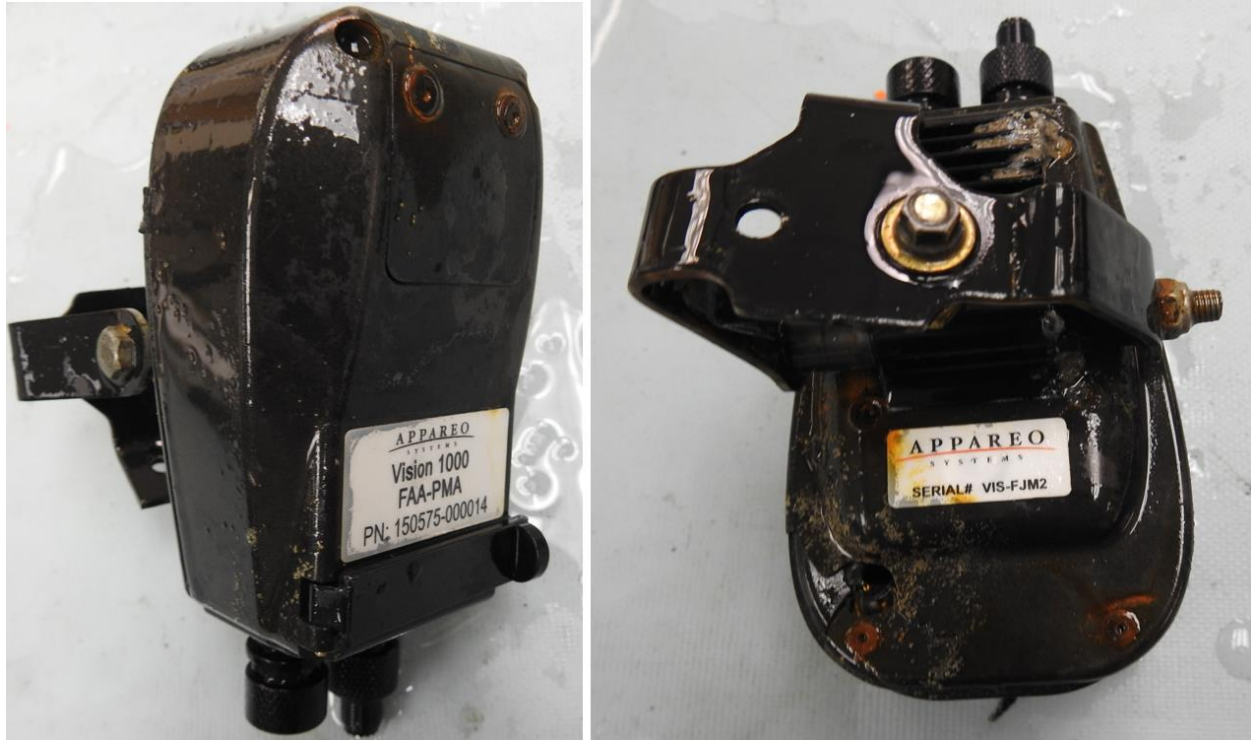
The Appareo Vision 1000 was contained in water upon arrival at the Vehicle Recorder Division. Figure 3 shows the condition of the device. A 32 GB SD card was found in the device. The SD card was cleaned and dried using laboratory procedures for water-damaged devices. After the recovery process, the SD card behaved normally when being read, and it contained both raw files and converted virtual drive files for numerous flights. The virtual drive files were playable within the manufacturer's playback software. The last flight recording was identified to be related to the accident, however, when played on the manufacturer's playback software, it did not show the accident. The last recovered image frame showed the helicopter idling on the helipad at 14:32:44 UTC on December 29, 2022.

Figure 3. Front and back of the Appareo Vision 1000 as received.

The internal circuitry of the Appareo Vision 1000 showed corrosion. The internal memory module was removed, cleaned, and dried using a laboratory procedure. The recovered memory module was then installed into a functional Appareo Vision 1000 surrogate. The surrogate powered up normally, and a full download following the manufacturer's procedure was successful. The downloaded data, 8 GB total, contained four flights, with the last flight being the accident flight. The image file of the accident flight ended shortly after the helicopter took off from the South Lafourche Leonard Miller Jr Airport (GAO), indicating the internal memory module of this Appareo Vision 1000 contained less data than the external SD card.

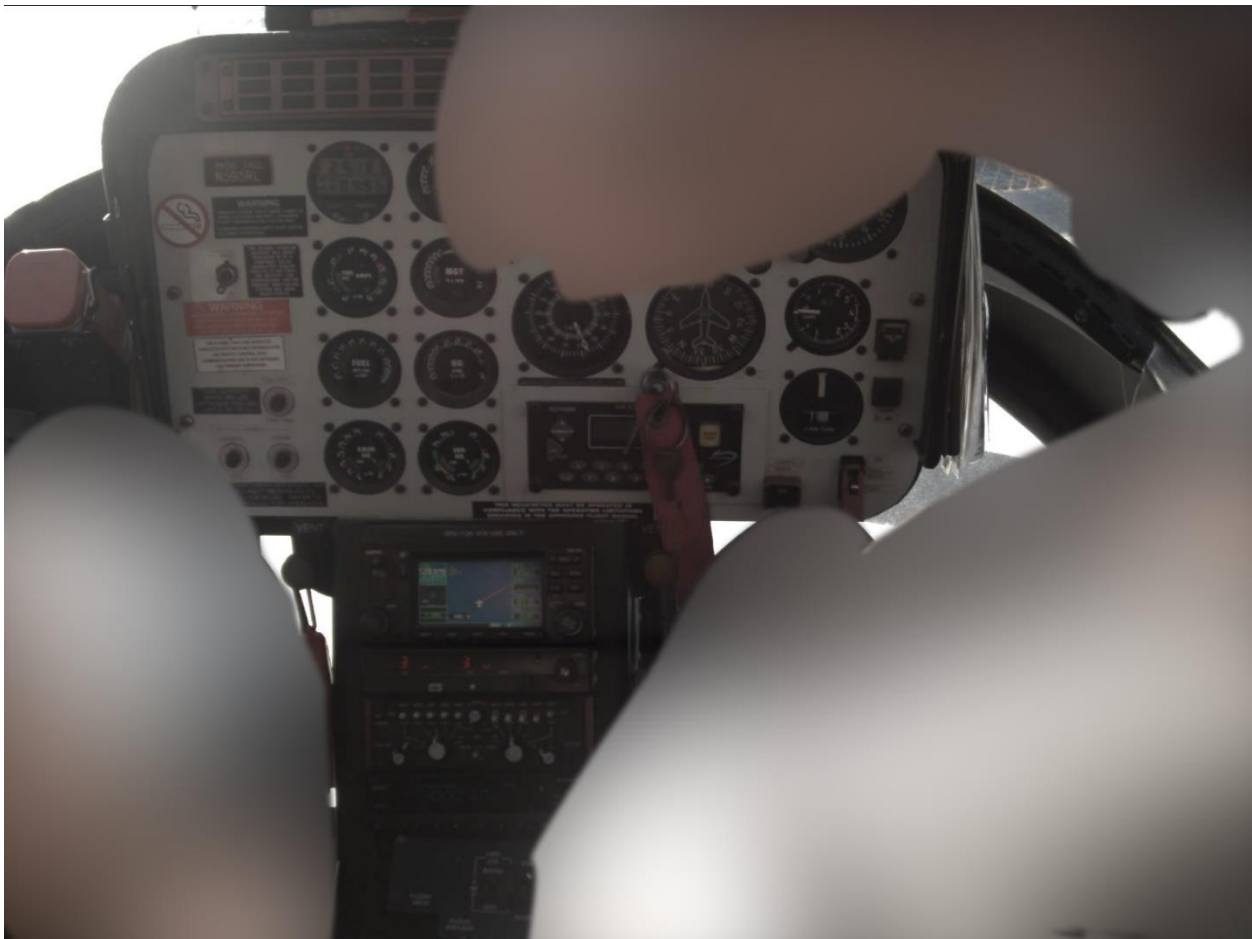
At 14:31:32.75, a part of the aiming circle was visible in the pilot's chin bubble. The tie-down was visible just past the pilot's shoulder harness. Figure 6 is the image frame at this time. Figure 7 and Figure 8 are additional image frames around the same time prior to the takeoff having a part of the aiming circle and the south light visible.

Figure 6. Image frame at 14:31:32.75. Parts of the image were redacted.

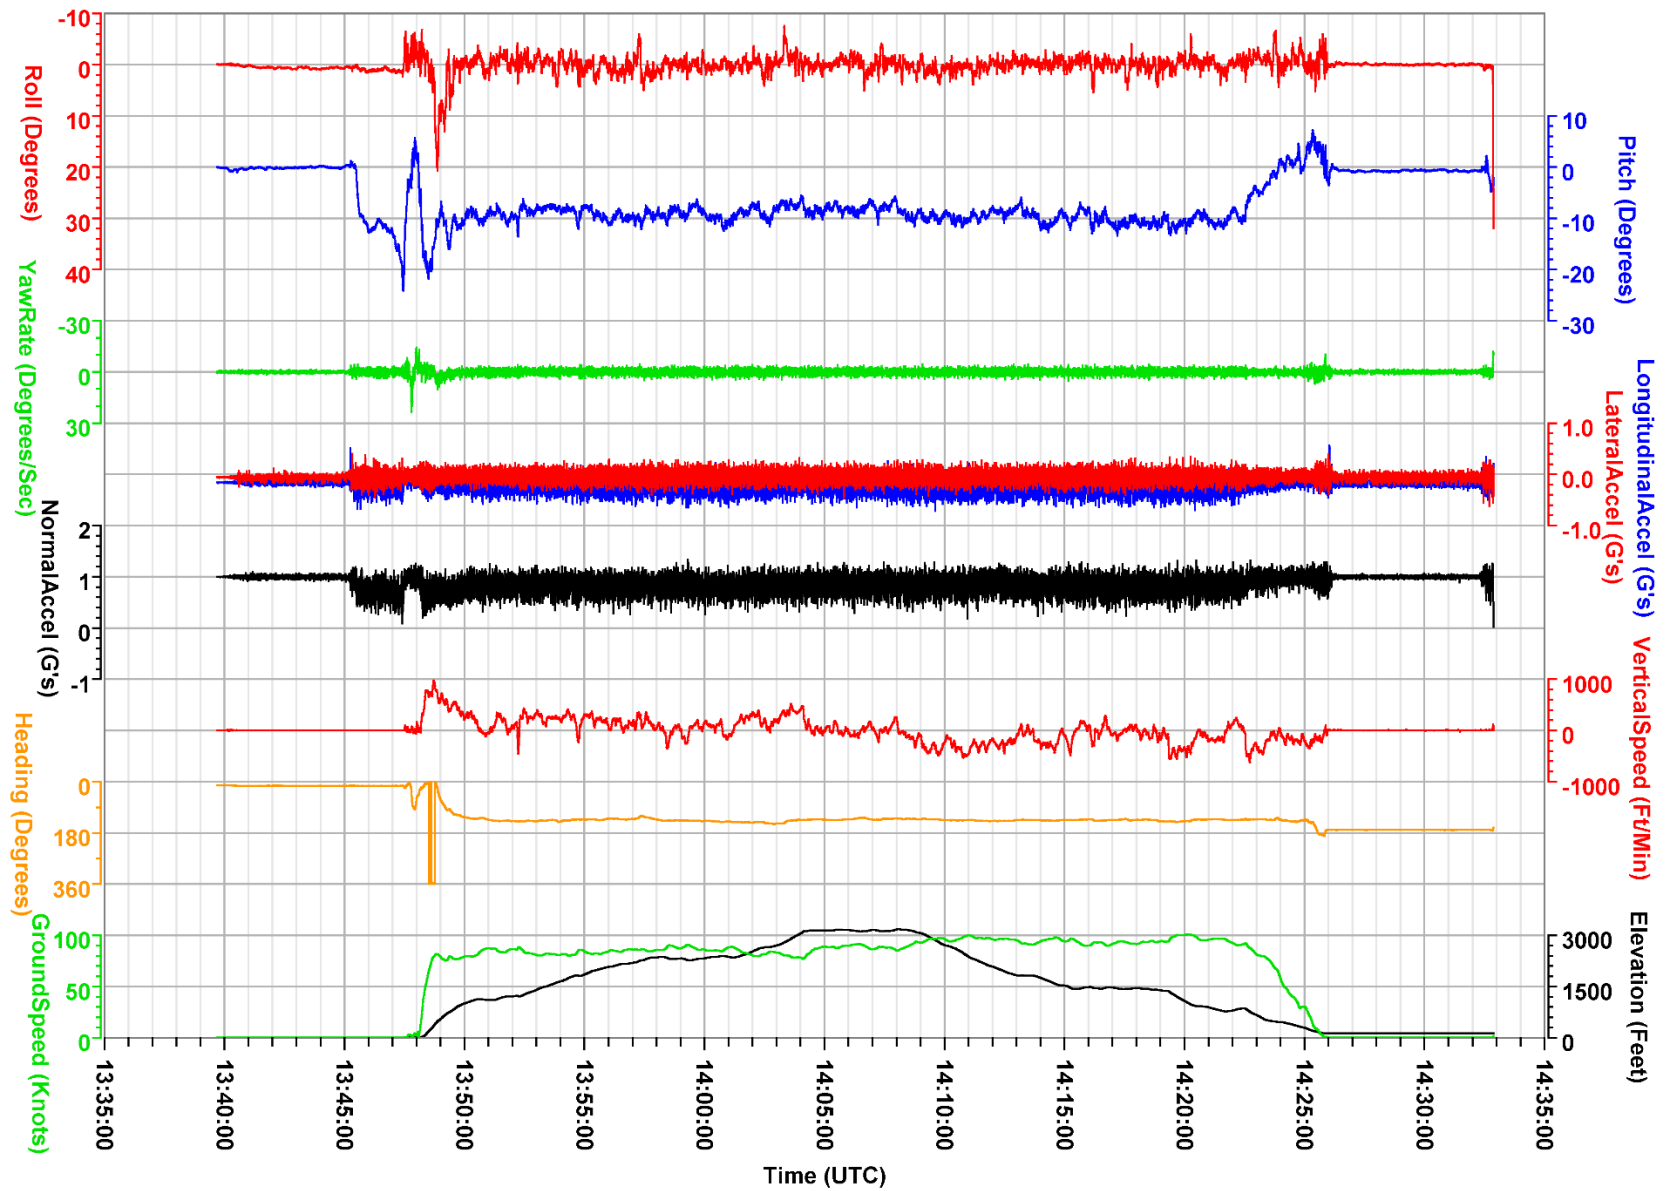
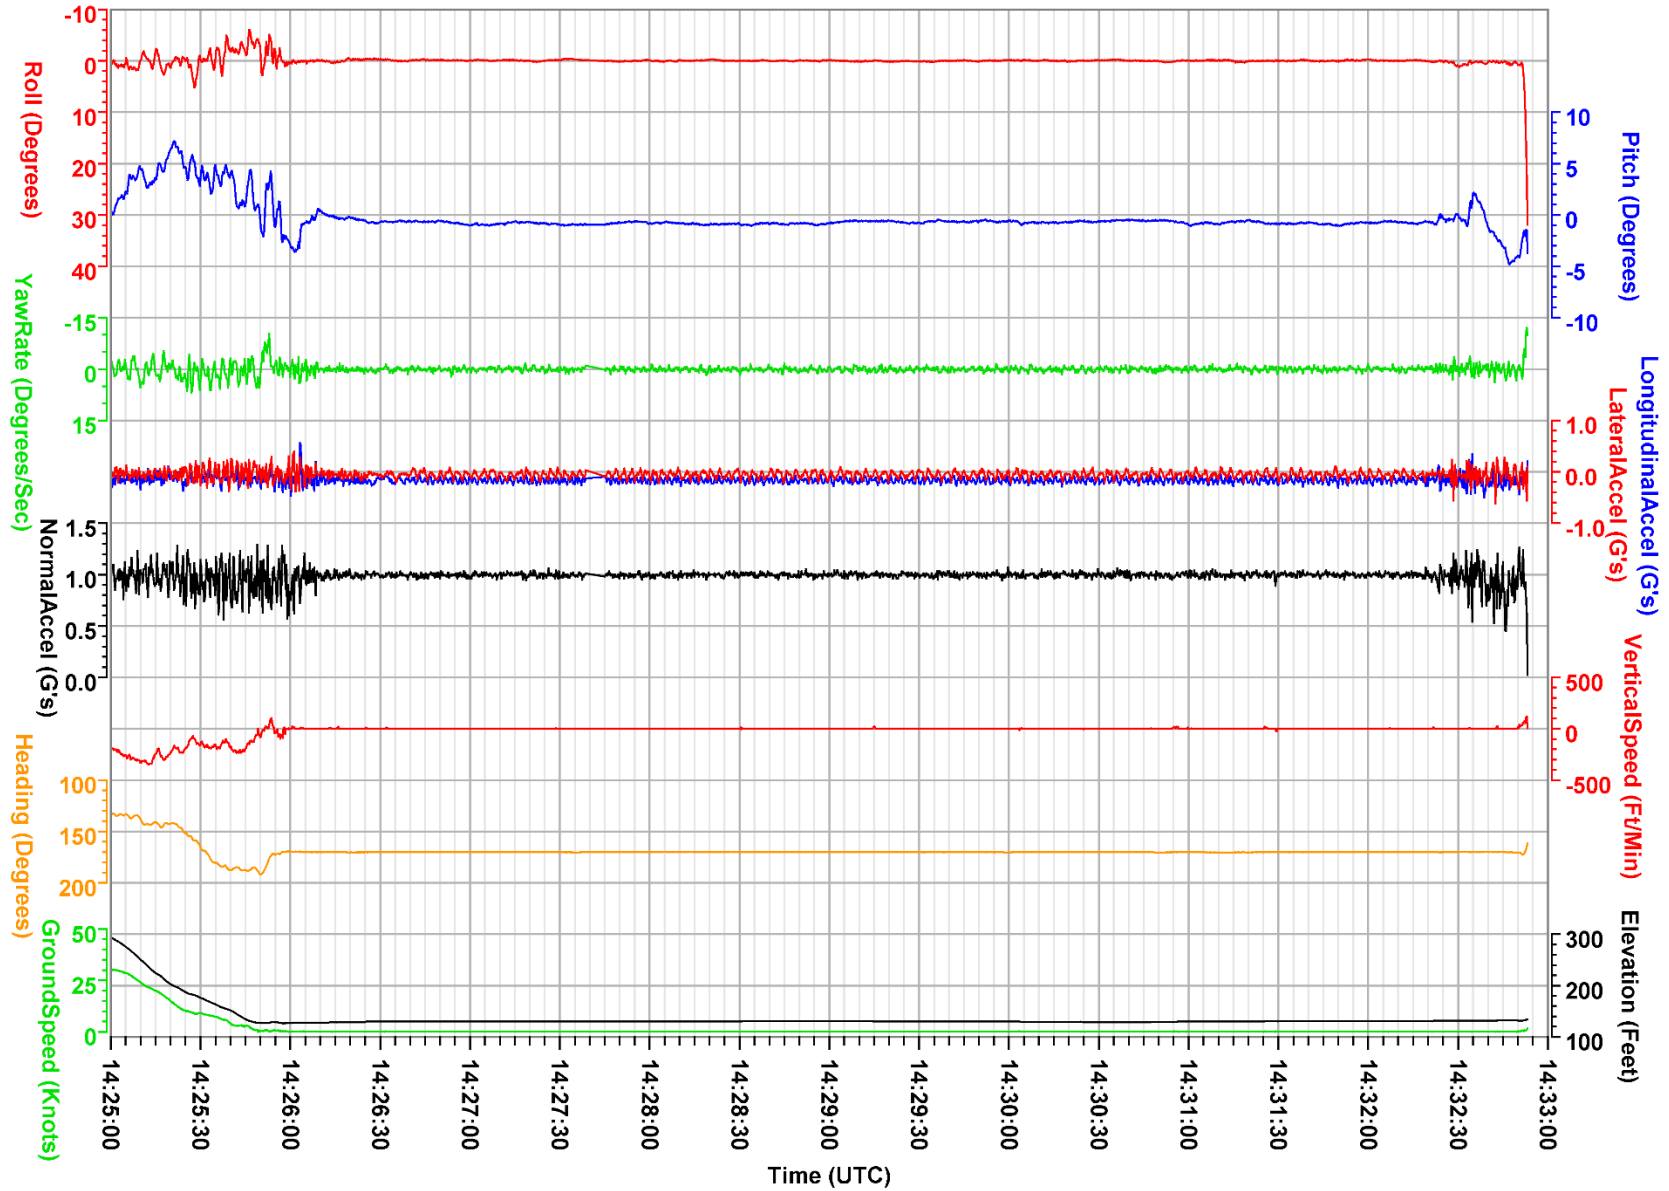
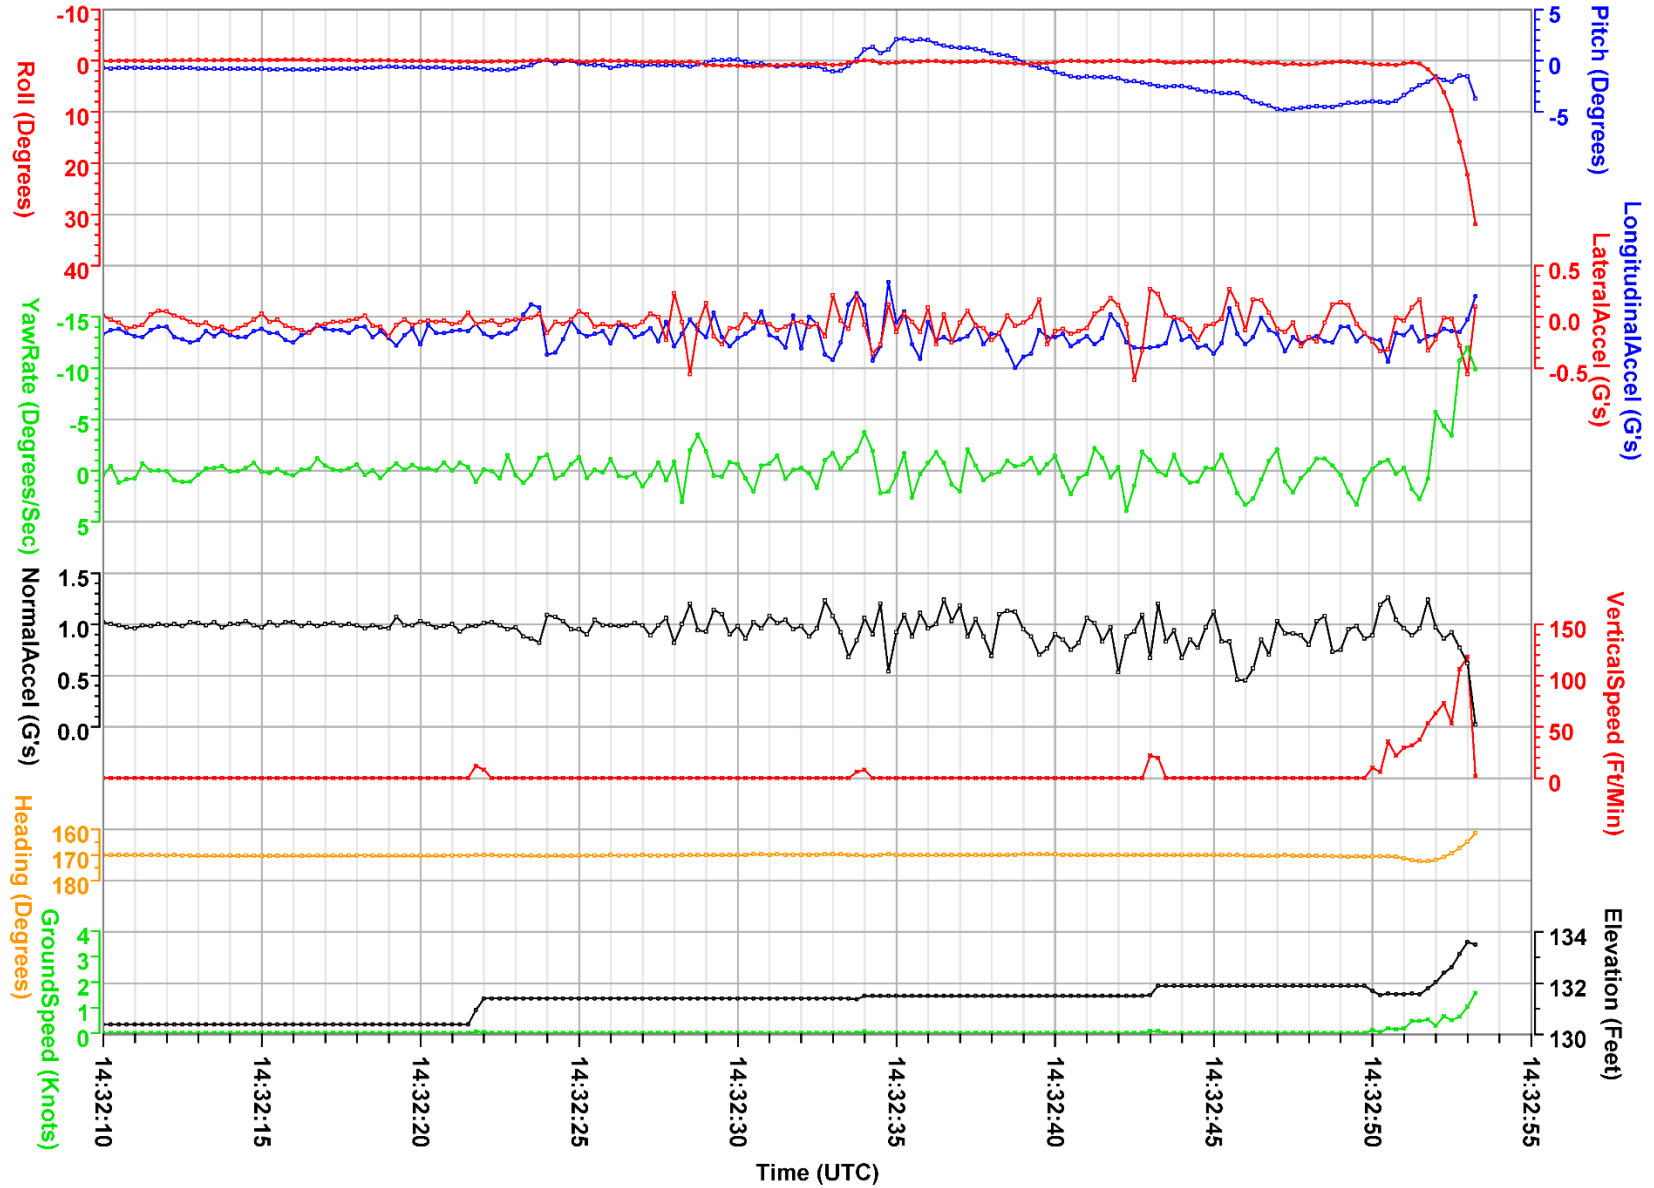
The parametric data were recorded at a sampling rate of 4 Hz. A review of the parametric data showed an offset in the recorded pitch and roll values for the dataset. This is likely a result of the Appareo Vision 1000 being installed at an angle and the proper offset not being entered when the unit was configured. The offset was corrected based on pitch and roll readings when the helicopter was stationary on the ground. Table 1 lists the recorded parameters verified and provided in this report.

Figure 10. Plot of parametric data for the entire accident recording.

Figure 11. Plot of parametric data for the session between 14:25:00 and the last recorded point.

Figure 12. Plot of parametric data for the session between 14:32:10 and the last recorded point.
