National Transportation Safety Board

CEN23FA071

OPERATIONS GROUP CHAIRMAN REPORT

Location: Galliano, Louisiana
Date: December 29, 2022
Time: 0832 CST
1432 UTC
Helicopter: Bell 407 / N595RL

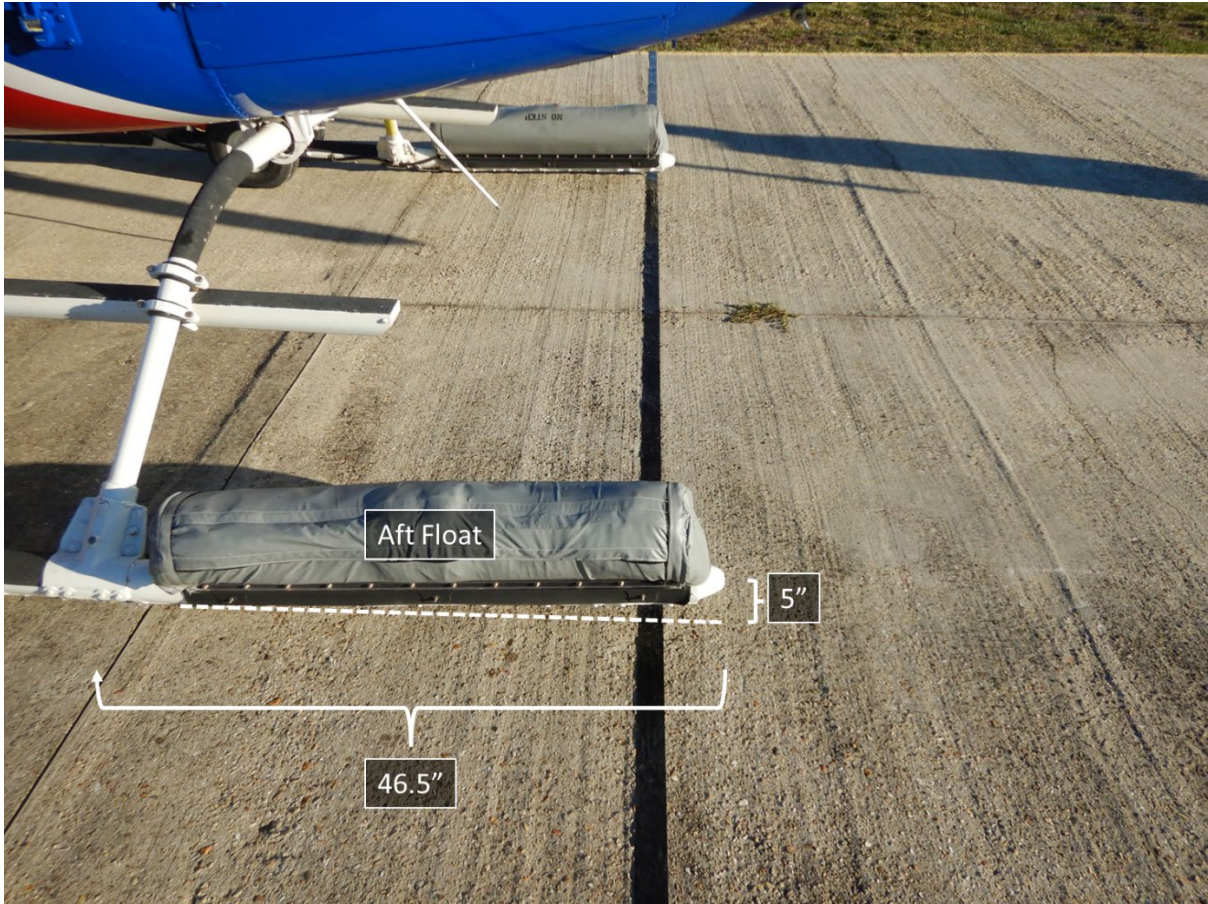
The helicopter was equipped with Dart Aerospace float skid tubes attached to high skid crosstubes. The float system used a forward, mid, and aft bag float system. The rear bag was attached to an aft skid section that measured about 46.5 inches from the center of the aft crosstube saddle to the aft end of the skid. The end of the skid was elevated five inches above the ground, as depicted in Figure 1.

Figure 1. Exemplar helicopter showing the aft float and the aft skid section

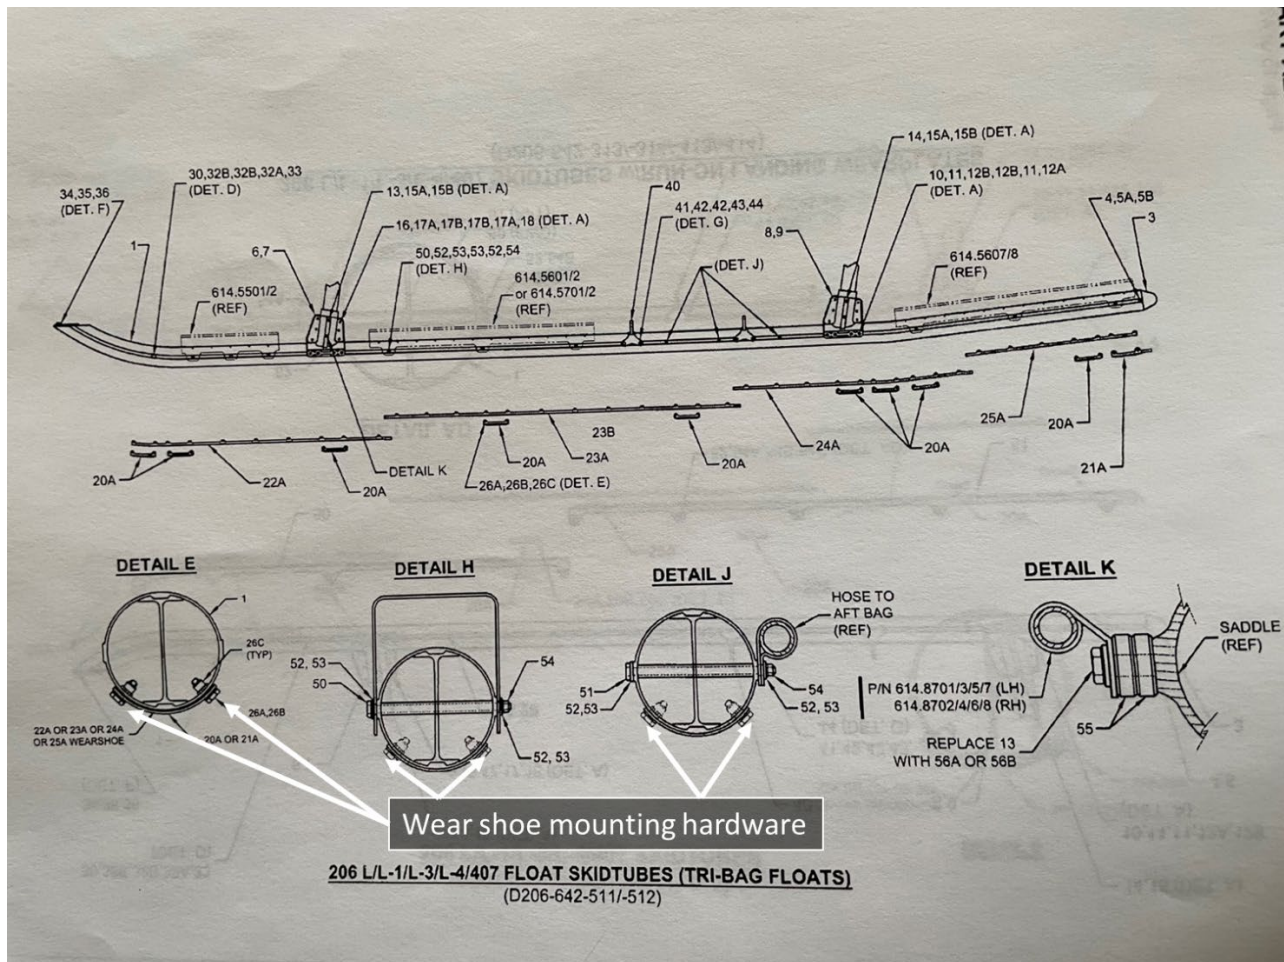
The skids were also equipped with multi-piece wear shoes. The wear shoes were fastened to the skids with bolts that can be seen in the image of Figure 2. Examination of an exemplar helicopter's wear shoes revealed that the bolt hole pattern was inline but not always equally spaced throughout the span of the skid.

Figure 2. Image showing a skid tube for the 407 helicopters. Mounting hardware for the wear shoes are shown in the details and are pointed out by the arrows.

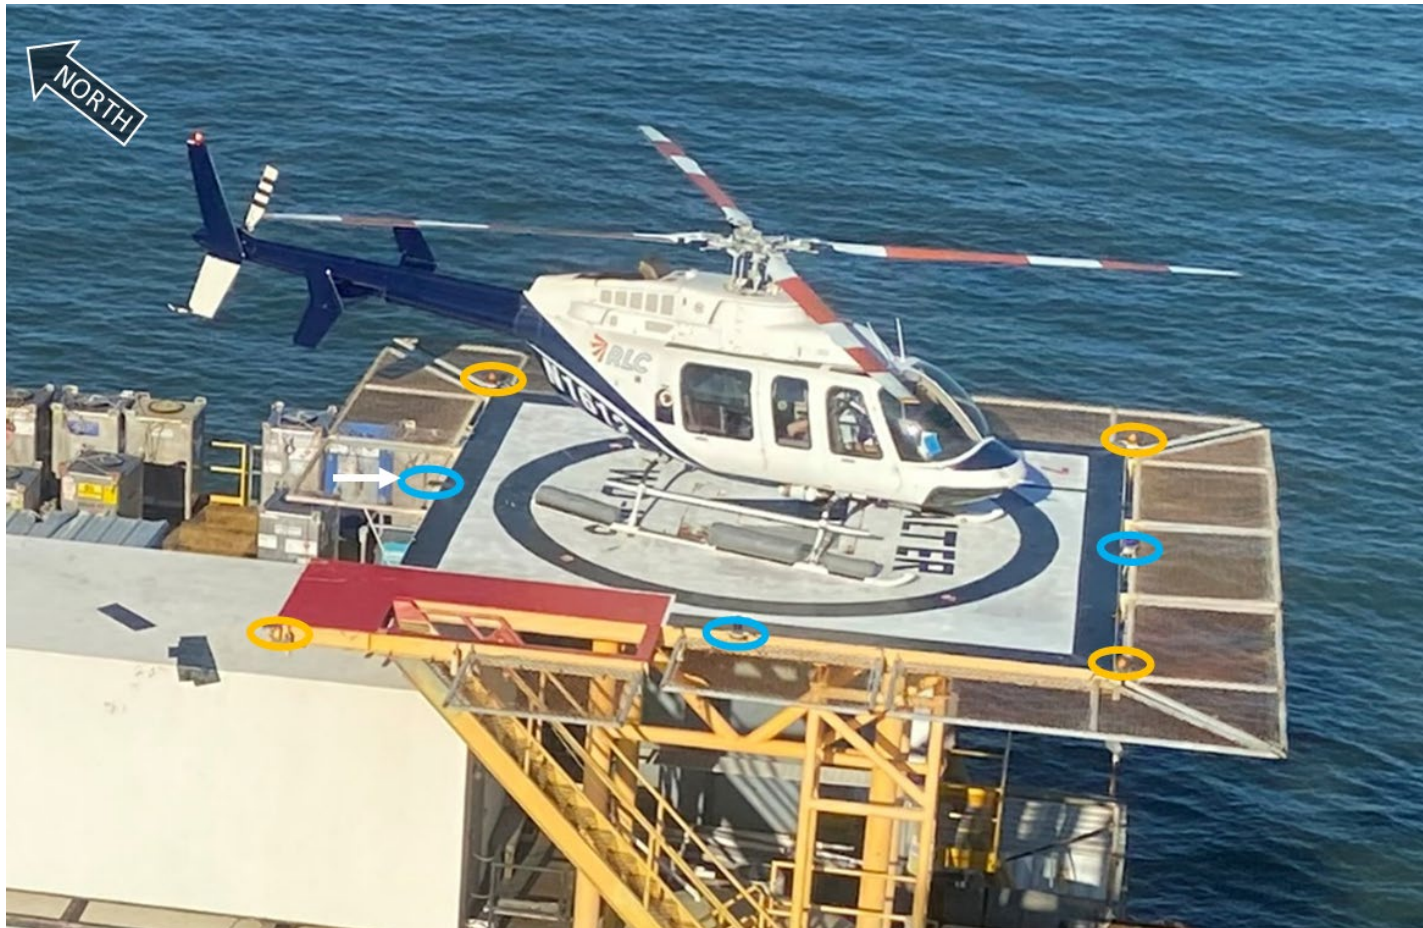
The helideck was outlined with eight lights of alternating amber and blue color. The light assemblies were guarded, no wiring was exposed and were located outboard of the flight deck. The light assemblies, whose attachment hardware to the helideck were not frangible, were about 8 inches tall. The helideck deck was painted white with a black border. A 10 ft diameter black aiming circle was in the center of the pad. The words "WALTER" and "WD-106" were painted inside the aiming circle, as was a gray and black "W" icon. The stairwell for the helideck was in the southwest elevation and had a red border around it. A metal perimeter safety skirting outlined the helideck. Except for the eight light assemblies, no objects were elevated, or stood proud on the helideck, as shown in Figure 7.

Figure 7. Close up image of an exemplar Bell 407 helicopter on the WD-106 helideck. Helideck perimeter amber lights are circled in amber, and perimeter blue lights are circled in blue. The arrow points to the light significant to the accident.

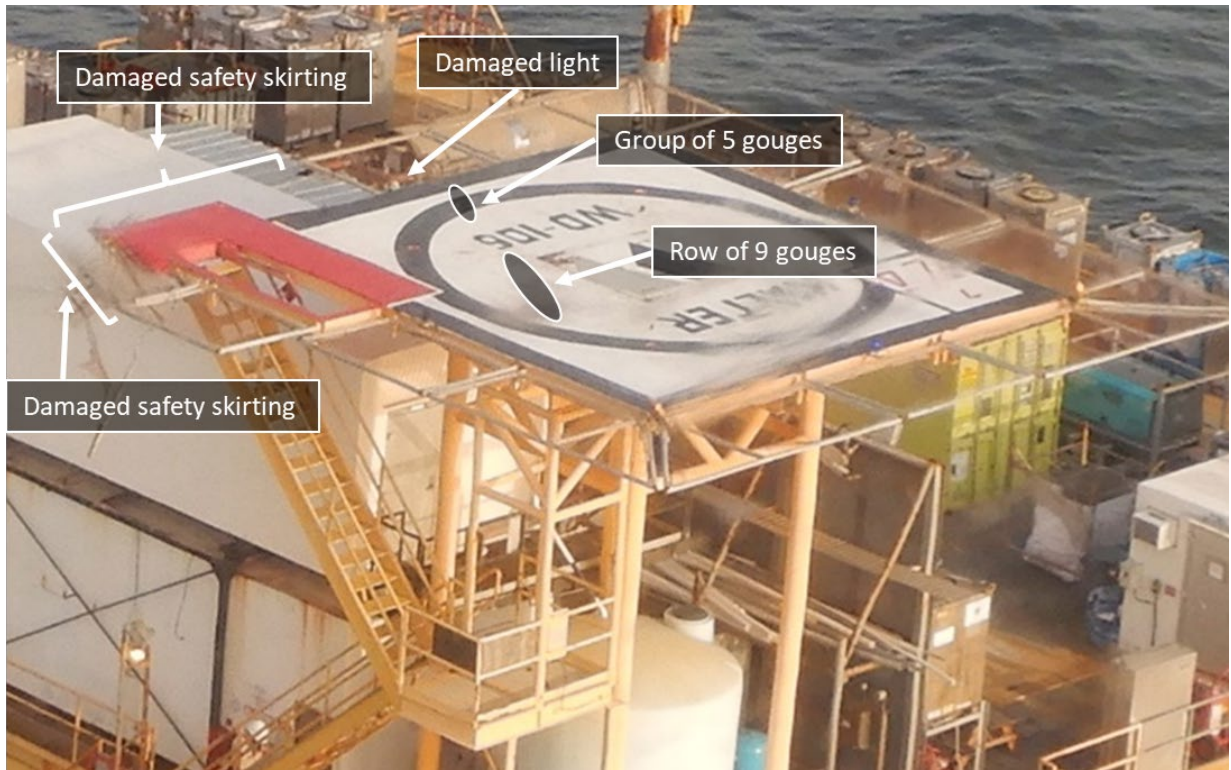
Further examination of the helideck, as shown in Figure 8, revealed the center blue light assembly on the northwest elevation was damaged but still remained attached to the 6 inch by 6 inch light mount. The light had remained installed on the mount, but the blue glass globe was fragmented and the metal protective guard for the globe was deformed and bent toward the stairwell. After the accident, an Island Operating employee removed the damaged light assembly from the mount out of concern for safety during future use of the helideck. An amber light, located on the west corner, near the stairwell separated from the mount and was not recovered. The red paint around the stairwell exhibited scratches and gouges. The safety skirting that bordered the stairwell (northwest and southwest elevations) was damaged. There were multiple impact marks on the metal frame of the helideck around and below the area of the damaged safety skirting and stairwell. Two areas of gouges in the paint on the helideck were present. The first area was a row of nine irregularly spaced but inline gouges, as shown in Figure 9, located inside the aiming circle, and adjacent to the "W" icon logo painted on the helideck. The second area was a group of five irregularly spaced gouges, found in the black paint of the aiming circle, as shown in Figure 10, near the northeast elevation and near the damaged center light. Figure 11 is an illustration showing the location of the two areas of paint gouges and the damaged light assembly.

Figure 8. Image identifying some of the damage to the helideck.

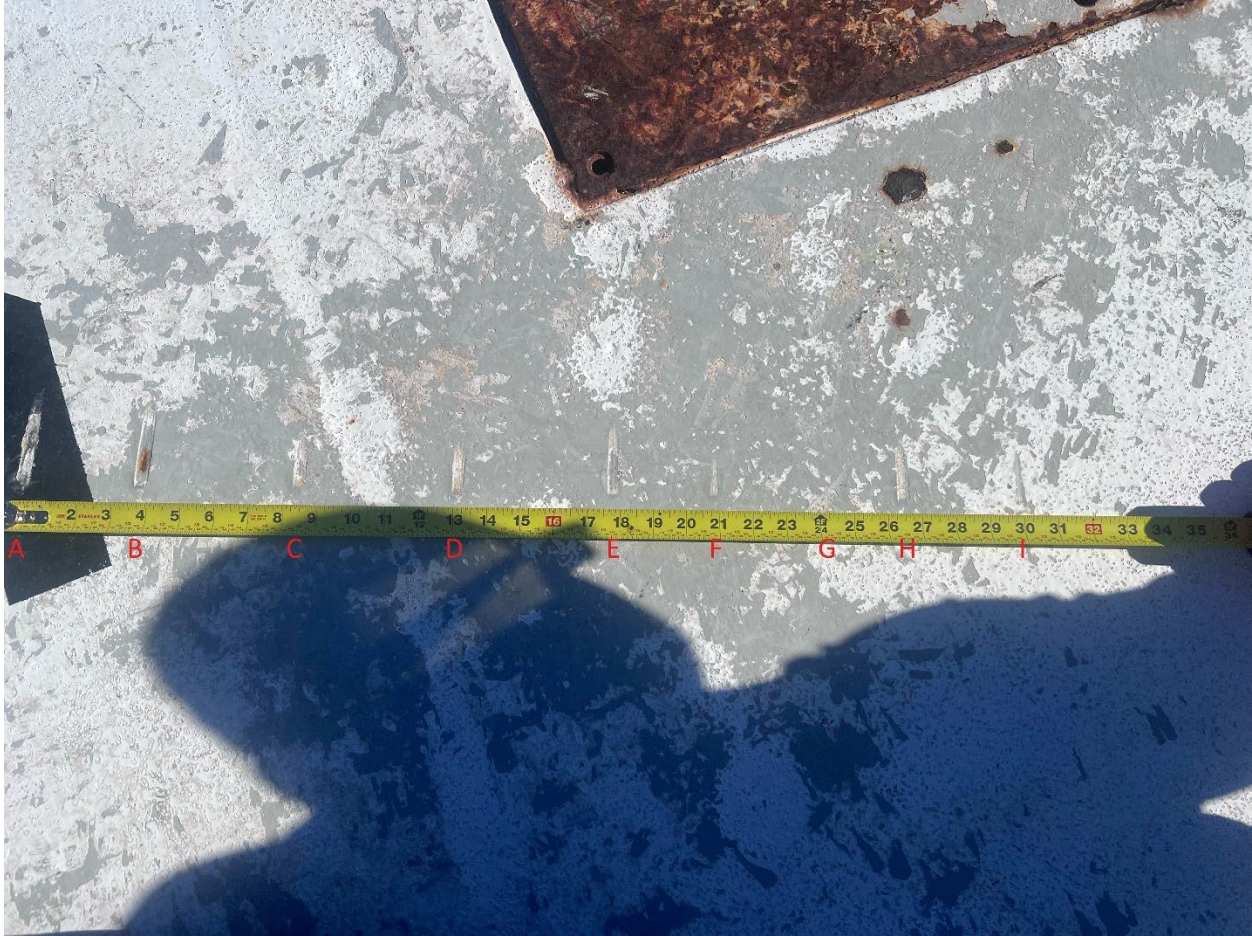
Figure 9. Photo showing the row of 9 irregularly spaced but inline gouges in the paint inside the aiming circle.

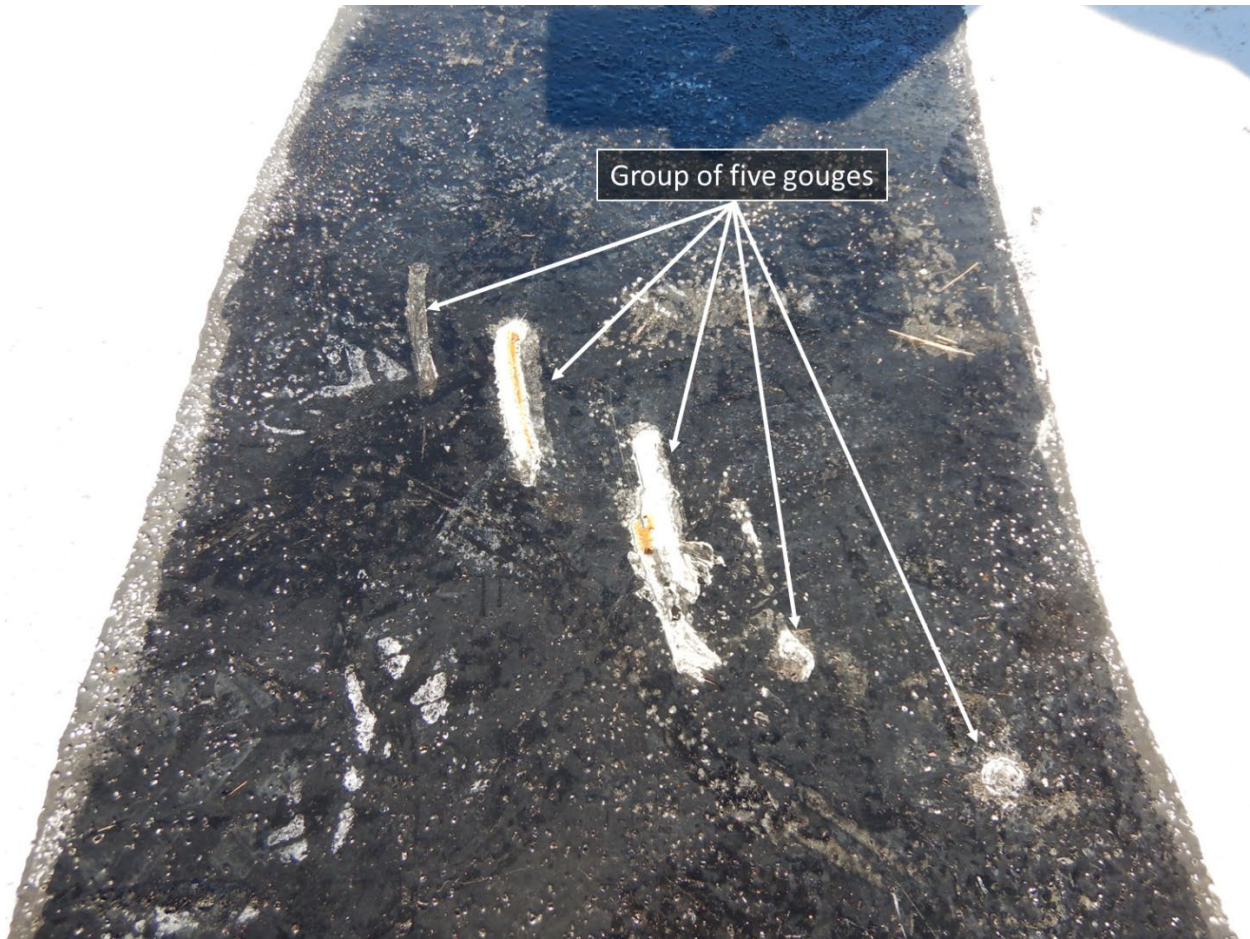
Figure 10. Photo showing the group of five irregularly spaced gouges in the aiming circle paint.

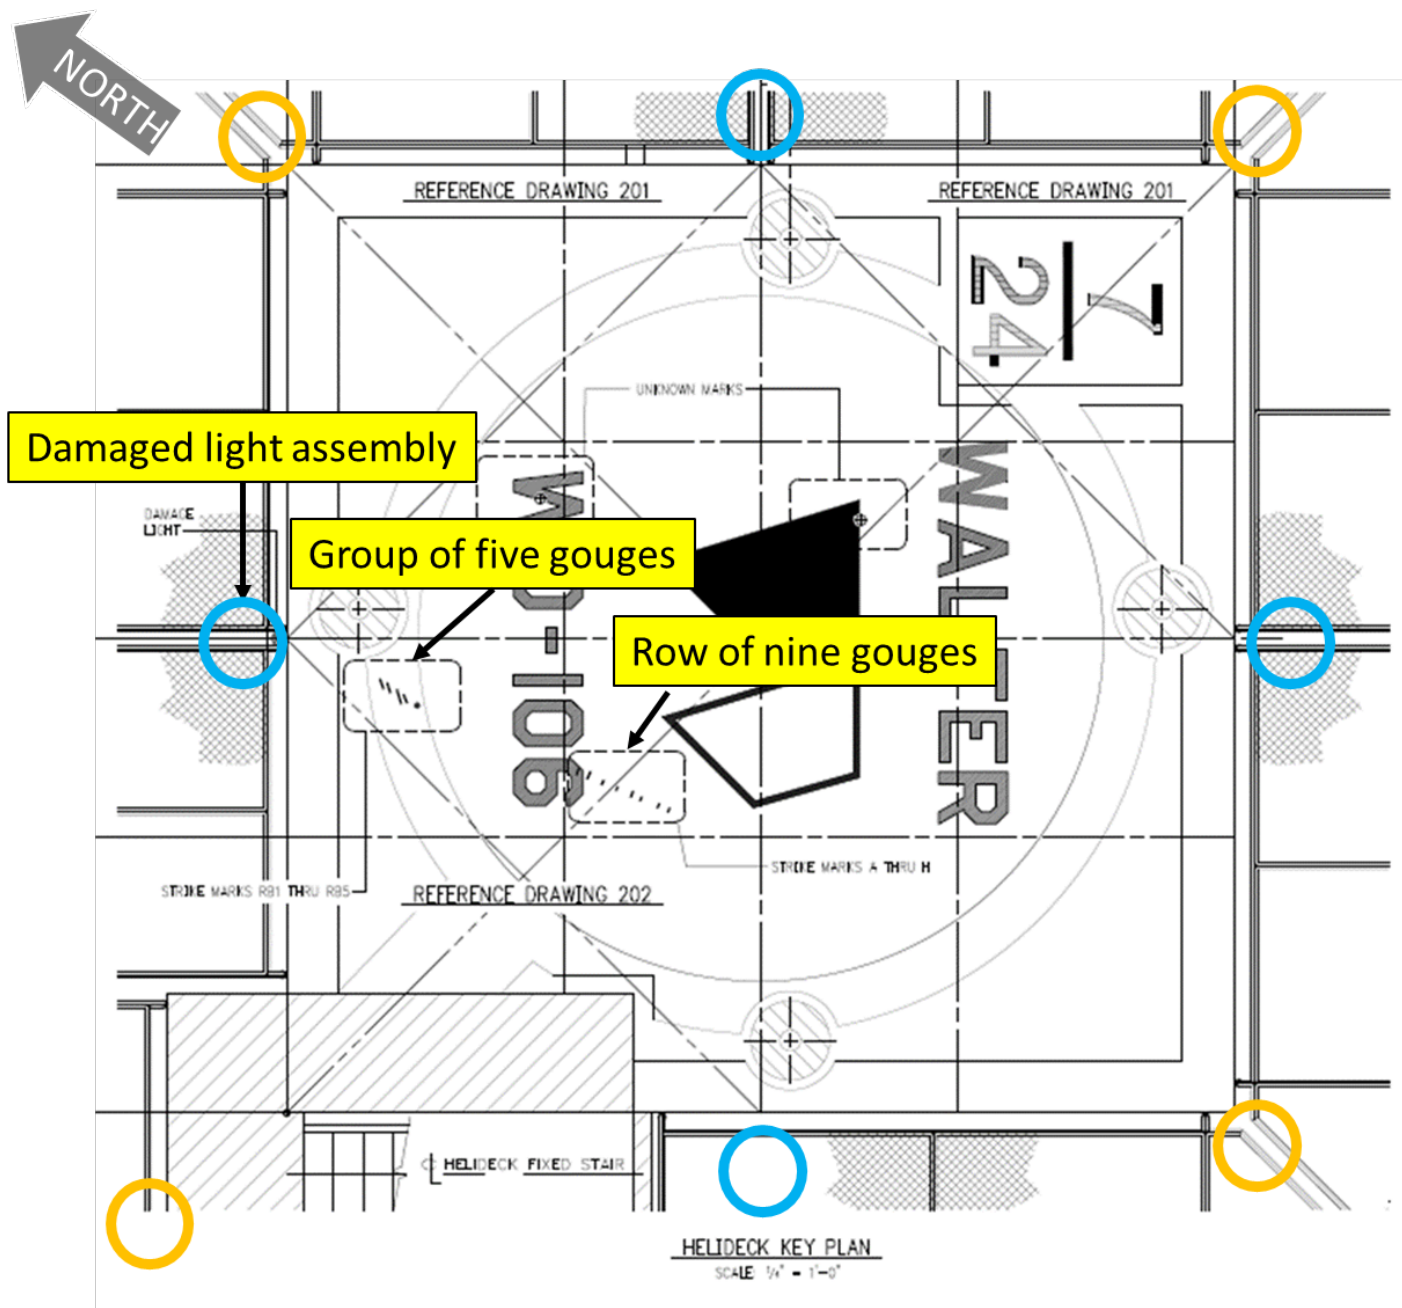
The location of the two gouged areas and the damaged light assembly is shown in Figure 11.

Figure 11. Illustration showing the location of the two groups of gouges in the helideck paint and the location of the damaged light assembly. Illustration provided by Walter Oil and Gas.

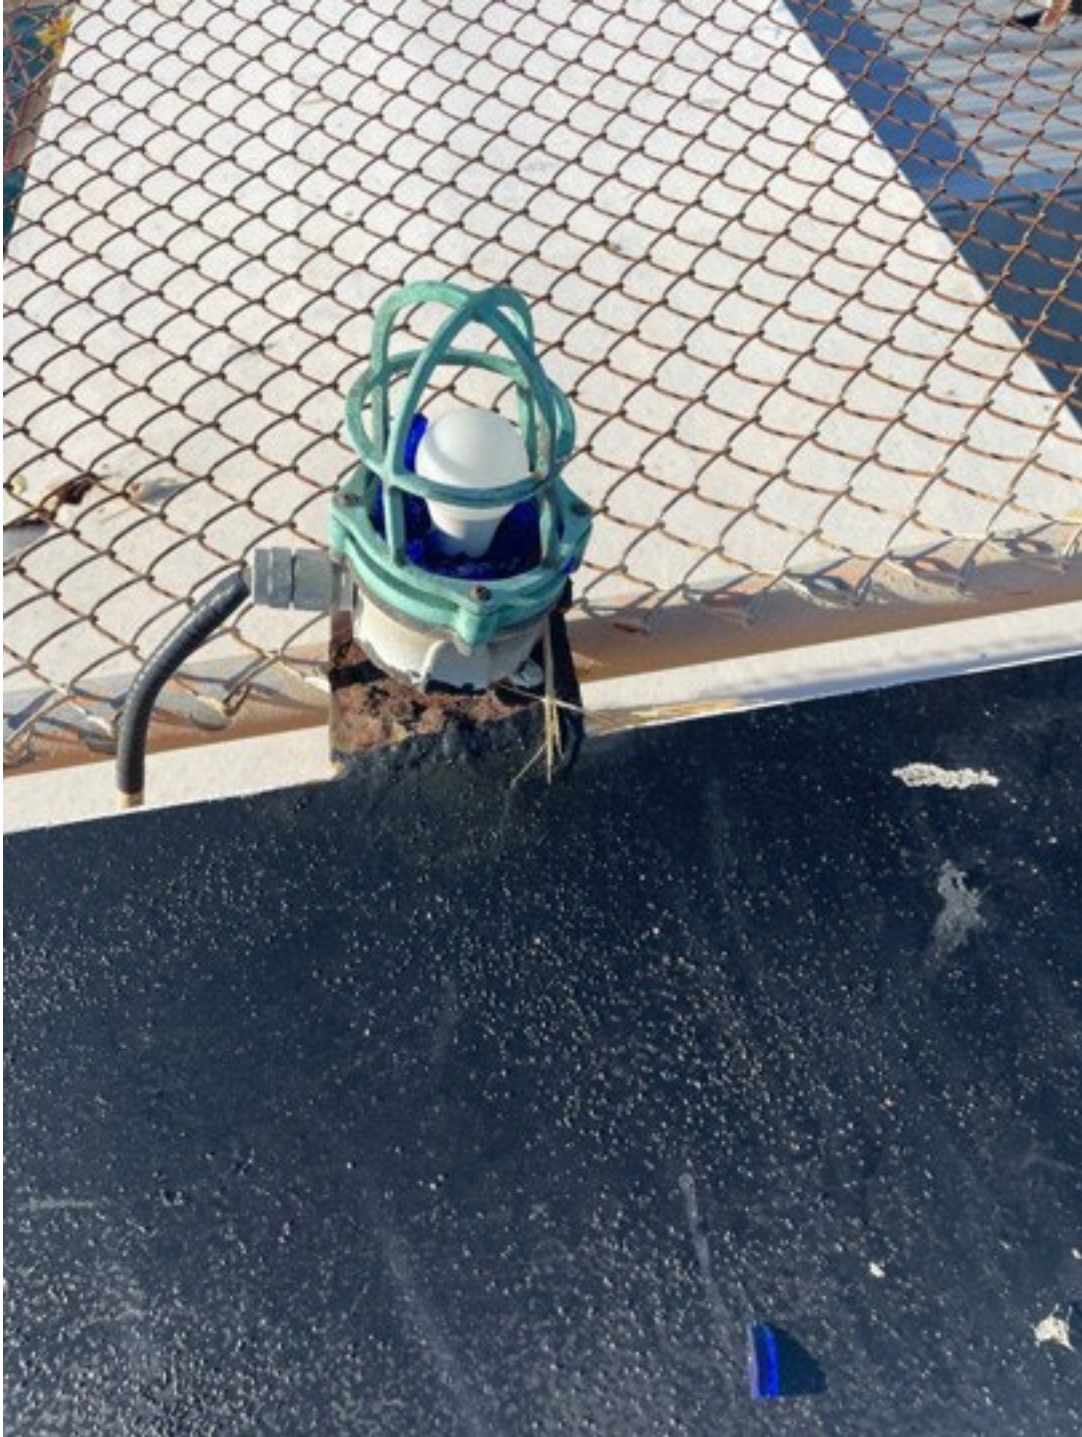
A closeup image of the damaged light assembly is shown in Figure 12.

Figure 12. Photo of the northwest elevation, center light, immediately after the accident. Photo courtesy of Walter Oil and Gas.

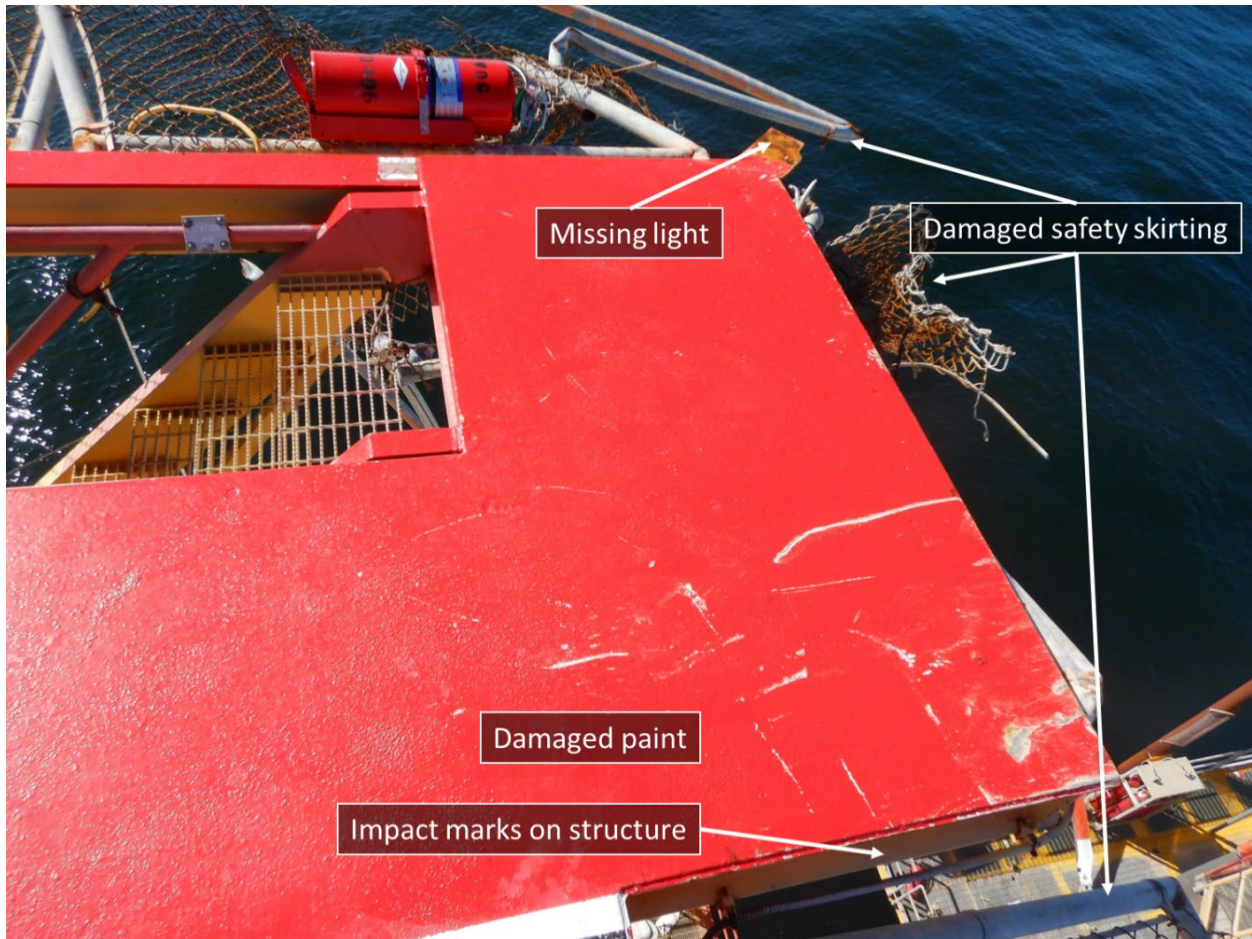
A closeup photograph of the damaged stairwell paint, the mount for the missing yellow light assembly and the damaged safety skirting is Figure 13.

Figure 13. Photo identifying some of the damage around the stairwell area.

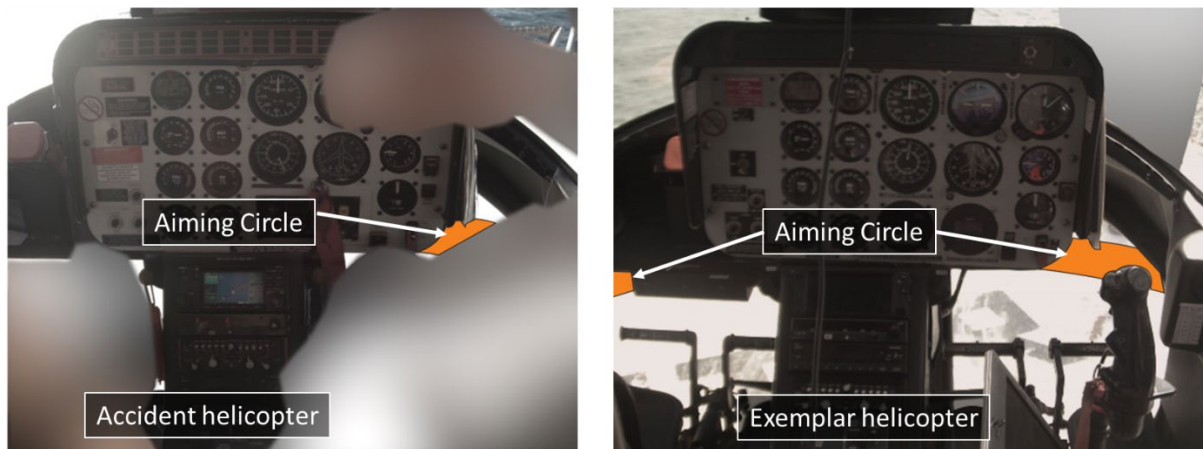
The exemplar helicopter was then repositioned straight aft to match the calibrated exemplar recorder FOV to the accident recorder’s FOV, as shown in Figure 17.

Figure 17. Side by side comparison of the accident Appareo’s FOV (left) and the exemplar Appareo’s FOV (right). Aiming circles are highlighted in orange.

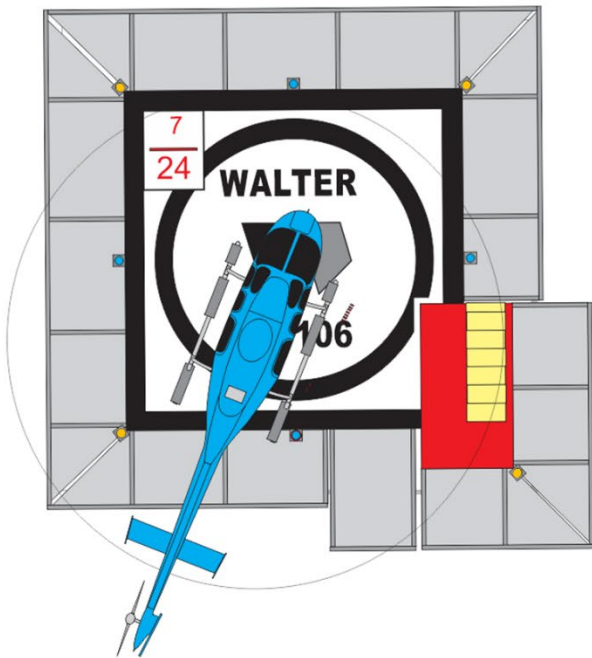
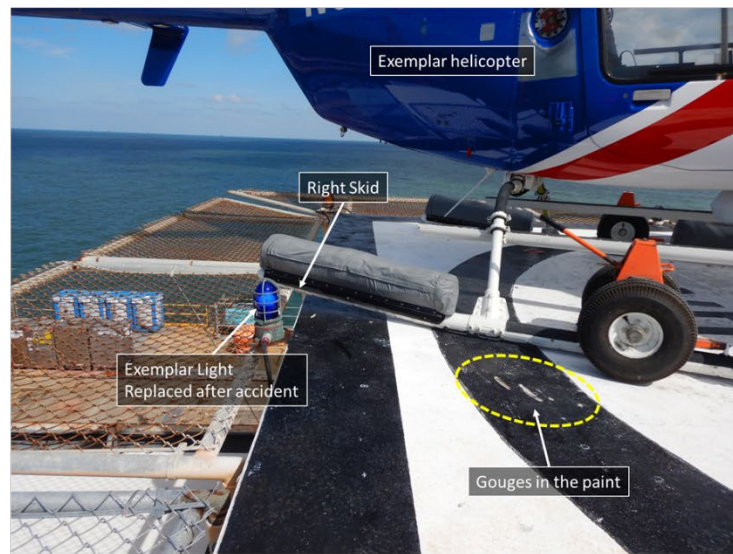
Moving the exemplar helicopter straight aft to match the accident FOV resulted in the right skid extending past the edge of the helideck, while the left skid remained completely on the helideck, as shown in Figure 18.

Figure 18. Image showing the aft section of the exemplar helicopter's right skid is beyond the edge of the northwest elevation of the helideck. The illustration shows the helicopter's location on the helideck.

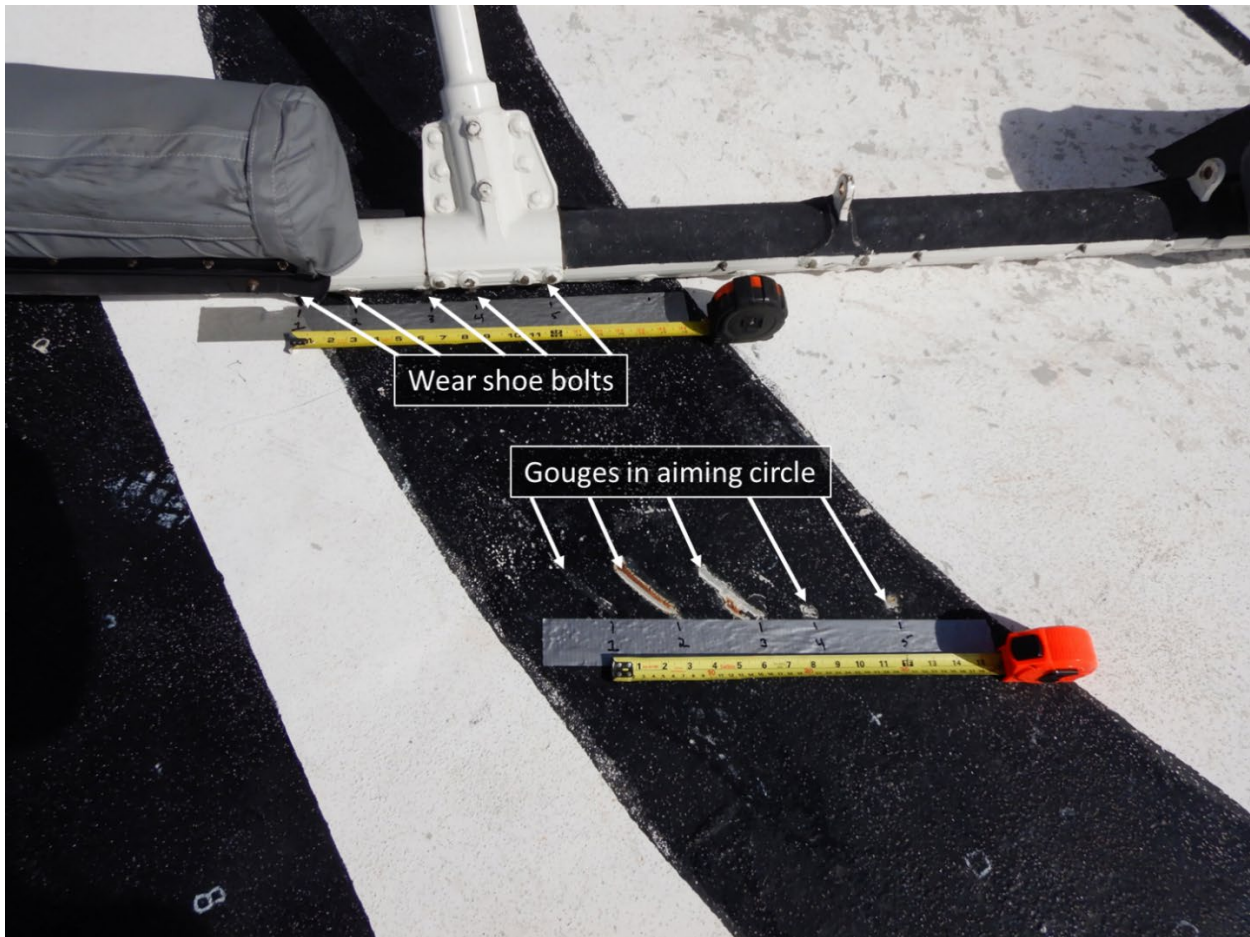
When compared to the group of five gouges in the aiming circle, five wear shoe mounting bolts were near the gouges and matched the spacing between the gouges, as shown in Figure 19 and Figure 20.

Figure 19. Image of an exemplar right skid showing the five wear shoe mounting bolts that matched the spacing of the group of five irregularly spaced gouges in the paint.

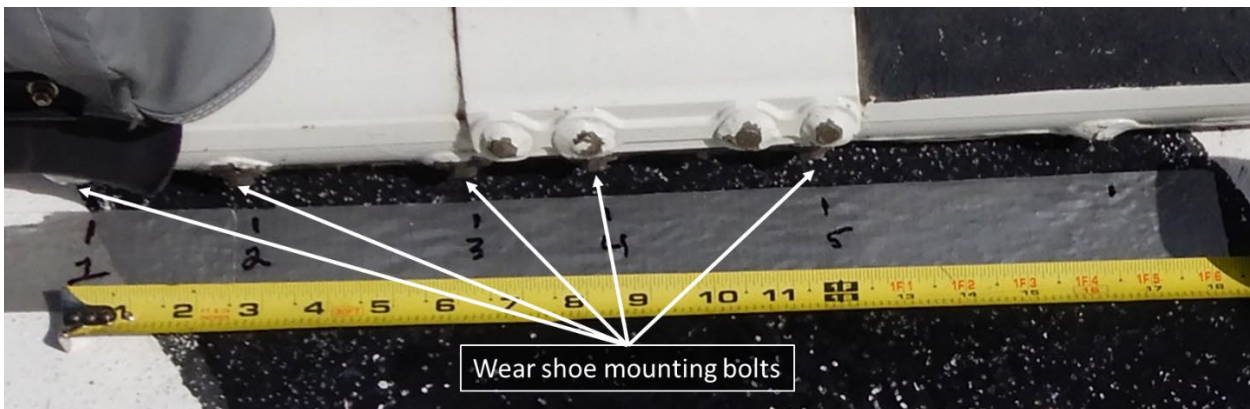
Figure 20. Close up of the five matching wear shoe mounting bolts underneath the aft cross tube saddle.

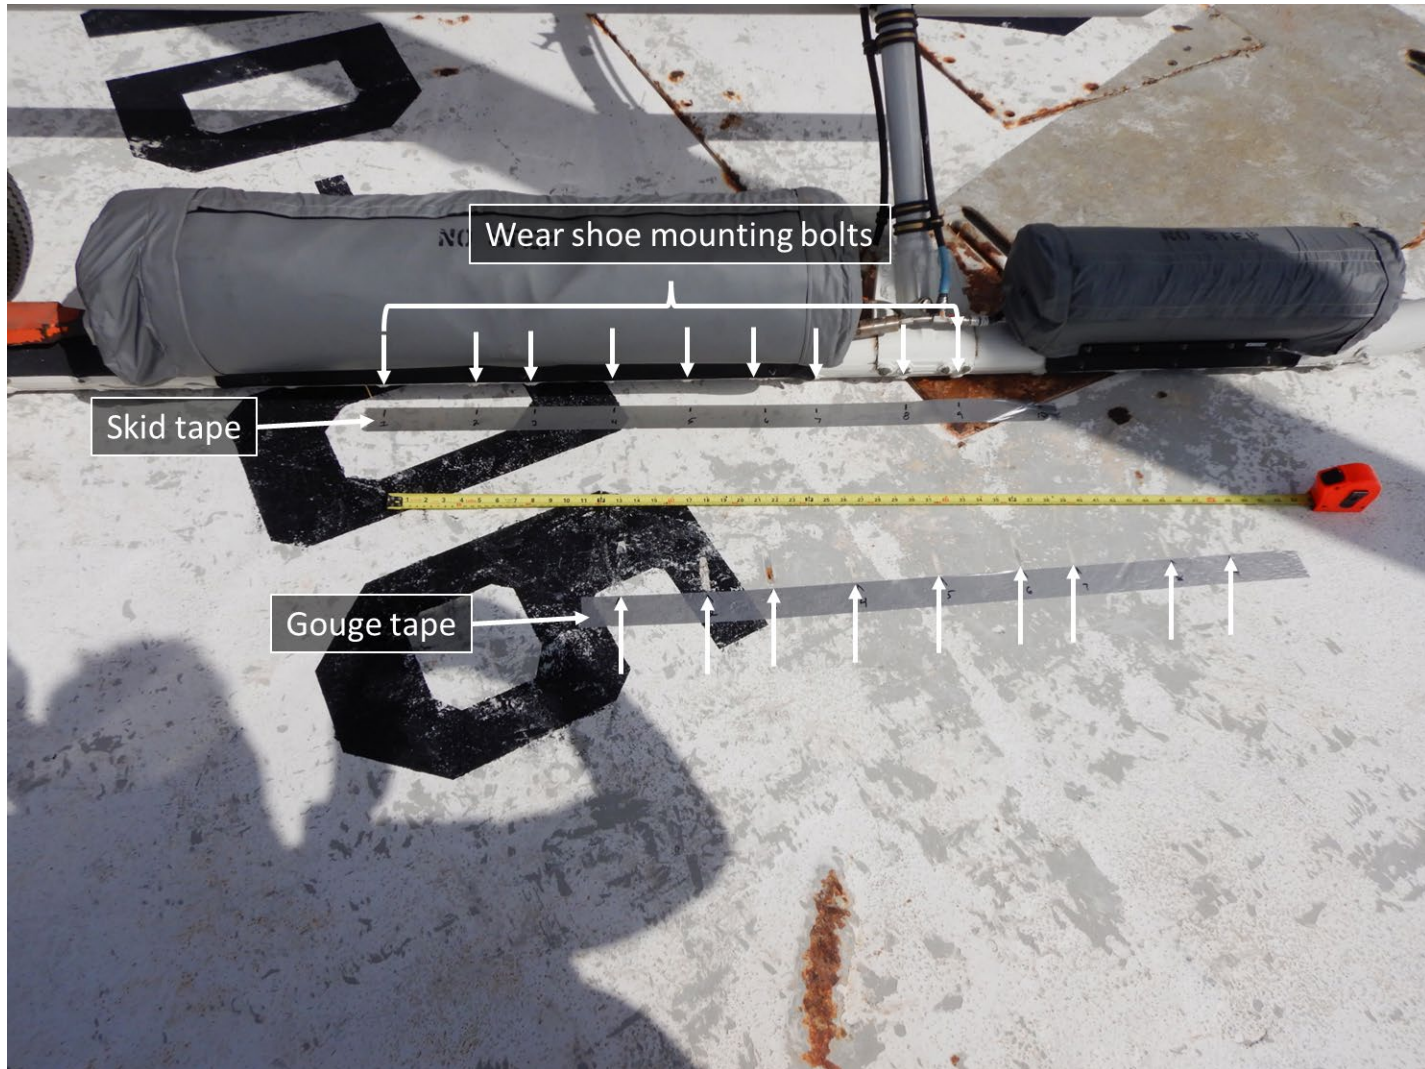
With the exemplar helicopter still in the position that matched the accident helicopter's FOV, the middle section of the right skid was compared to the row of nine irregularly spaced but inline gouges to the paint. A section of nine wear shoe mounting bolts were near the gouges and matched the spacing of the gouges, as

Figure 21. Photo showing the row of nine irregularly spaced but inline gouges in the paint alongside the matching wear shoe mounting hardware.

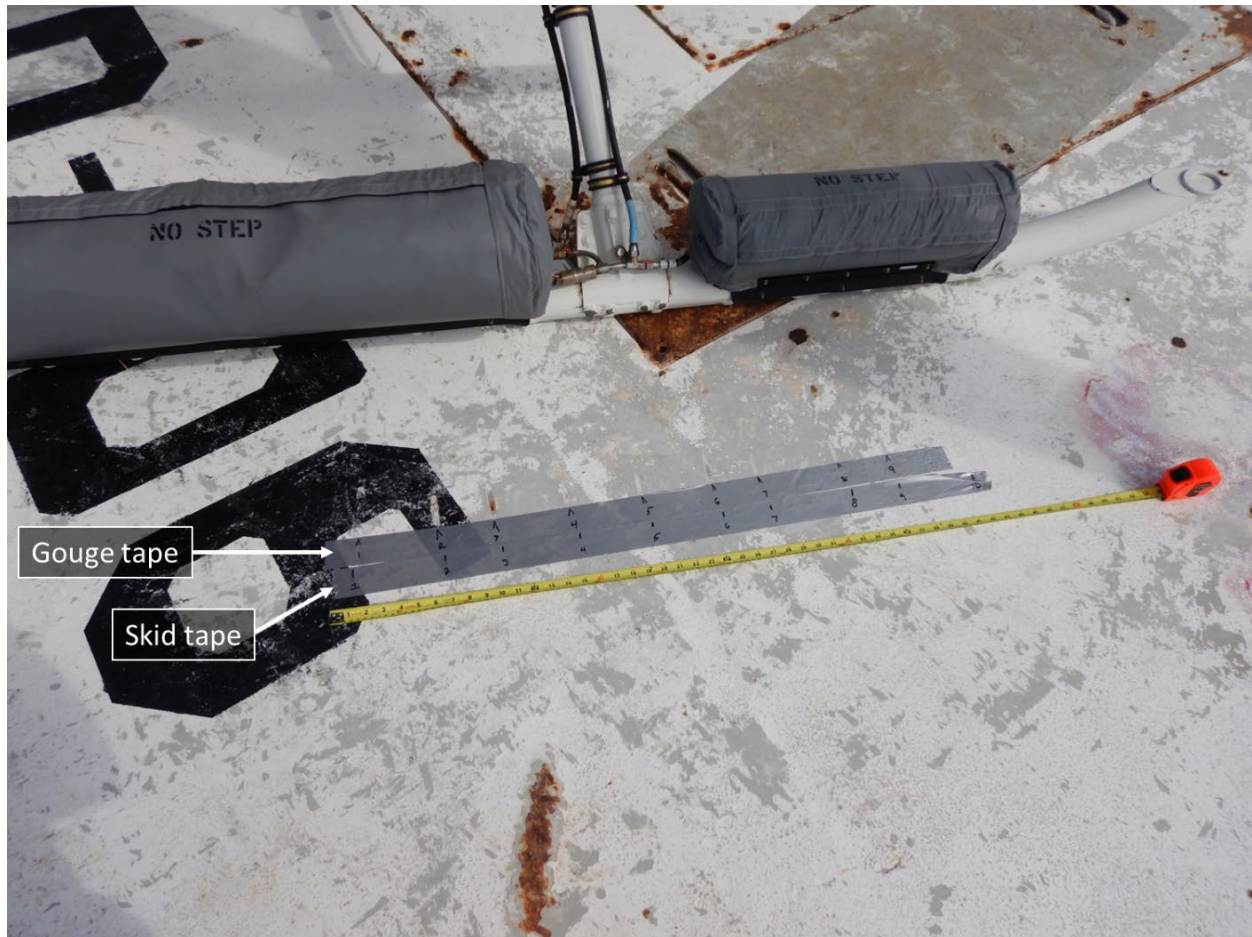
shown in Figure 21. The spacing of the wear shoe bolts was marked onto a section of tape and the spacing of the gouges in the paint were marked onto a section of tape. When placed side by side, the spacing was nearly identical, as shown in Figure 22.

Figure 22. Photo showing the spacing of the wear shoe bolts and the paint gouges.
