National Transportation Safety Board

Response to Petition for Reconsideration

December 11, 2024

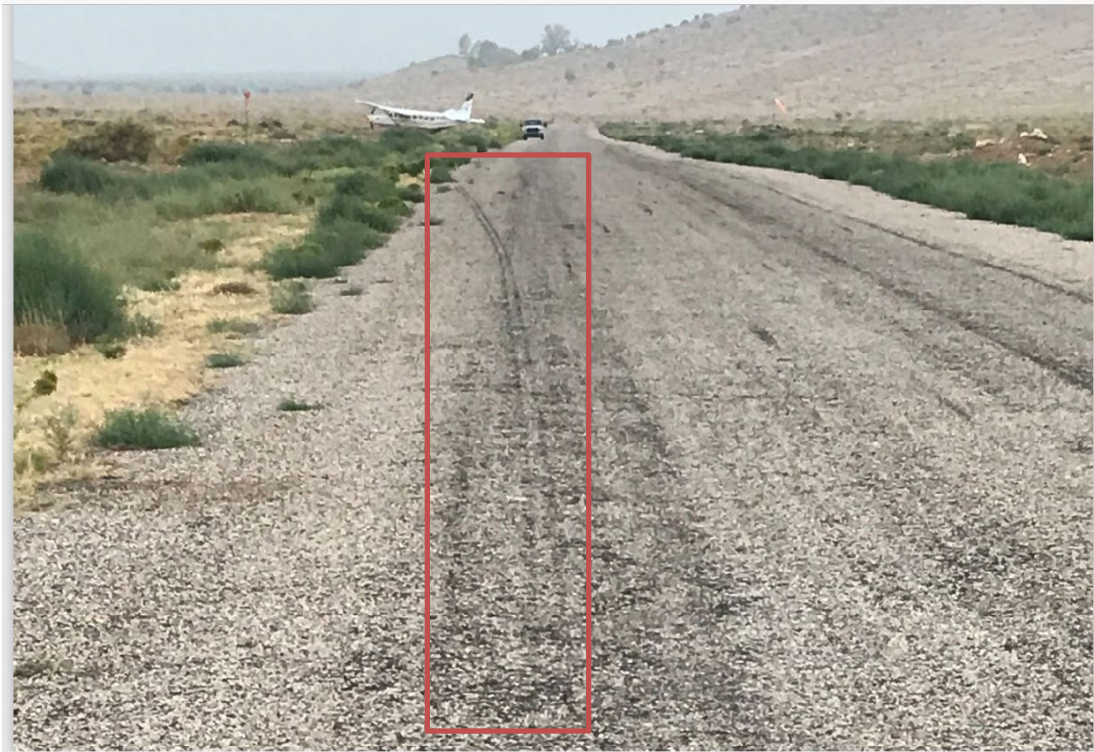
To further support his position, the petitioner submitted photographs taken during the on-scene investigation. The petitioner explained one photograph (see figure 1) showed the "double track characteristic of a flat tire" on the runway, which he stated was evidence that the airplane did not depart the runway until after the left main tire was flat. The petitioner claimed that the photograph demonstrated that the tire "went flat without adverse [pilot] action."

Figure 1. Tire markings on the runway with the airplane in the foreground (Source: Grand Canyon Air).

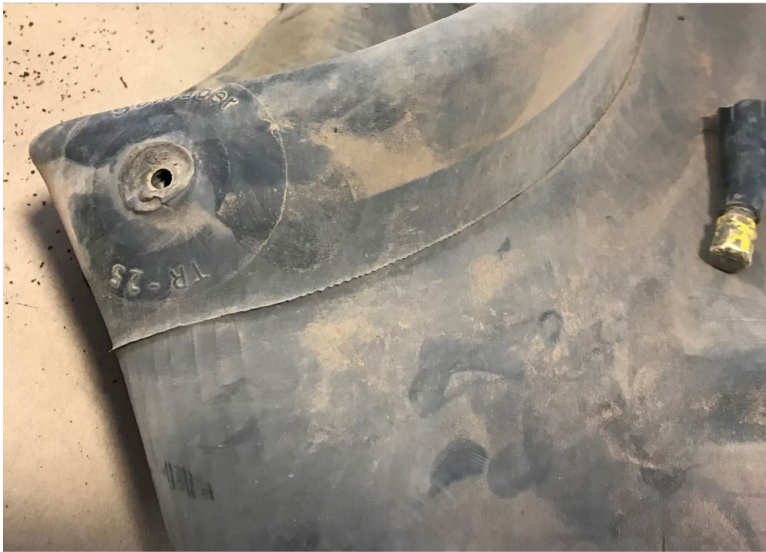
Another photograph that the petitioner submitted (see figure 2) showed that the valve stem of the left main tire's rubber inner tube had sheared off, which the petitioner claimed might have been due to "slippage of the main tire."⁶

Figure 2. Sheared valve stem of the left main tire inner tube (Source: Grand Canyon Air).

⁸ The valve stem could have sheared if the inner tube of the tire shifted (slipped) during touchdown. Also, the valve stem could have started to shear during previous flights before fully separating during the accident landing. The condition of the valve within the valve stem is unknown.
