National Transportation Safety Board

RRD24LR012

MECHANICAL

Group Chair's Factual Report

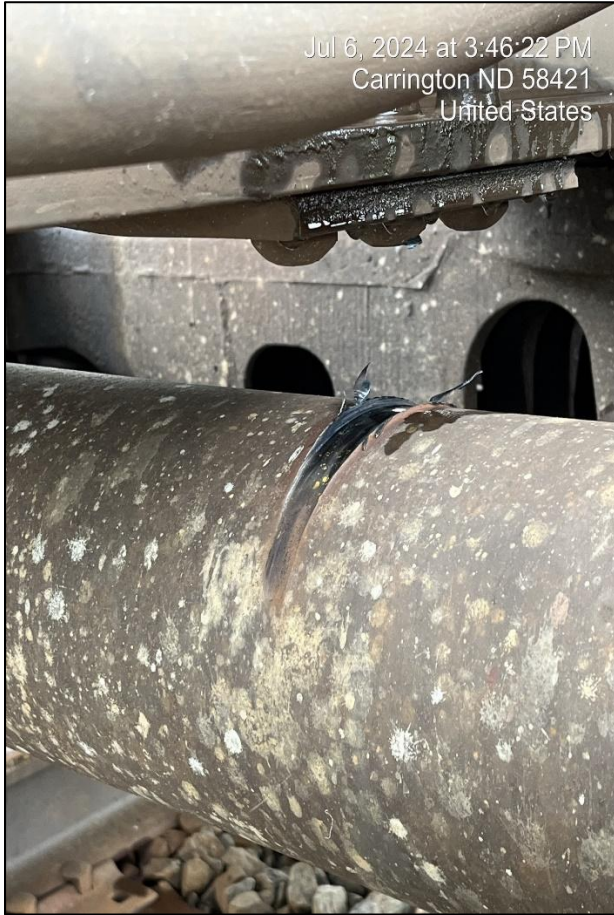
Line Number	Car Number	Defect
36	TILX 500727	#1 axle contact with draft sill
37	TILX 500866	#1 axle contact with draft sill
38	TILX 500886	#1 axle contact with draft sill
39	TILX 500825	#1 axle contact with draft sill
40	SHQX 10765	#4 axle contact with draft sill, rail impact marks on R1, R3, and R4 wheels
41	SHQX 10687	#4 axle contact with draft sill, rail impact marks on R1, R2, R3 and R4 wheels

Figure 1- Exemplar photograph of the axle contacting the draft sill on car TILX500825

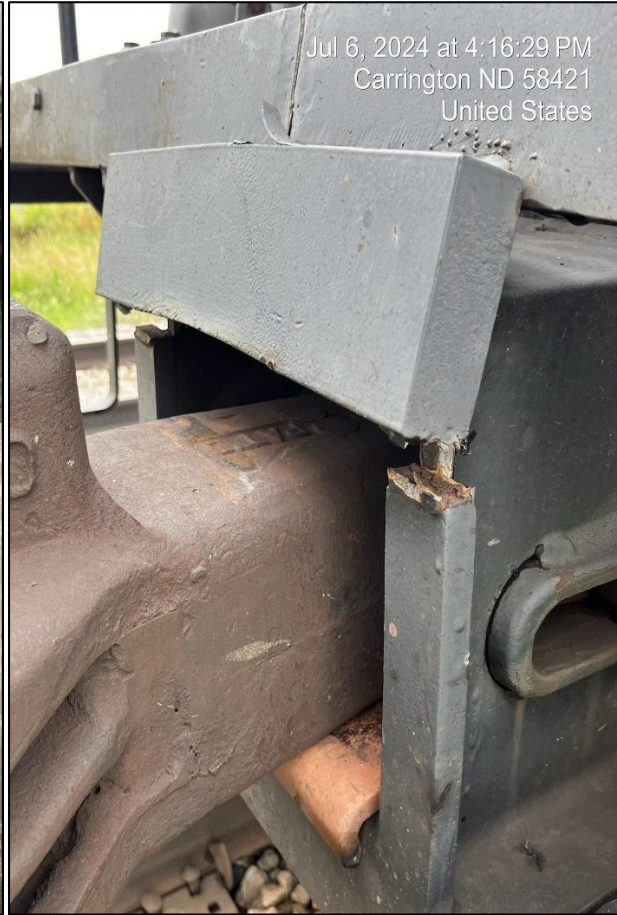
42	TILX 500738	#1 axle contact with draft sill, rail impact marks on L2 wheel
43	TILX 500913	#4 axle contact with draft sill, rail impact marks on R2 wheel
44	TILX 500961	#1 axle contact with draft sill
45	PROX 45410	#1 axle contact with draft sill, Buffer castings on the A and B ends broken, rail impact mark on L3 wheel
46	PROX 43474	#1 axle contact with draft sill, Buffer castings on the A and B ends broken, rail impact mark on the L2 wheel
47	CTCX 300366	A end knuckle broken. The A end coupler shank is straight, the coupler draft key is bent.

Figure 2- Exemplar photograph of a damaged buffer casting on car PROX43474

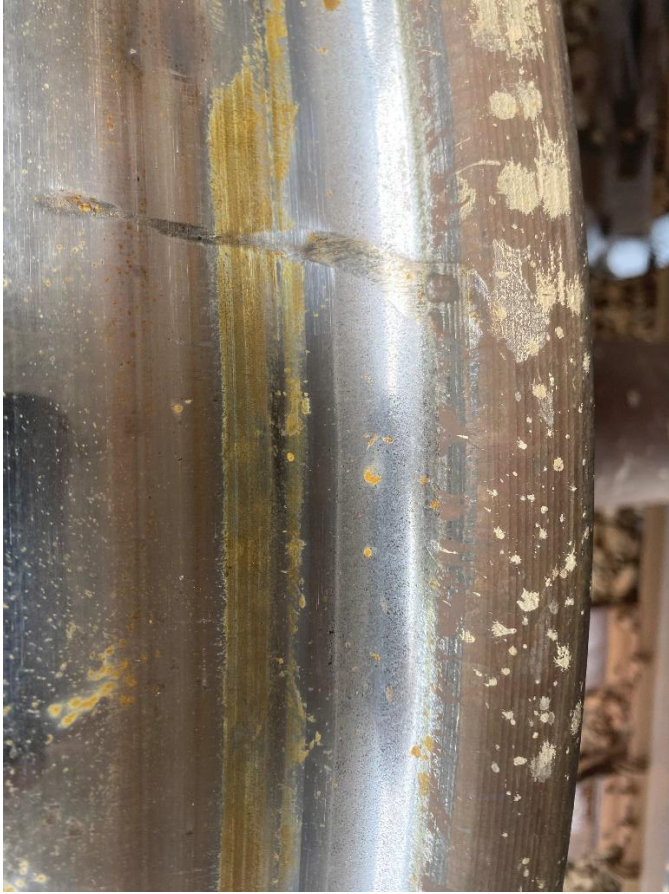
**Figure 3- Exemplar photograph of broken rail
Witness mark on wheel of car SHQX 10687**
