BEFORE THE NATIONAL TRANSPORTATION SAFETY BOARD

NTSB Accident Number: RRD24FR001

Proposed findings, probable cause, and safety recommendations in connection with the derailment involving BNSF Train C-ATMCRDO-31 that led to a bridge collapsing onto the southbound lanes of Interstate 25 5 miles north of Pueblo, Colorado, causing one fatality to a semi-truck driver on October 15, 2023

Final Submission

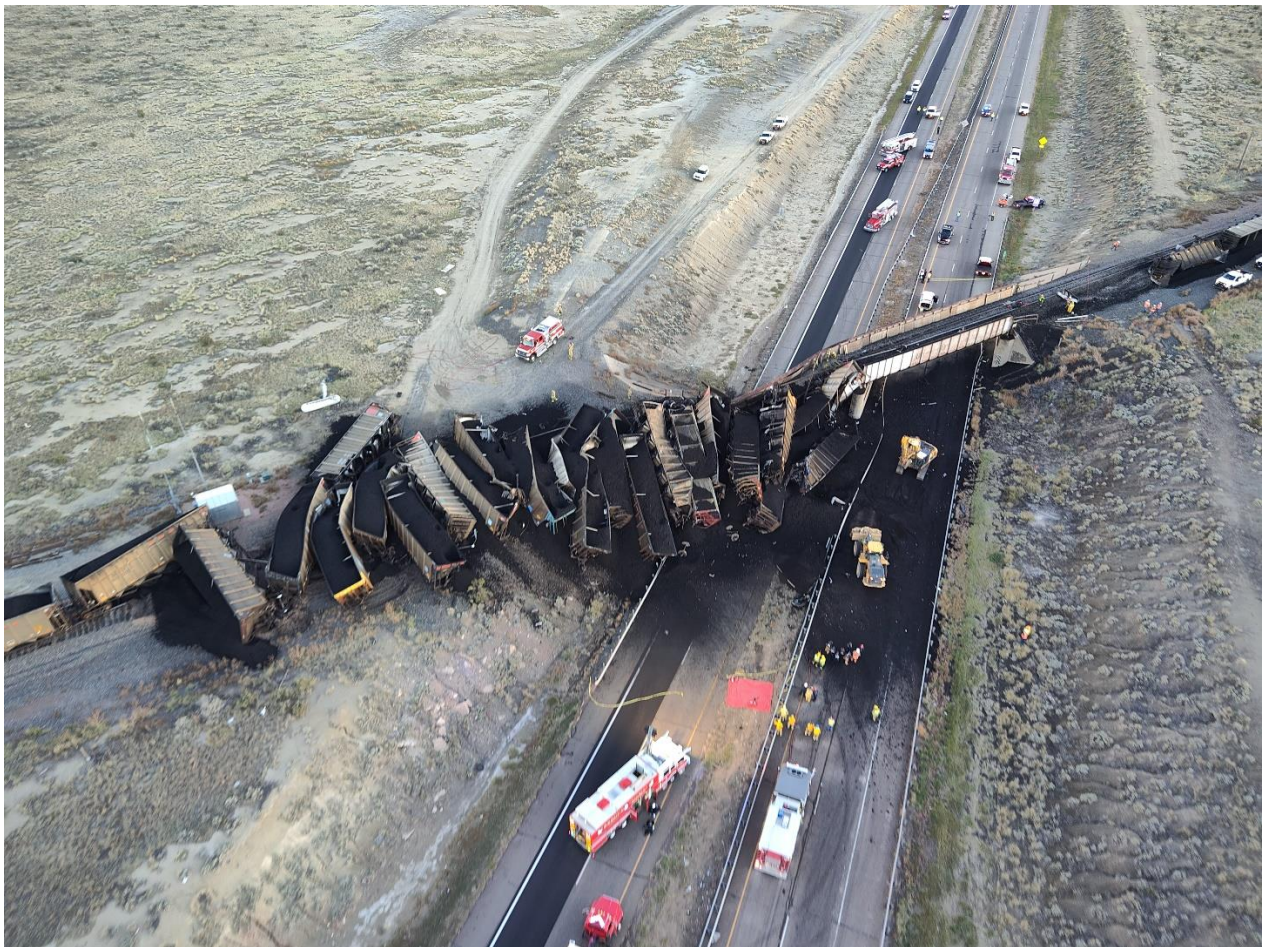
On October 15, 2023, at approximately 3:24 PM MDT, southbound BNSF Railway (BNSF) freight train C-ATMCRD0-31 derailed 31 cars at Mile Post 109.656 on the BNSF Pikes Peak Subdivision, approximately 5 miles north of Pueblo, Colorado. The derailment occurred as the train approached a railroad bridge, resulting in the collapse of the bridge onto the southbound lanes of Interstate 25. One fatality was reported, as a semi-truck driver was trapped under the collapsed bridge.

Figure 1. Aerial photo of the point of collision site. (source: BNSF Drone footage)

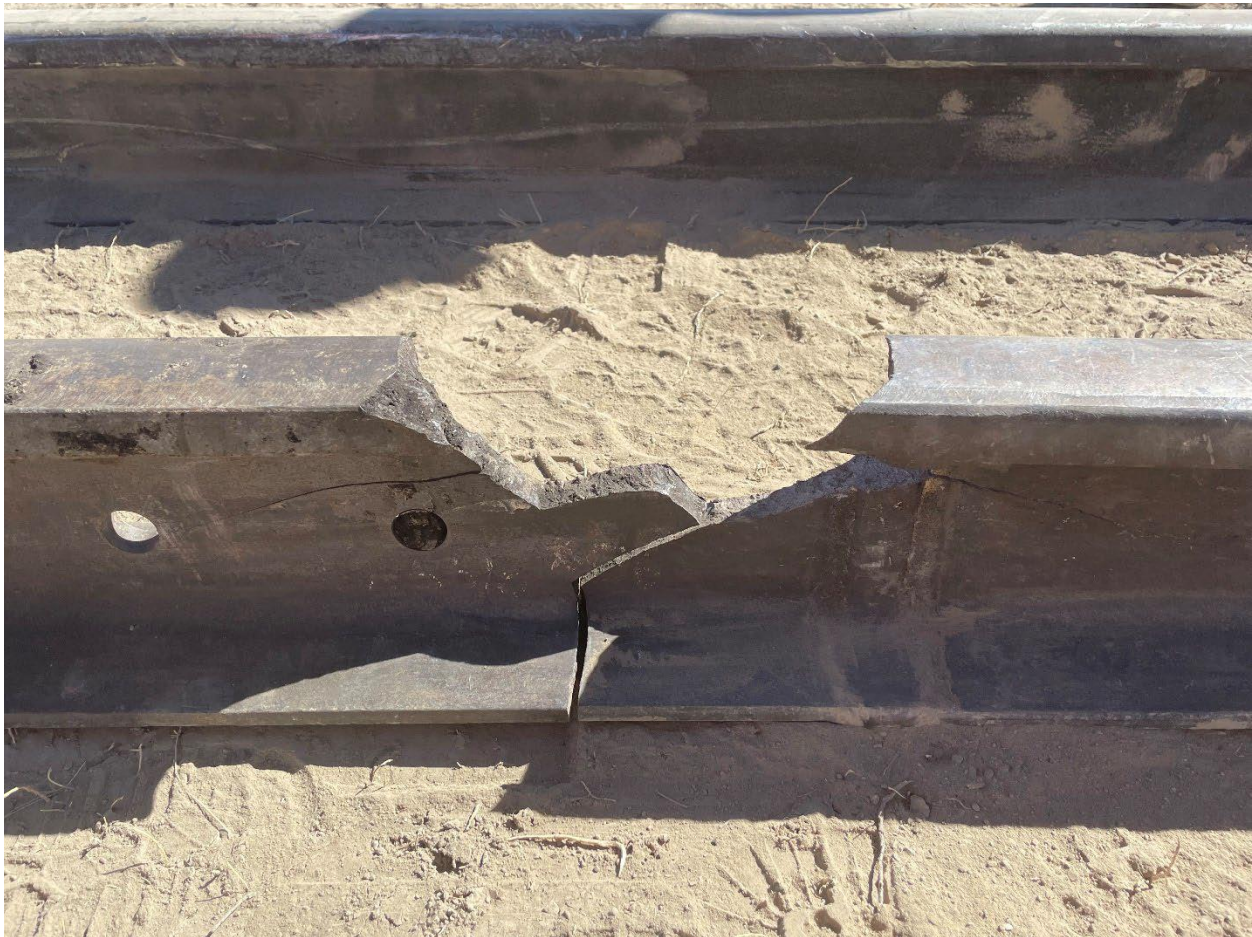
The derailment itself occurred at M.P. 109.656 on the west rail (Main 1 straight lead), approximately 21 crossties north of the switch points. Witness marks on the east rail and rear locomotive footage from the previous train revealed a broken rail at this location. The incident caused severe damage to the switch's turnout section and approximately 215 ft of track, including the switch, required repair. A rail recovery and rebuild operation on site managed to salvage about 90% of the rail, predominantly 136 lb. rail manufactured by Bethlehem Steel in

1996 and Rocky Mountain Steel Mill in 2004. Two thermite field welds on the west rail of Main Track 1 between the heel block and guard rail were identified: the South weld (Weld #71), executed on May 24, 2023, exhibited friction batter on the rail end, while the second weld, created on June 19, 2007, displayed signs of sudden catastrophic failure. Three rail pieces, including the welds, were subsequently sent to the NTSB Materials Lab for further examination.

Furthermore, the NTSB Operations investigation group reviewed Track Image Recorder (TIR) and outward facing camera footage from the lead locomotive of C-ATMCRD0-31D (BNSF 9015). During this examination, a broken rail was observed on the west rail of Main Track No. 1 just before the train passed through the area.

Figure 2. Photograph of breakout in the rail located 71” north of the initial broken rail (weld #71). This rail broke under the last train prior to the derailment as confirmed in video footage.

1. Increase the frequency for main track switch inspections over BNSF tracks until regulations or guidance are published for appliances that could alert an operating train crew to compromised track, broken rail within opposing signals of a Control Point, or damage to its infrastructure.
2. Increase the frequency of main track walking switch inspections on BNSF to bi-monthly. This enhanced inspection schedule should include a thorough examination of all track components, with particular focus on vulnerable joints and dead zones. By identifying and addressing potential issues in these critical areas more frequently, the goal is to improve track safety, prevent failures, and ensure the integrity of the rail infrastructure. Additionally, detailed records of these inspections should be maintained to track the condition of the track over time and to facilitate timely maintenance and repairs.

3. Implement rulemaking requiring an increased frequency of main track walking switch inspections to bi-monthly. This enhanced inspection schedule should include a thorough examination of all track components, with particular focus on vulnerable joints and dead zones. By identifying and addressing potential issues in these critical areas more frequently, the goal is to improve track safety, prevent failures, and ensure the integrity of the rail infrastructure. Additionally, detailed records of these inspections should be maintained to track the condition of the track over time and to facilitate timely maintenance and repairs.
