**SAFETY TASK FORCE
INDEPENDENCE, OHIO**

NTSB Accident Number: RRD24FR001

Proposed findings, probable cause, and safety recommendations, in connection with the Burlington Northern Santa Fe Railway (“BNSF”) train derailment near Pueblo, Colorado on October 15, 2023.

Final Submission

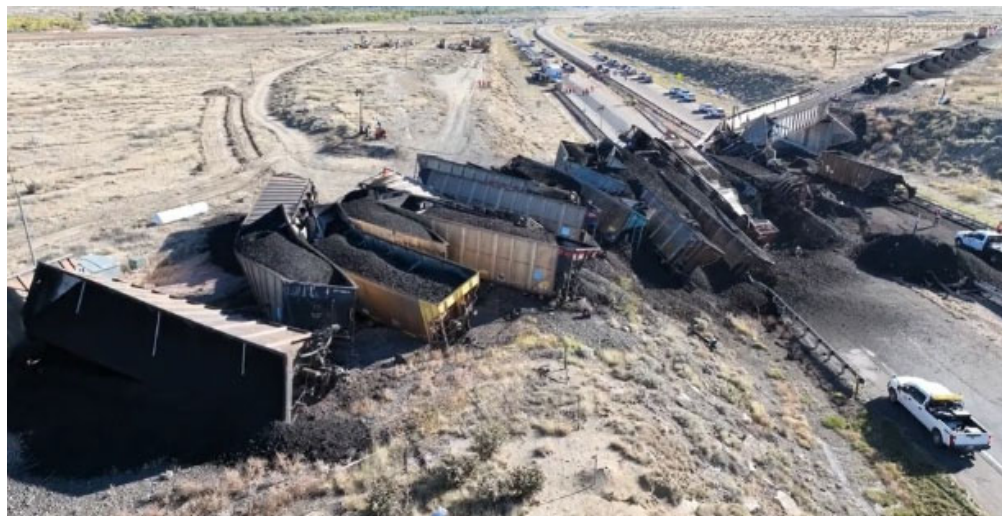
In the derailment, five (5) railcars struck the railroad bridge, and six (6) railcars dropped to the I-25 below. One (1) of the derailed railcars struck a northbound semi-truck in combination with a utility trailer (“combination vehicle”). As a result of the derailment, the eastern span of the railroad bridge partially collapsed over I-25’s northbound lanes. The combination vehicle came to rest beneath the collapsed railroad bridge span, derailed railcars, and lading. As a result of the derailment and the ensuing collision with the combination vehicle, the semi-trucks driver was fatally injured.

Figure 1 – Overhead view of accident site *(Photo courtesy of Colorado State Police)*

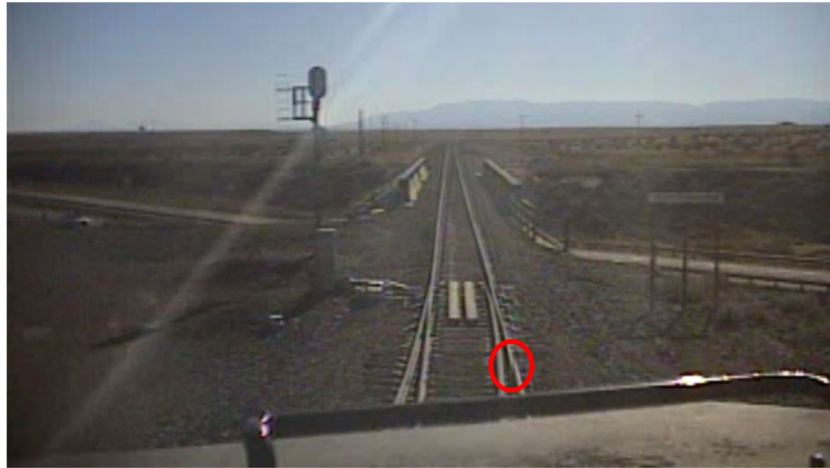
In addition to a review of the LER, the NTSB Operations investigation group conducted a review of the TIR or outward facing camera footage from the lead locomotive of the C-ATMCRD0-31D (BNSF 9015). During this review, a broken rail can be observed on the north rail of Main Track No.1 just prior to the train traversing over the area.

Figure 3 – Photo from the outward facing camera of lead locomotive (BNSF 9015) showing a broken rail on the north rail of Main Track No.1 at MP 109.654 (Photo courtesy of NTSB Operations Group Factual Report)

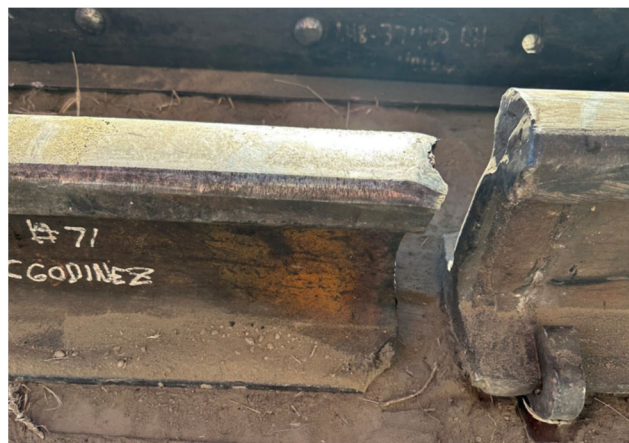
The Brotherhood of Locomotive Engineers and Trainmen concludes that the probable cause of the October 15th, 2023, derailment on Main Track No.1 at MP 109.654 on the BNSF Pikes Peak Subdivision was a break in the north rail of Main Track No.1.

Figure 4 – Photo showing the break in the thermite weld at MP 109.654 (Photo courtesy of NTSB)

- According to the NTSB Track Group Factual report findings, the segment of rail that was compromised was sent to the NTSB laboratory for analysis in December of 2023. Their findings concluded that this section of rail had suffered a prior break on May 24, 2023, in which a thermite weld was used to repair it. This thermite weld repair suffered contamination along the edges during its application. The contamination created a weak point that, over the course of the next 144 days of rail traffic and weather, suffered cracking and micro fractures until catastrophic failure occurred on October 15th, 2023.

- Although this rail break occurred on a section of track that was overlaid with both CTC and PTC, the broken rail did not result in a Stop signal governing train movements or a track indication for the Train Dispatcher. This notification failure was due to the broken rail occurring between the opposing signals of a Control Point within CTC. Essentially a “blind spot” is created between these opposing signals, and no warnings are provided to the Train Dispatcher or approaching trains.

1. Increase the frequency for main track inspections over BNSF tracks until regulations or guidance are published for appliances that could alert an operating train crew to compromised track, broken rail within opposing signals of a Control Point, or damage to its infrastructure.

1. Implement rulemaking to revisit the value of guidance, regulations or orders for currently unregulated appliances, that may mitigate or prevent similar accidents in the future such as:
 - switch position monitoring devices or indicators
 - broken rail indicators to detect breaks between opposing signals of a Control Point
