National Transportation Safety Board

WPR24FA291

ACCIDENT SITE EXAMINATION

Location: Meeteetse, Wyoming
Date: September 1, 2024
Time: 11:02 Mountain Daylight Time
Airplane: N23BD, American Champion Aircraft, 8GCBC

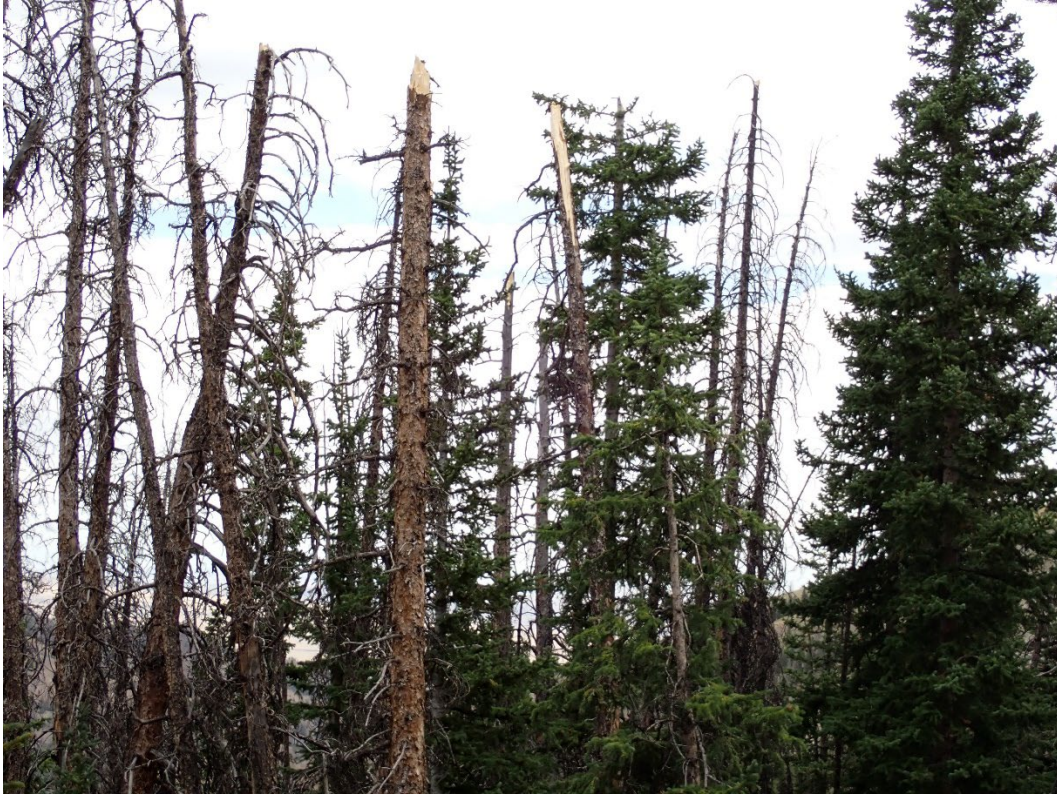
Examination of the accident site revealed that the airplane impacted mountainous terrain along the southern edge of a valley about 37 miles southwest of the Yellowstone Regional Airport (COD), Cody, Wyoming. The first identifiable point of contact (FIPC) was a 150 to 175 ft tall tree that had damaged limbs near the top of the tree. The debris path was oriented on a heading of about 210° magnetic and was about 200 ft in length from the FIPC. Various portions of airplane surface, and propeller fragments were observed throughout the debris path. Additionally, several trees were damaged throughout the debris path. The fuselage came to rest upright with several tree limbs lying against the fuselage, on a heading of about 240° magnetic at an elevation of 9850 ft msl.

Figure 1: View of damaged treetops near accident site.

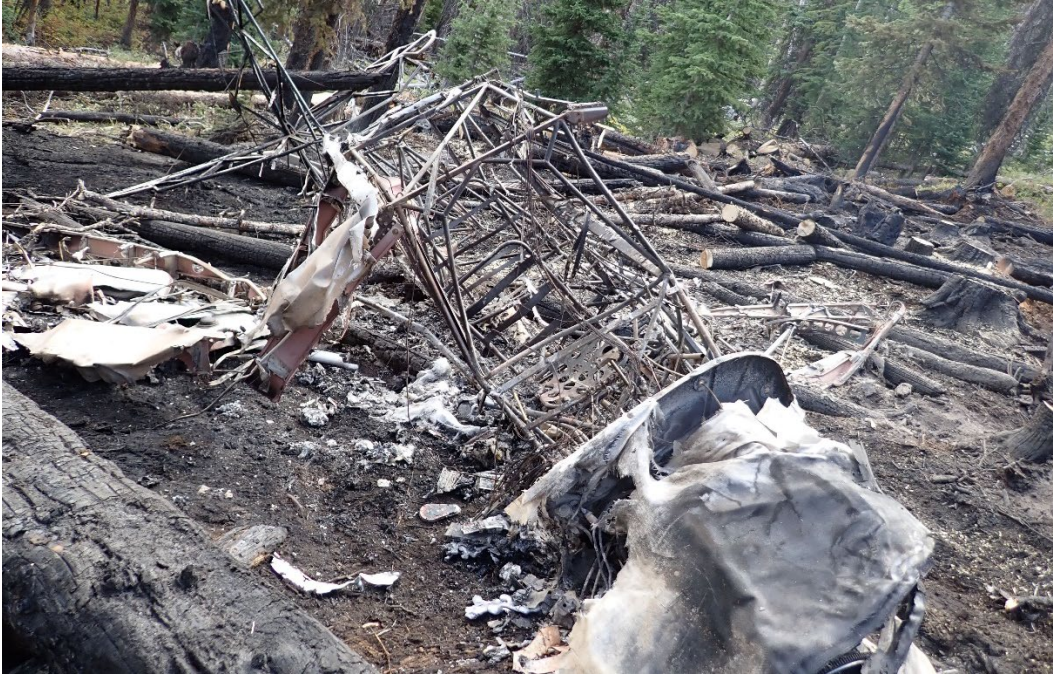
Examination of the fuselage revealed that it was thermal and impact damaged. The fuselage came to rest upright on uneven mountainous terrain on a magnetic heading of about 240°. The instrument panel was thermal and impact damaged with instruments separated. Flight controls were only observed in the forward seat station. The forward flight control was fracture separated at the torque tube attachment point. The landing gear was separated from the fuselage and thermally damaged.

Figure 2: Front view of accident airplane.

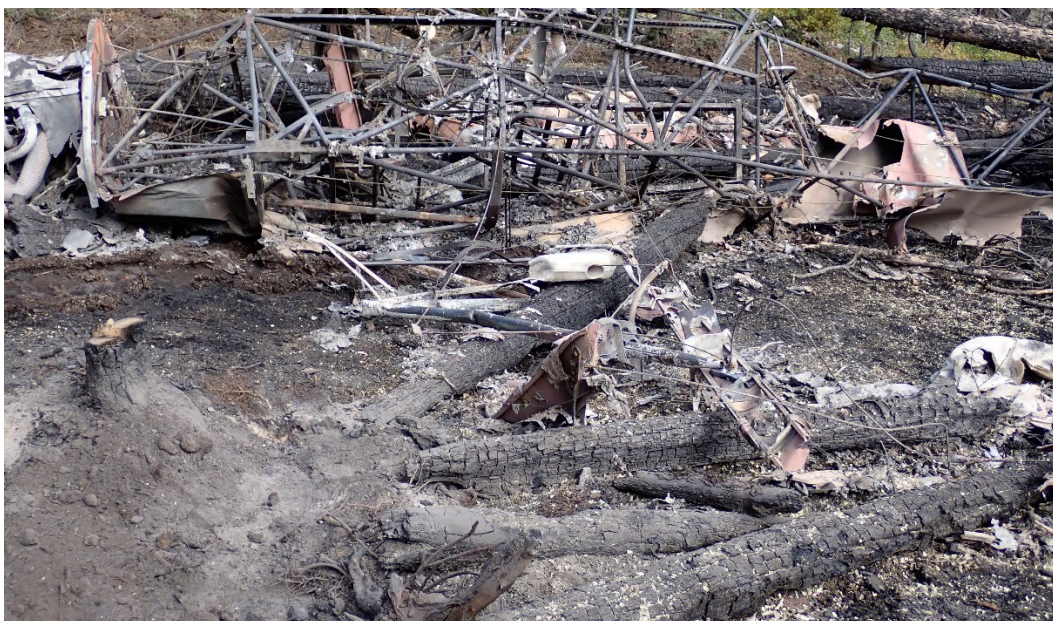
The left wing separated from the fuselage near the wing root and was mostly destroyed by fire. The left wing aileron and flap were mostly destroyed by fire. The flight control cables remained within the fragmented left wing and traced from the aileron attached points to the center fuselage. The left wing aluminum fuel tank was mostly destroyed by fire. Aluminum pooling was observed throughout the left wing area.

Figure 3: View of left wing thermal damage.

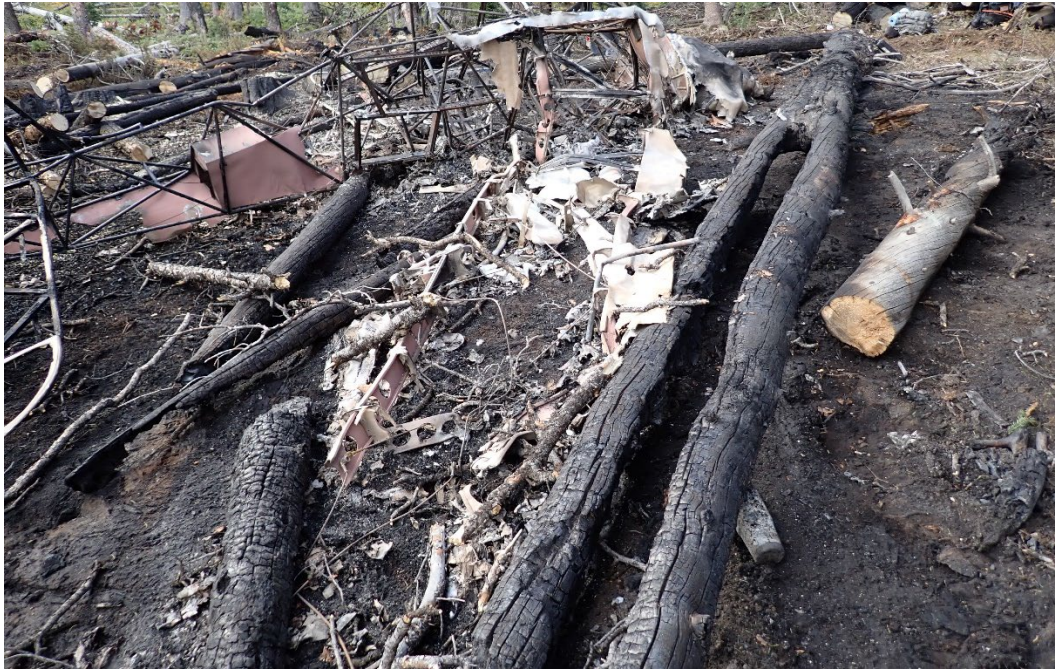
The right wing separated from the fuselage near the wing root and was mostly destroyed by fire. The right wing aileron and flap were mostly destroyed by fire. The flight control cables remained within the fragmented right wing and traced from the aileron attached points to the center fuselage. The right wing aluminum fuel tank was mostly destroyed by fire. Aluminum pooling was observed throughout the right wing area.

Figure 4: View of right wing thermal damage.

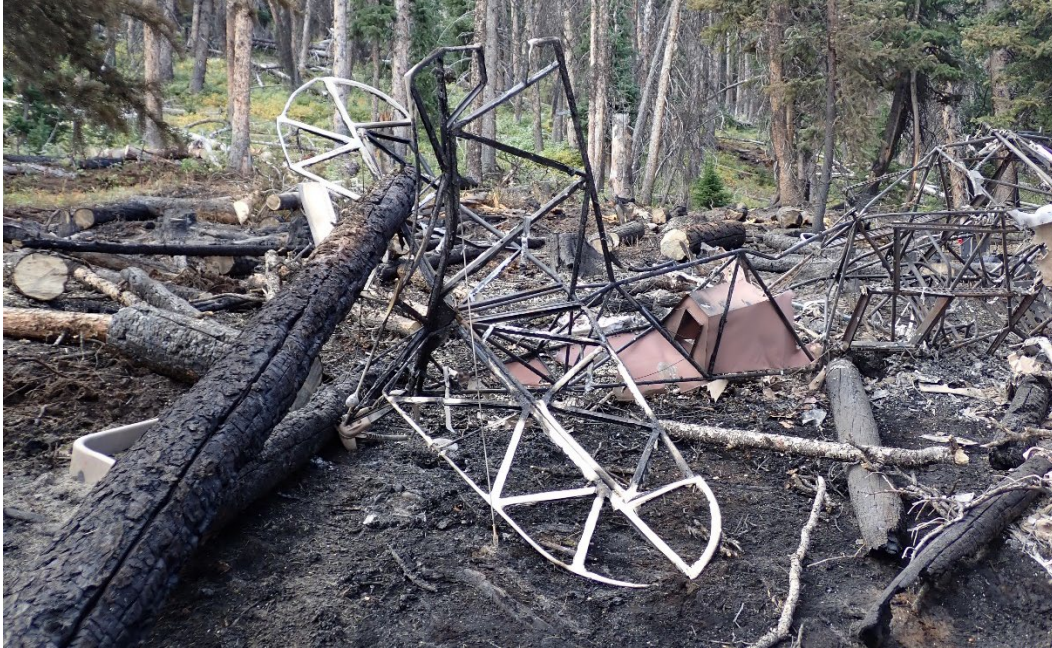
The empennage remained attached to the fuselage and was thermal damaged throughout. The elevator remained attached to the horizontal stabilizer. The elevator flight control cables remained attached to their respective mounts, the control cables were traced to the cockpit and where attached to the flight control torque tube. The rudder was thermal damaged throughout. The rudder flight control cables remained attached to their respective mounts, the control cables were traced to cockpit, where they remained attached to the rudder pedals.

Figure 5: Rear view of empennage.

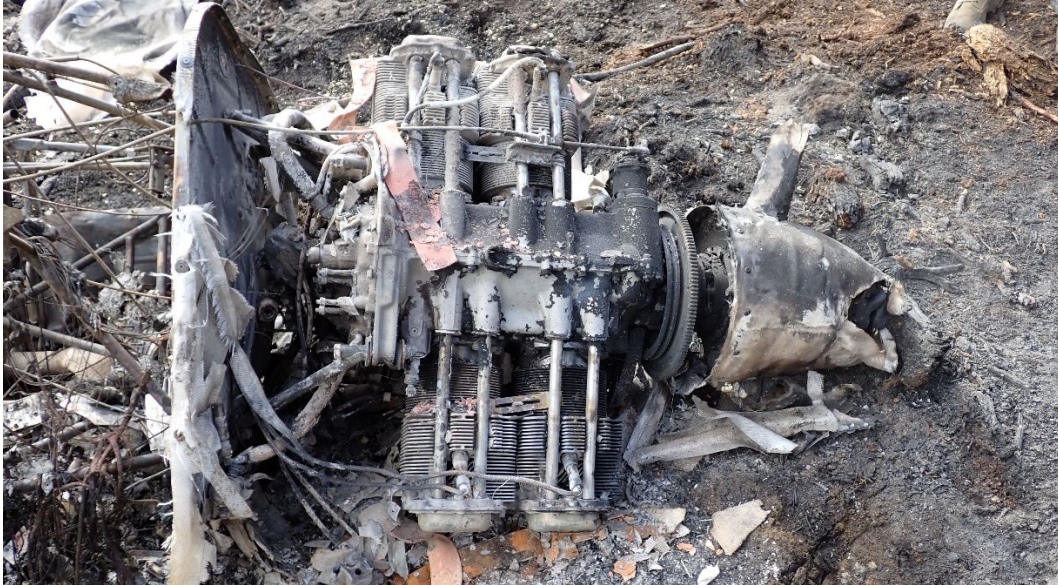
The engine remained attached to the engine mount and fuselage. No damage was noted to the steel engine mount tubes. Thermal damage was observed throughout the engine from post impact fire. The engine was covered in burned fiberglass cowl remains which appeared to all be draped over the engine area only.

Figure 6: View of airplane engine.

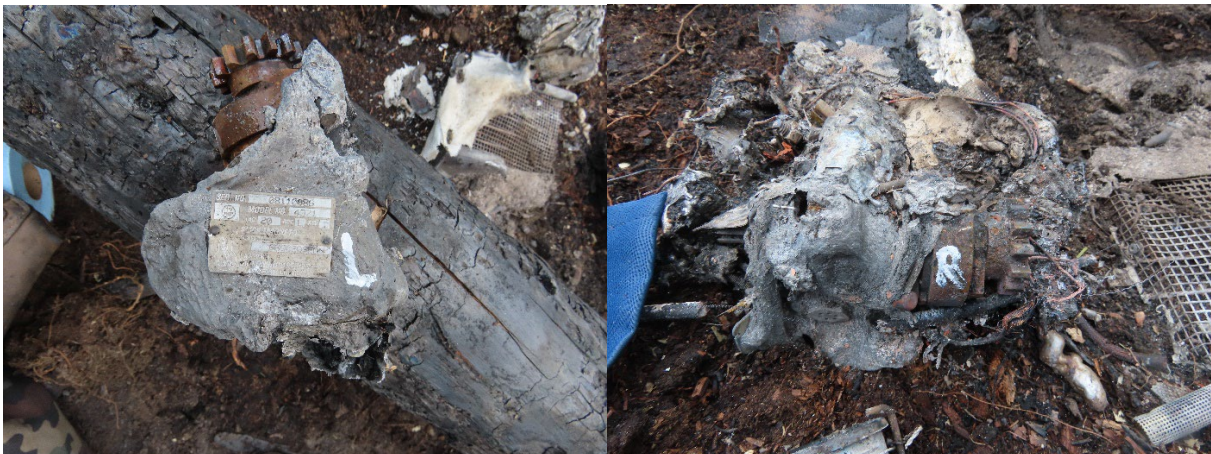
Both magnetos were mostly destroyed and thermal damaged. The left-hand magneto remained attached to the rear of the engine, but outside of the accessory case and was only attached by solidified aluminum. The right-hand magneto was found underneath the engine, but largely consumed by fire and in a solidified pool of aluminum. Neither magneto would rotate and could not be tested for functionality.

Figure 7: View of left and right magnetos.

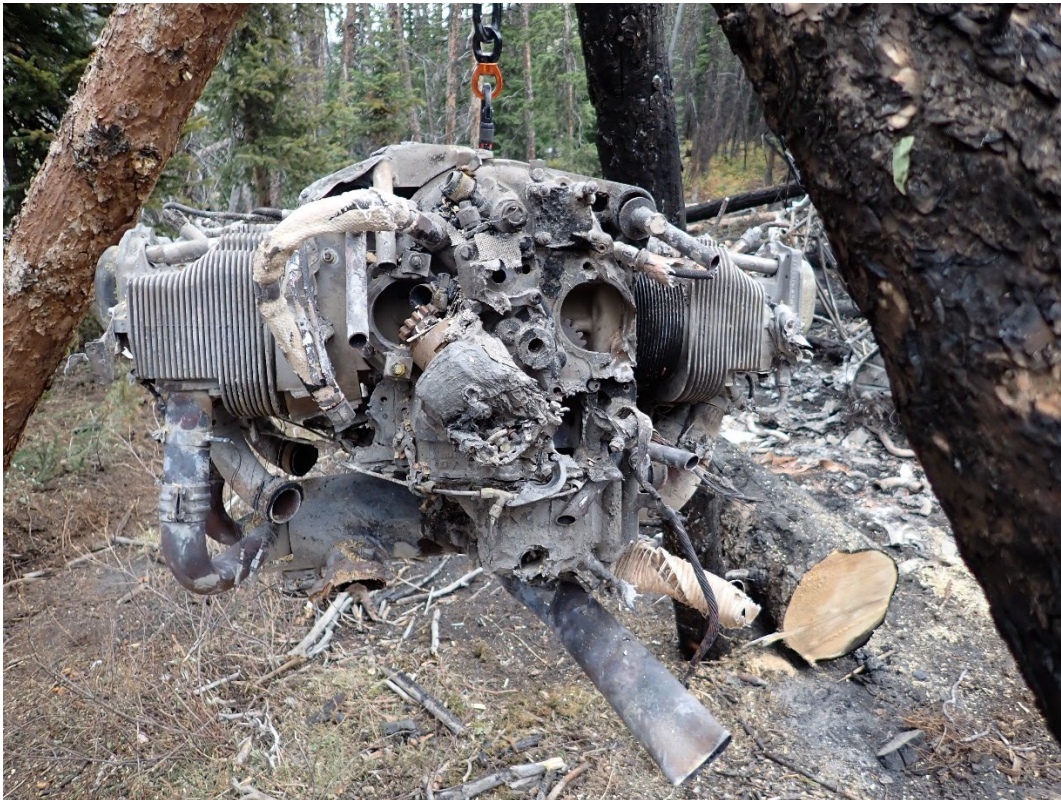
The accessory case was partially consumed by fire and was removed from the engine case. The engine driven oil pump was present but thermally damaged and could not be removed from the accessory case. The oil sump was largely consumed by fire exposing the oil suction screen that was found free and clear of any debris at the time of the examination. The canister type oil filter was found separated from the rear of the engine but recovered within the aircraft wreckage. The oil filter was cut open exposing the burnt remains of the filter pleats, no metallic debris was noted within the filter remains.

Figure 8: View of engine's accessory case.

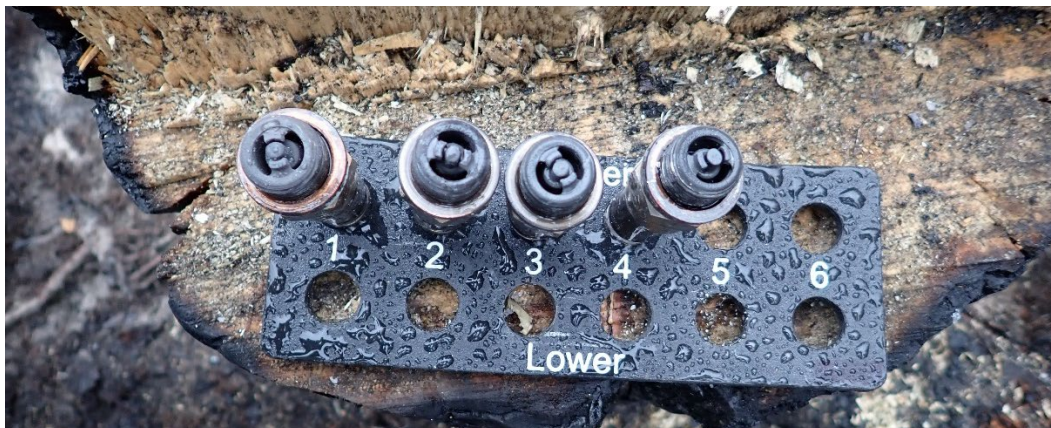
The rocker box covers were removed. The intake and exhaust rocker arms were intact, and debris consistent with post accident fire was observed on all cylinders. All intake and exhaust valve springs were in place and visually appeared to be undamaged. The top engine spark plugs were removed from the engine, and they

were the massive electrode type. All spark plugs exhibited gray deposits within the electrode area. The spark plugs exhibited signatures consistent with WORN NORMAL when compared to the Champion Check-A-Plug comparison chart.

Figure 9: View of top engine spark plugs.
