# National Transportation Safety Board

WPR24FA291

## **AIRFRAME AND ENGINE EXAMINATION**

Location: Meeteetse, Wyoming  
Date: September 1, 2024  
Time: 11:02 Mountain Daylight Time  
Airplane: N23BD, American Champion Aircraft, 8GCBC

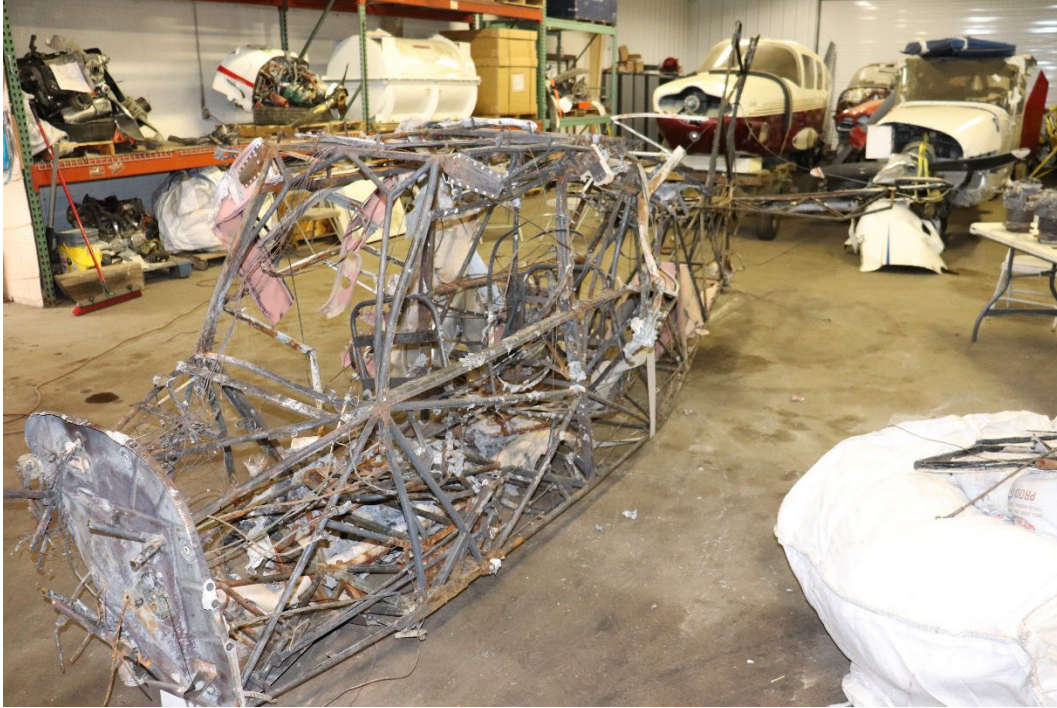
Examination of the fuselage at the accident site revealed that it was thermal and impact damaged. Flight control continuity had been established from the cockpit torque tube and rudder pedals to the flight control surfaces.

The fuel system from the wings to the engine was destroyed by post accident fire.

**Figure 1: Front view of accident airplane fuselage.**

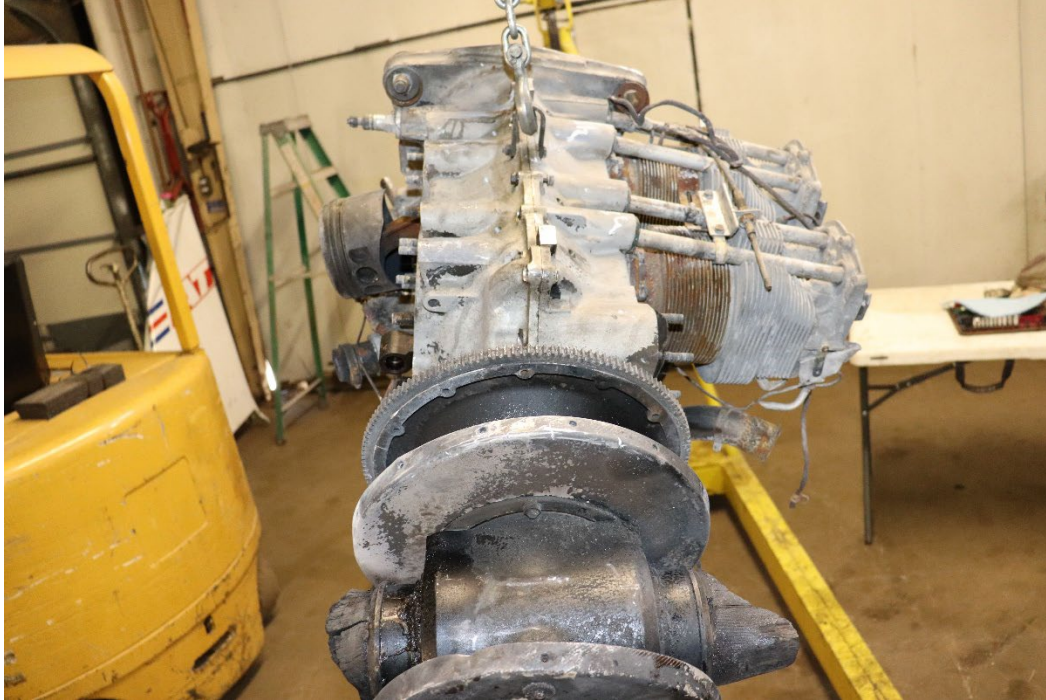
The engine was separated from the engine mount and fuselage during the accident site examination. Thermal damage was observed throughout the engine from post impact fire.

The rocker box covers had been removed during the accident site examination. The intake and exhaust rocker arms were intact, and debris consistent with post accident fire was observed on all cylinders. All intake and exhaust valve springs were in place and visually appeared to be undamaged.

**Figure 2: Front view of engine during examination.**
