Preliminary Report RRD25FR006

Southeastern Pennsylvania Transportation Authority Train Fire and Passenger Evacuation

Ridley Park, Pennsylvania
February 6, 2025

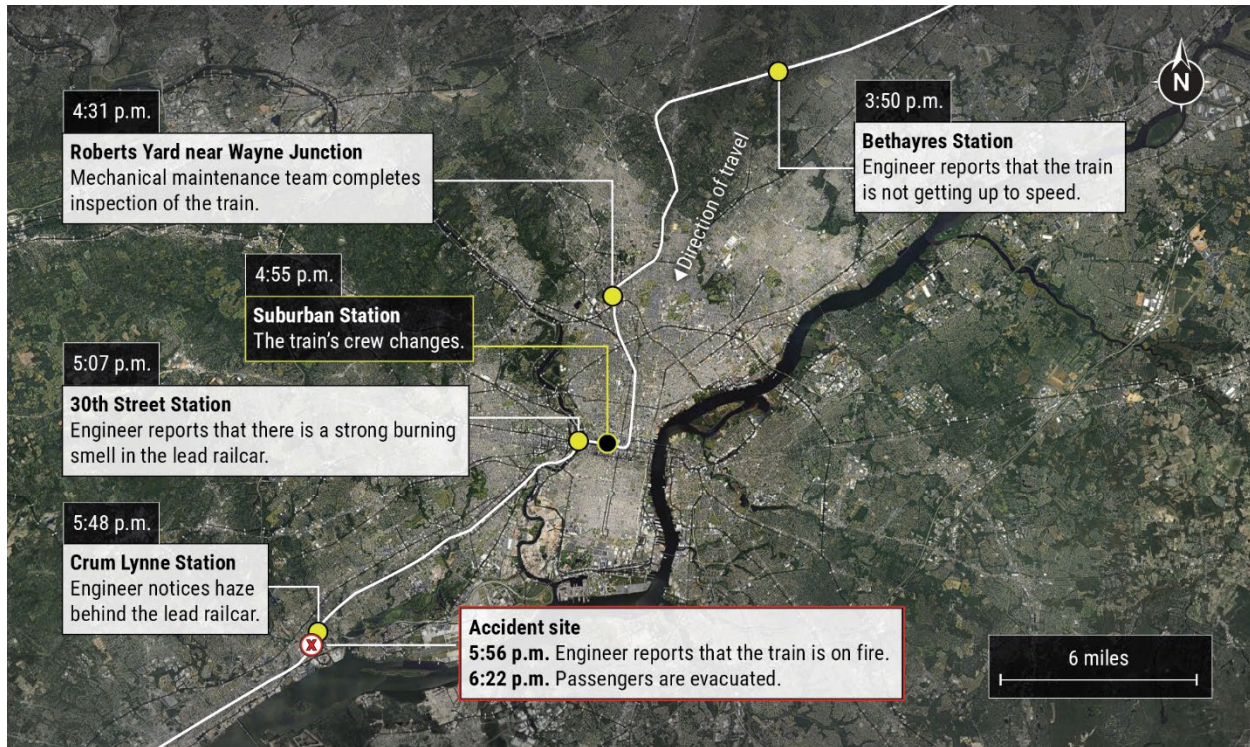
On February 6, 2025, about 5:56 p.m. local time, the lead railcar (railcar 132) of Southeastern Pennsylvania Transportation Authority (SEPTA) Regional Rail train 3223 caught fire as the train departed Crum Lynne Station in Ridley Park, Pennsylvania.¹ (See figure.) Train 3223 was traveling from West Trenton, New Jersey, to Newark, Delaware. There were about 325 passengers and 4 crew members on board the train. There were no injuries or fatalities. SEPTA estimated damages to equipment to be about \$10 million. Visibility conditions at the time of the accident were overcast with light mist; the temperature was 37°F.

Figure. Timeline of events that led to the fire on train 3223.
