# National Transportation Safety Board

HWY24FH004

## **FACTUAL REPORT OF INVESTIGATION**

Group Chair's Factual Report

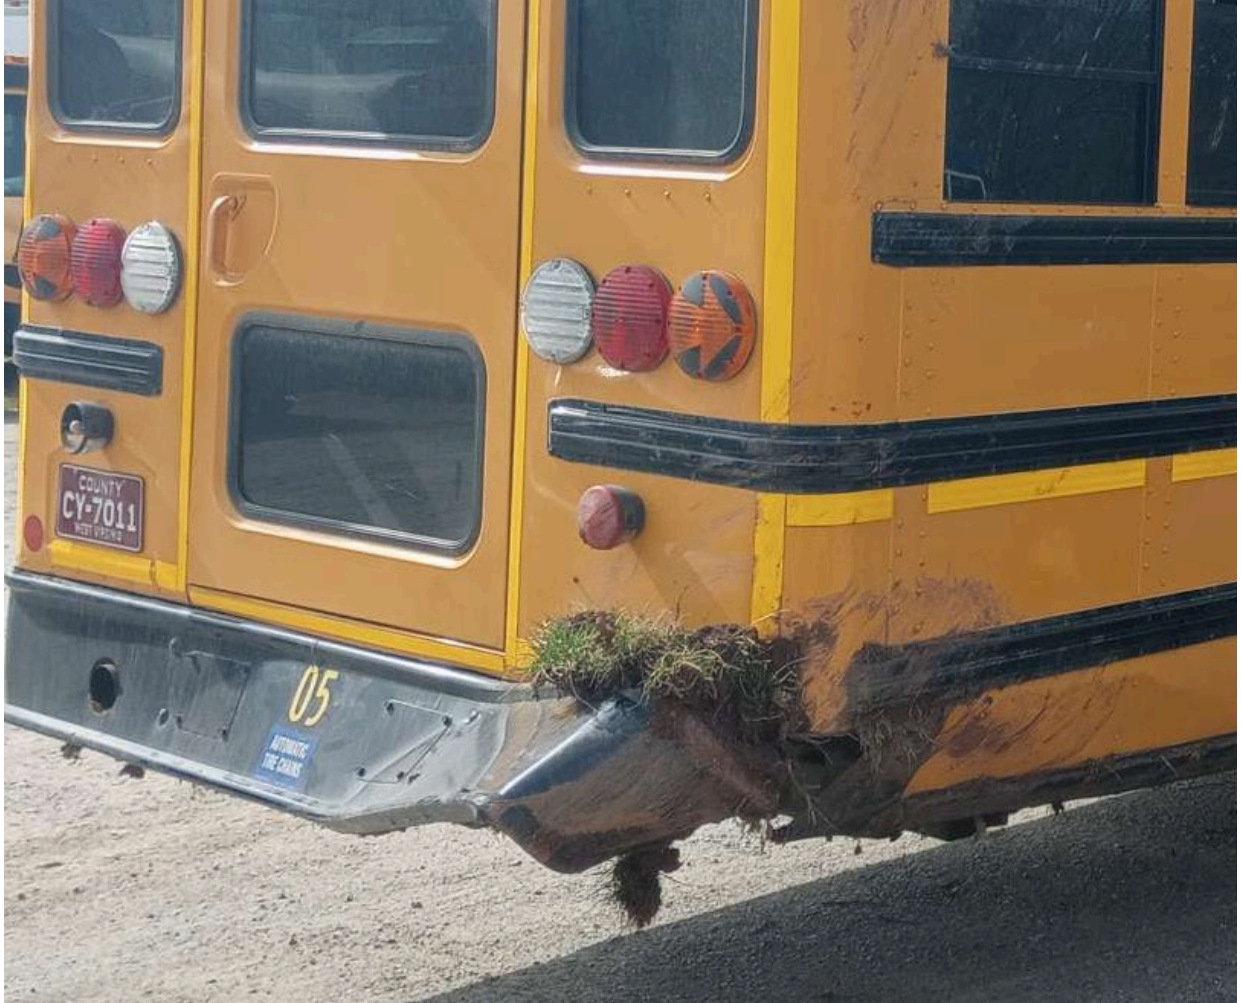
At the right rear corner, the bus bumper was bent away from the bus body and twisted, with the top of the bumper closer to the body and the bottom of the bumper further away (Figure 2).

**Figure 1.** Damage to the right rear corner off the bus. (Source: WVSP)

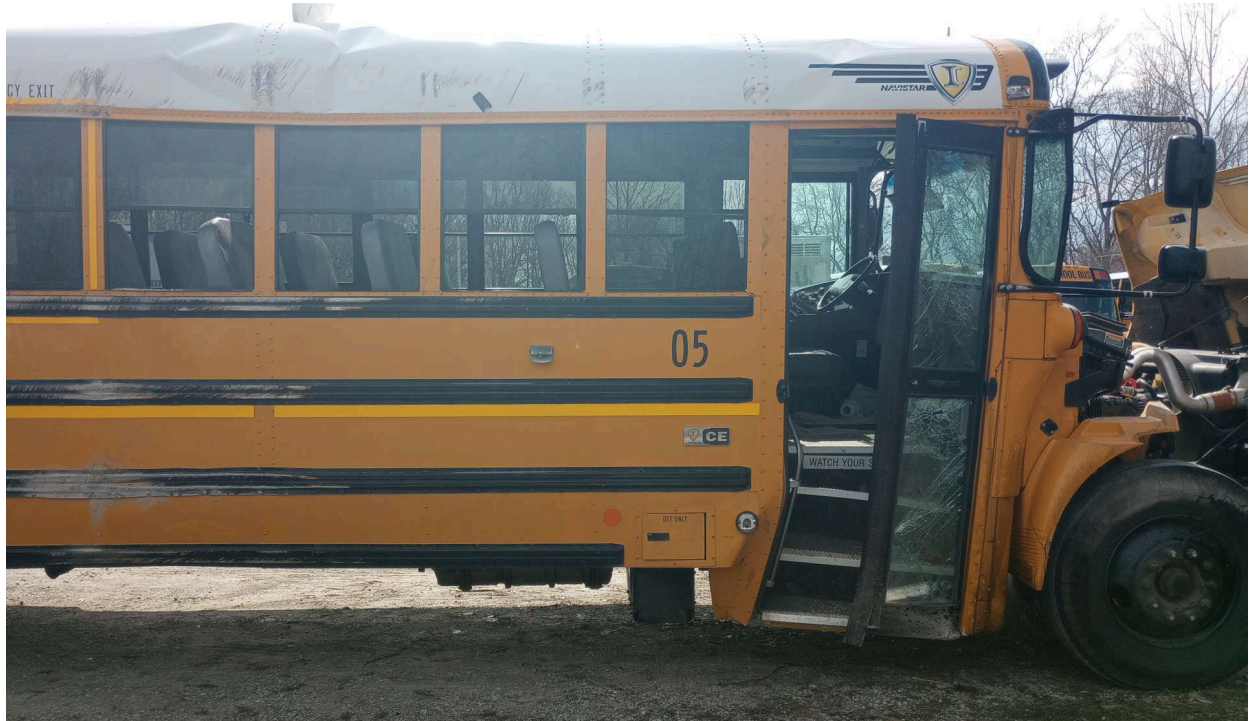
The right side of the bus was scraped. The left loading door was detached and missing. The right loading door remained attached, but the door glass was cracked. The steps were deformed towards the rear of the bus (Figure 3). The right side of the roof was damaged and dented.

**Figure 2.** Damage to the right side and right-side roof of the bus. (Source: WVSP)

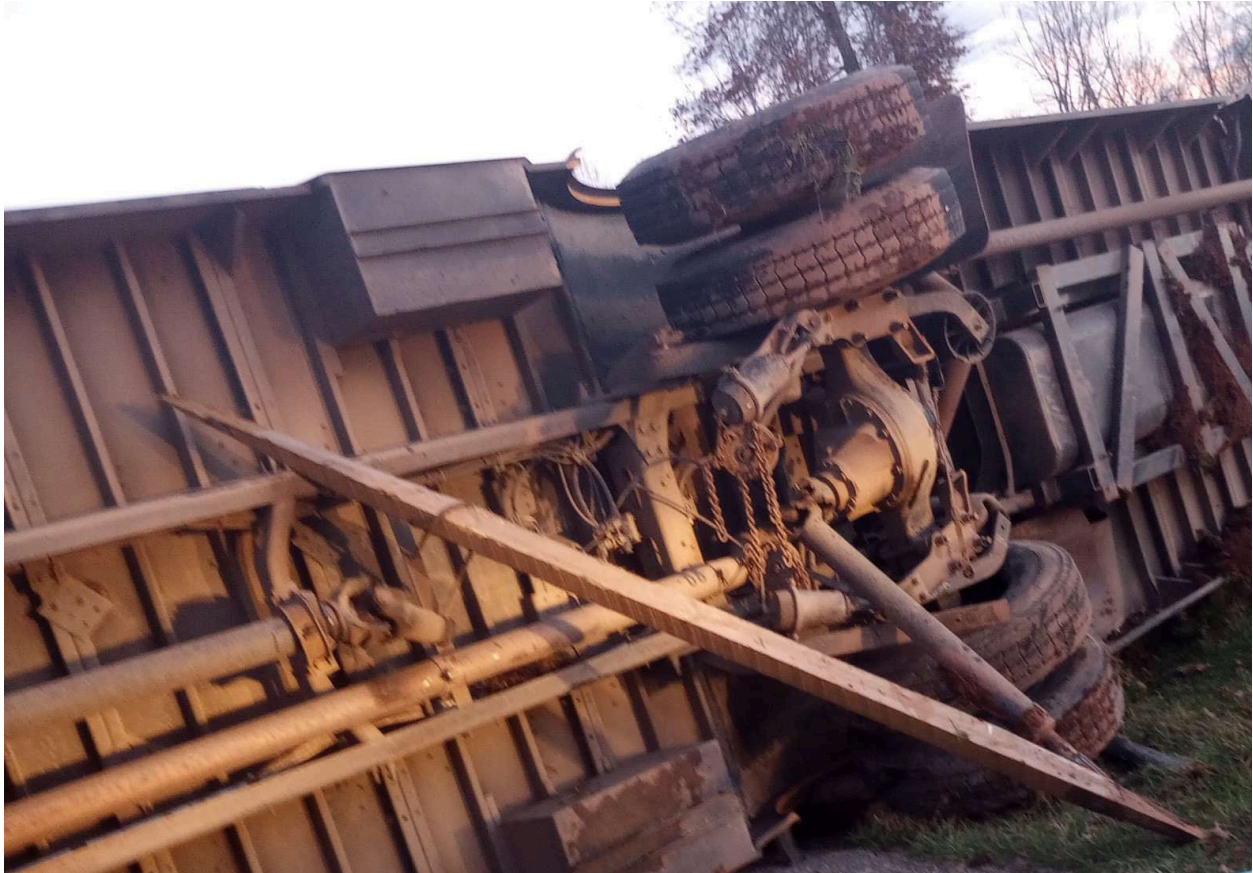
The undercarriage of the bus sustained a fractured driveline and broken rear axle shackles (Figure 4).

**Figure 3.** Undercarriage of the bus showing a fractured driveline and broken rear axle shackles (Source: WVSP)
