# National Transportation Safety Board

HWY24FH004

## **VIDEO AND OCCUPANT SAFETY**

Group Chair's Factual Report

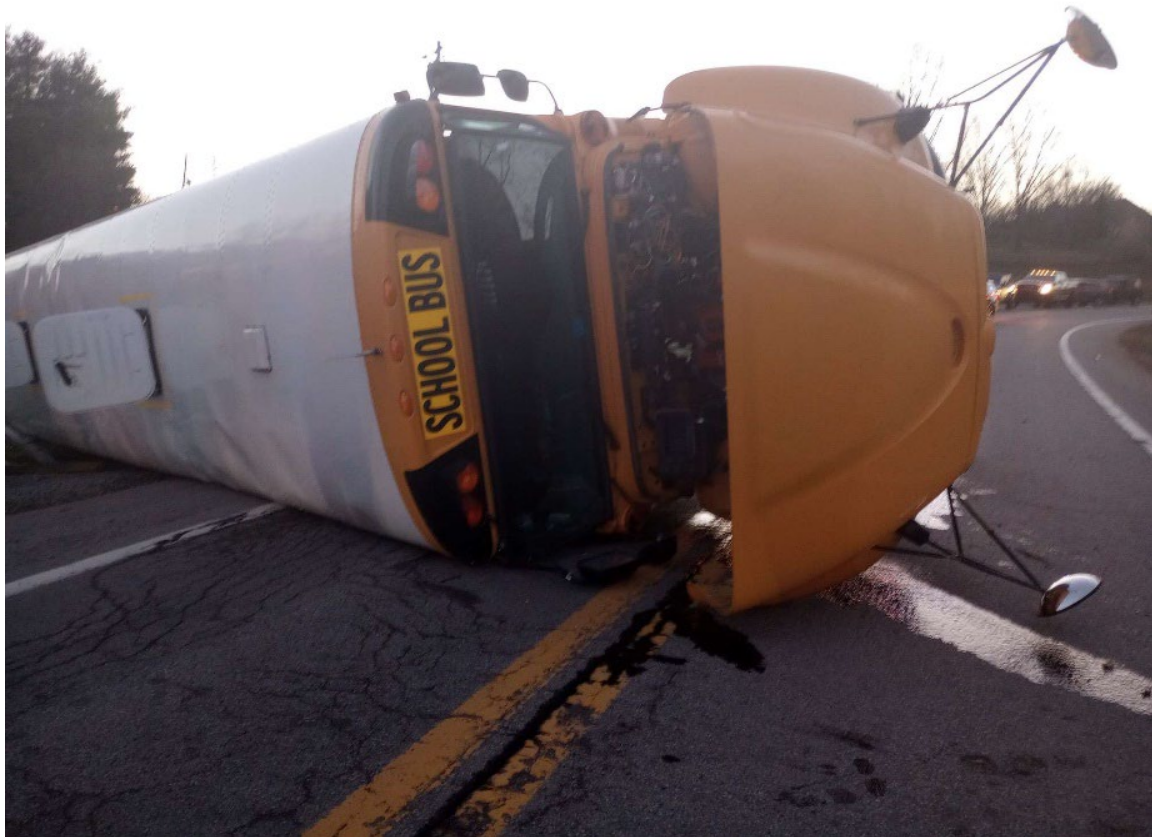
The school bus departed the paved roadway traveling at 39 mph. It impacted a culvert off the right side of the roadway. The bus began a counterclockwise yaw, reentered the roadway, and overturned ¼ turn onto the loading door side blocking most of the roadway, see Figure 1.

**Figure 1. The school bus at its final rest position across the southbound lane of the roadway. View is looking toward the north. (Source: West Virginia State Police)**

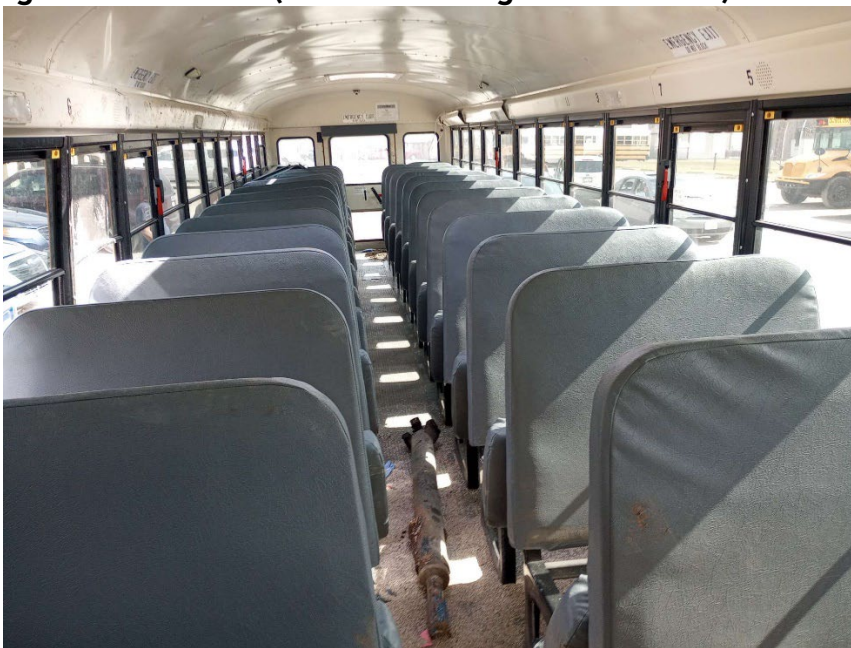
**Figure 2: Interior of the school bus post-crash (after the bus was righted) looking from front toward the back.**

The interior of the school bus post-crash is shown in Figure 2. Little damage was noted to the interior seats, sidewall structure, windows, or roof. The school bus driver was restrained by the available lap/shoulder belt although the belt webbing was visibly twisted near the buckle (visible in the onboard video) such that the lap and shoulder portion were twisted together. The student passengers were seated facing forward throughout the trip in a position associated with the best performance of compartmentalization. The passenger seats were high-back bench seats with no restraints. Occupant injury information described in Figure 3 was obtained from the West Virginia State Police and a review of medical records by NTSB investigators, as noted in the Factual Report of Investigation.

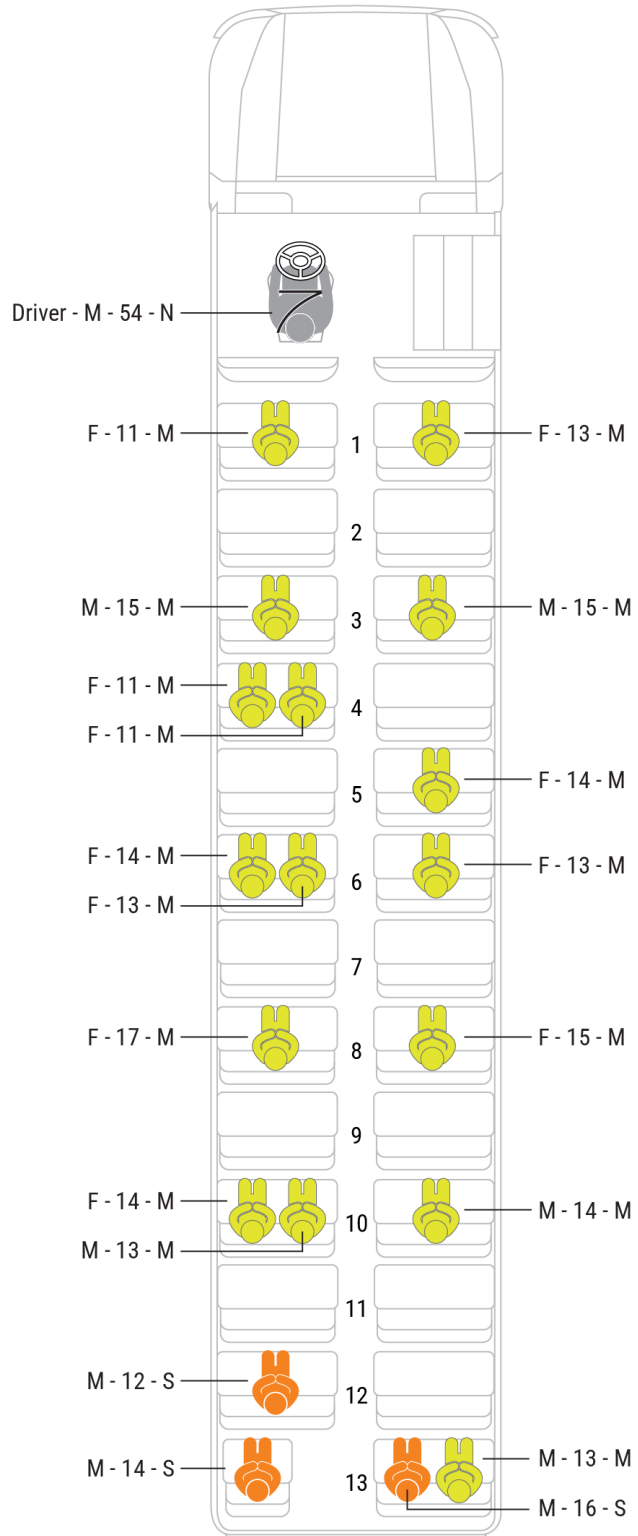
Figure 3 shows the occupant seating position, age, gender, and injury. Three students sustained serious injuries, and 16 sustained minor injuries. The three students with serious injuries were seated in the last rows of the bus. The driver was not injured.

Figure 3: Seating chart with age, gender, and injury severity noted.
