## TEST DEPARTMENT LABORATORY REPORT

**Subject:** Derailment: Bordulac, North Dakota      **Keywords:** ES, RAIL, CM, EC, 092  
Broken Rail Analysis

**Report Date:** December 31, 2024      **Project No.:** 2024-092

**Sample Description:** One 43" section of 115lb rail manufactured by Colorado Fuel & Iron. Based off available stampings the age is unknown.

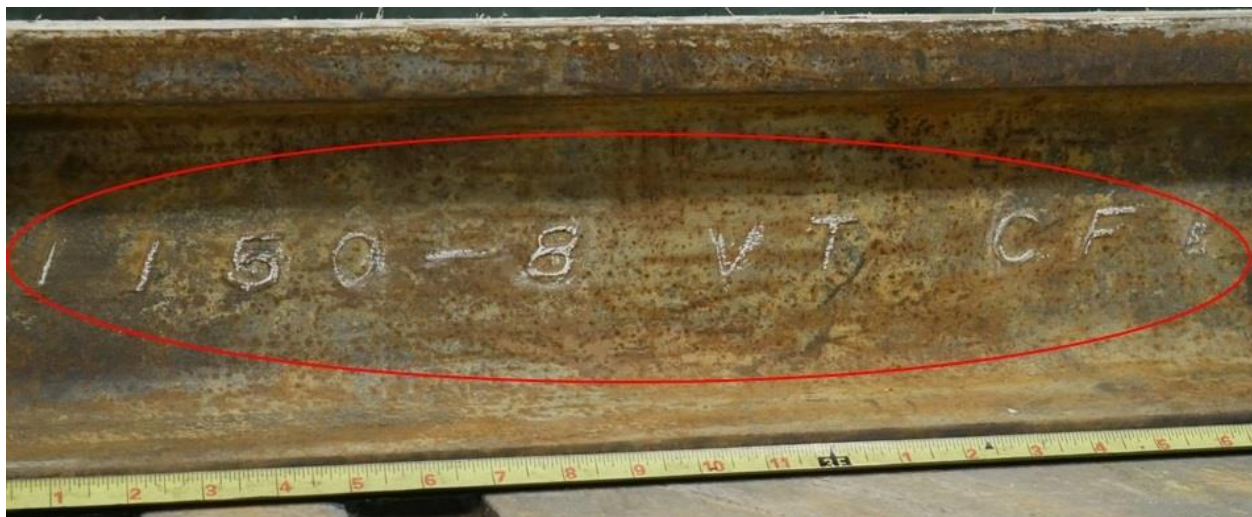
It should be noted that due to incomplete markings; the vintage of the rail is unknown. Testing compared the rail to current AREMA and internal specifications.

Image 2: Field side rail brand saying "1150-8 VT CF &" on side of rail.

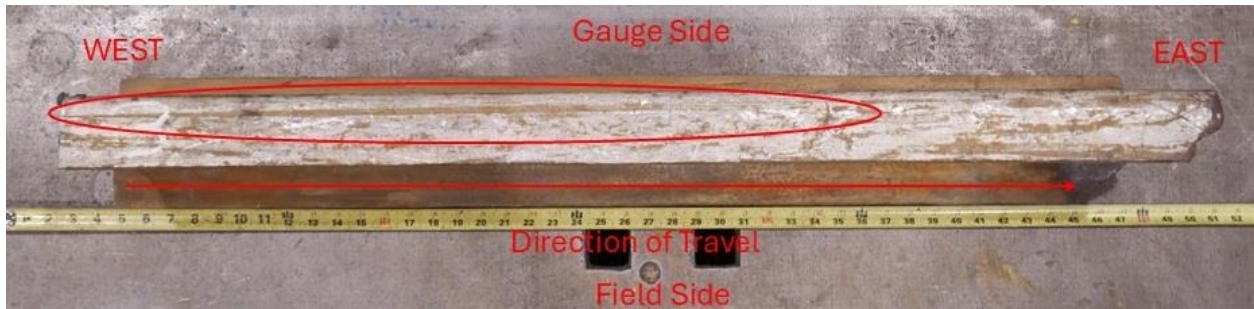
Many small batter marks are scattered across the head, lacking a consistent direction. There was a single long mark that ran the length of the rail section, consistent with a wheel flange riding along the rail running surface (Image 4). There were no batter marks on the sides of the rail.

Image 4: A composite image of the railhead showing the batter with the damage caused by wheel ride circled in red.

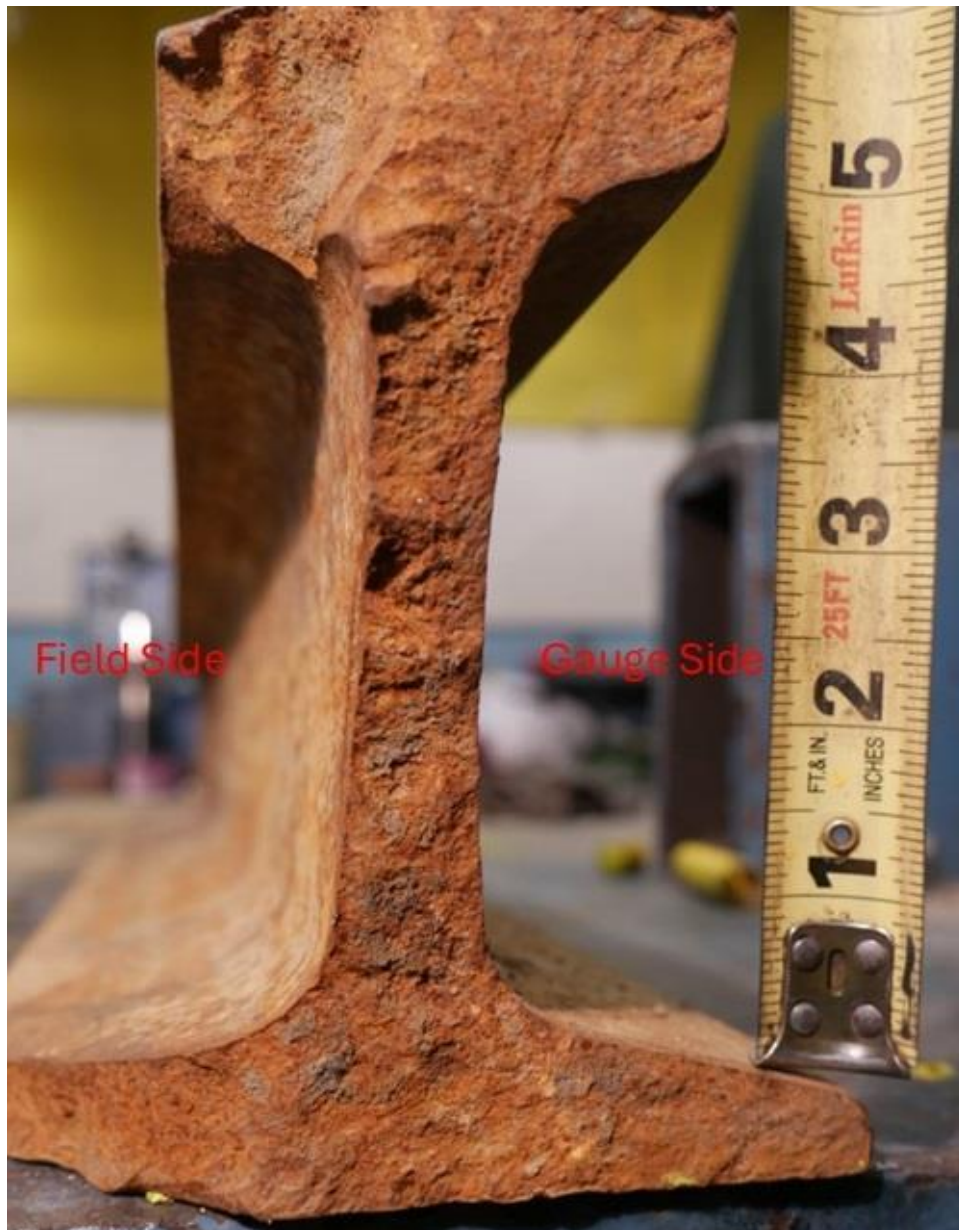
In the received condition, the fracture face of the rail was heavily corroded/rusted. Though some features may be obscured as a result, the fracture face (shown in Image 5) displayed the traits of a sudden and catastrophic brittle fracture throughout its entirety. It was relatively flat with a granular appearance and exhibited chevrons denoting an initiation point at the base corner (gauge side) of the rail (Image 6). No visual evidence was found of any pre-existing defects or fatigue growth.

Image 5: The fracture face showing characteristics of brittle fracture, namely a flat surface and chevrons pointing towards the initiation sites.

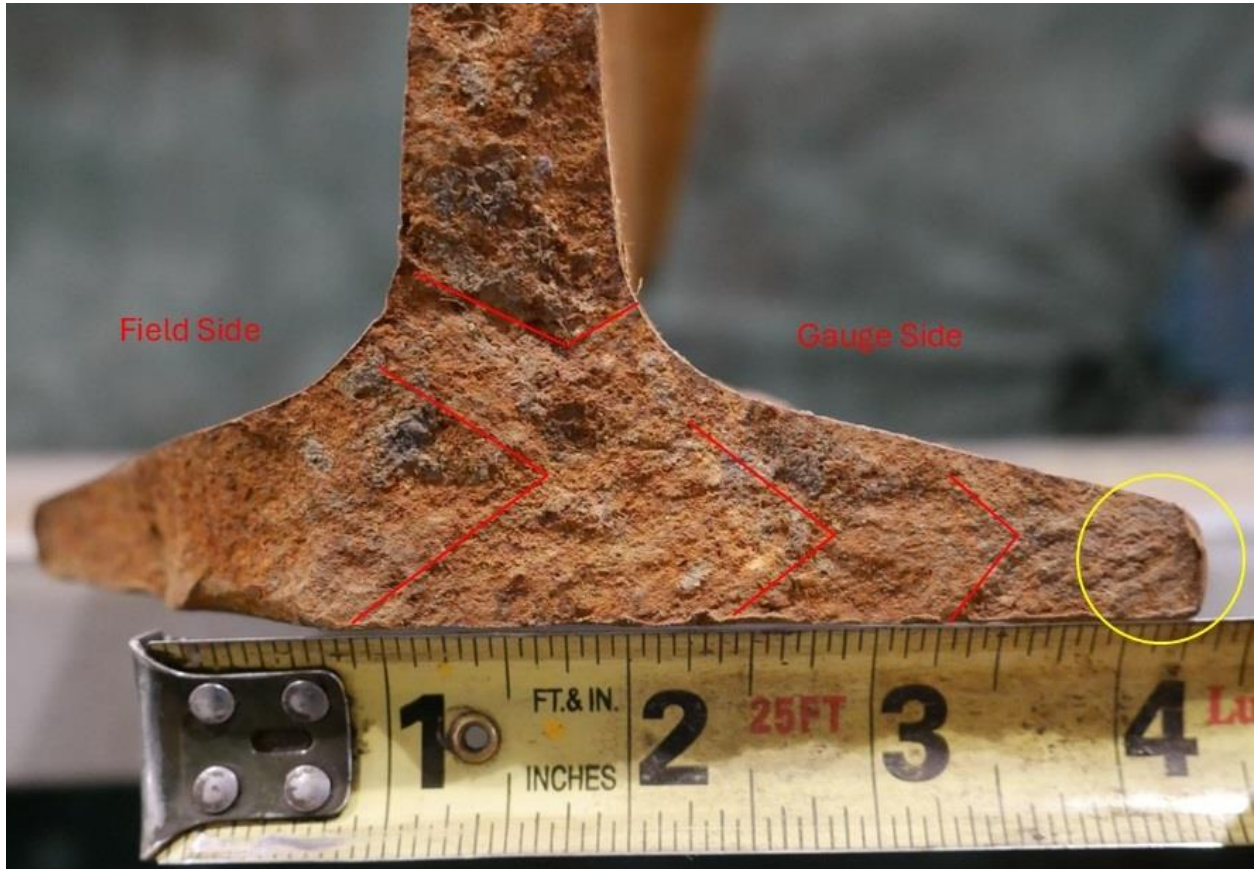
The location of the initiation point suggests that the rail had been loaded such that the gauge side was under the most stress.

Image 6: A closeup of the bottom half of the fracture face highlighting the chevrons (red) pointing towards fracture initiation location (circled in yellow).

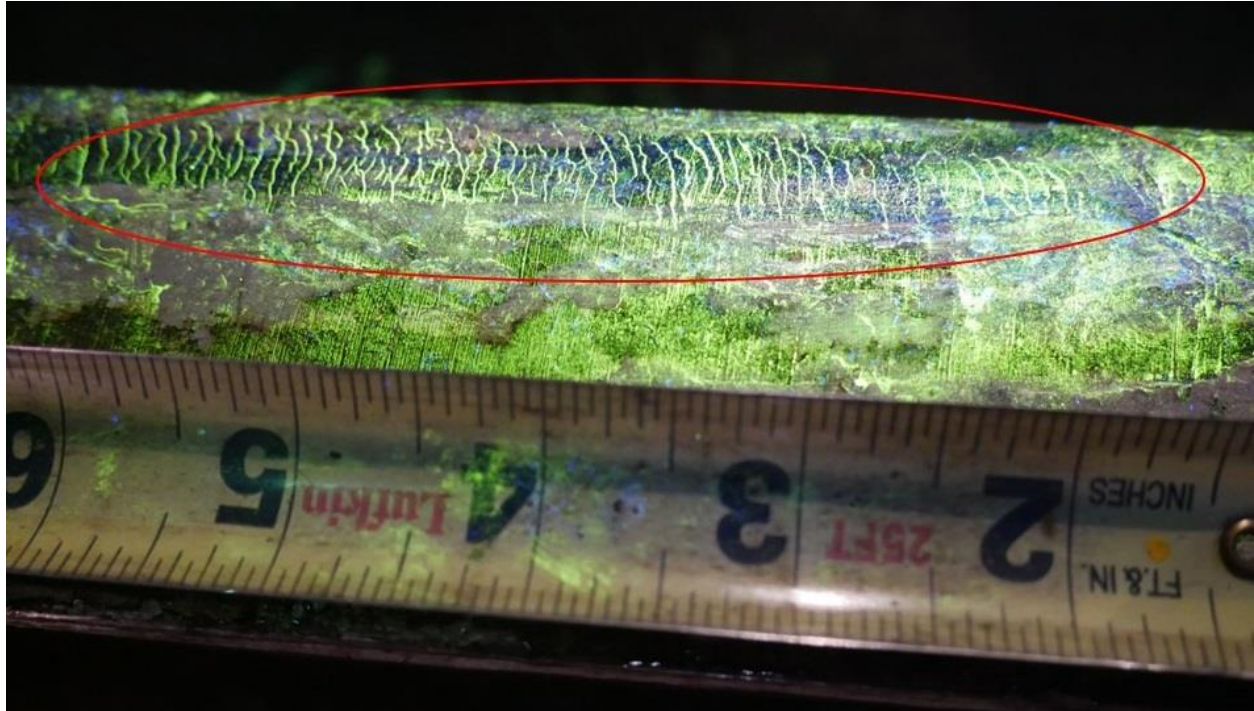
All surfaces of the rail were subject to magnetic particle inspection (MPI), including the fracture face. Testing found rolling contact fatigue cracks along the gauge side of the rail running surface, however none appeared causal to the primary fracture. No other indications were found along the rail segment, including secondary fractures along the fracture face.

Image 8: The gauge corner cracking revealed by MPI along the gauge side of the rail.

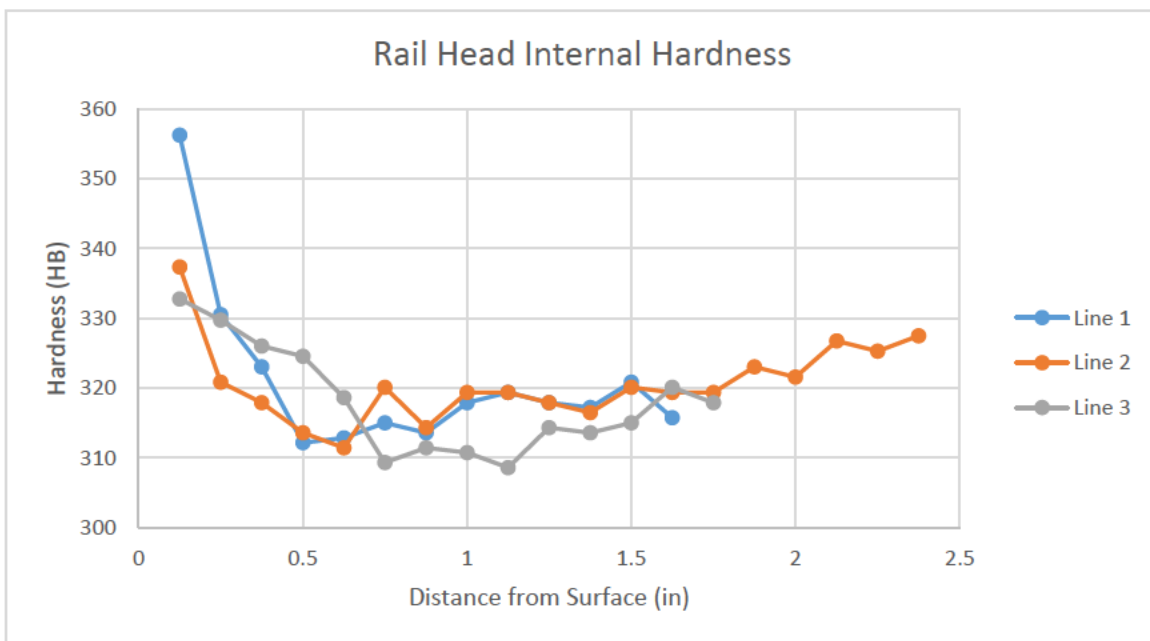
Figure 2: Hardness gradient within rail head cross section.

Figure 2, illustrates the hardness gradient within the rail head along lines 1, 2, and 3. Point 1 on line 1 hardness was found to be 356 BHN, above the minimum requirement for intermediate strength rail head hardness (350 BHN). However, similar hardness measurements for point 1 on lines 2 and 3 fell below this minimum but were above the minimum for standard rail (310 BHN).

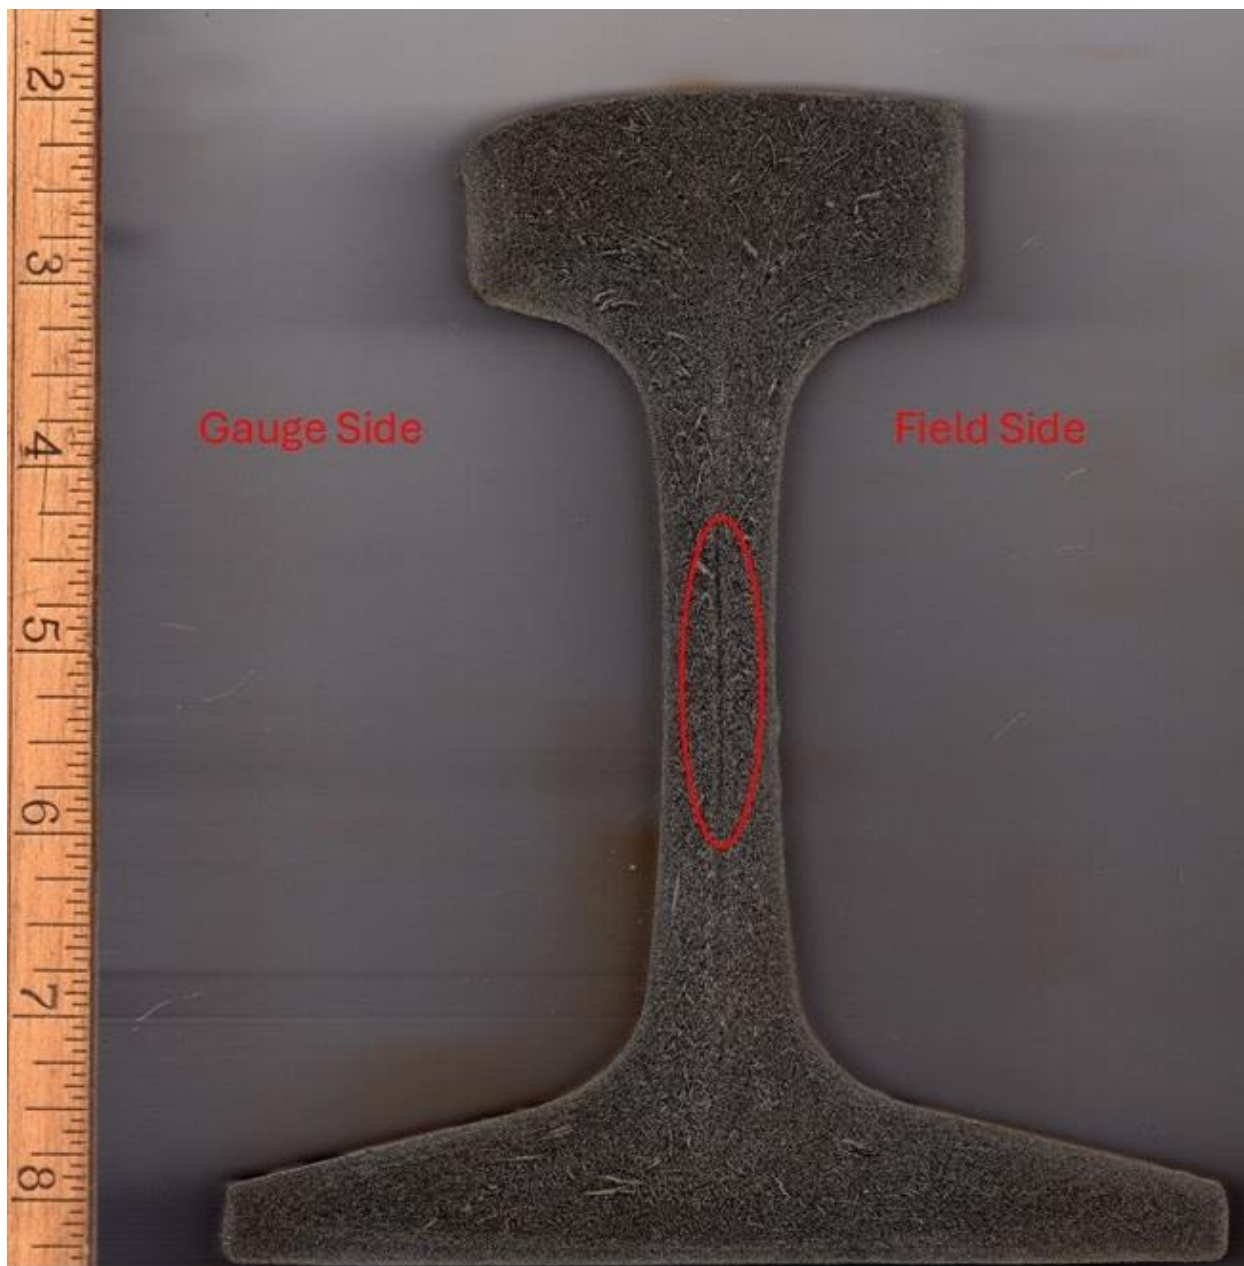
To examine the general structure of the sample, a transverse cross section was macroetched with a 50-50 mixture of hydrochloric acid and water at 200°F for 20 minutes. As can be seen below in Image 11, a 1.5" long segregation line is present in the web. In accordance with AREMA Chapter 4 Section 2 Table 4-2-3, segregation is allowable as long as it is confined entirely to the web. As such, the rail meets the standard. The remainder of the macrostructure appeared homogenous, with no internal defects observed.

Image 11: The macroetched sample with the segregated area circled in red.
