National Transportation Safety Board

ERA24FA058

WRECKAGE EXAMINATION

Location: Pulaski, Tennessee @ 35.249998° -86.848157°
Date: December 7, 2023
Time: 1103 CST
1703 Z
Airplane: Beech "Debonaire" BE 35-C33 N5891J

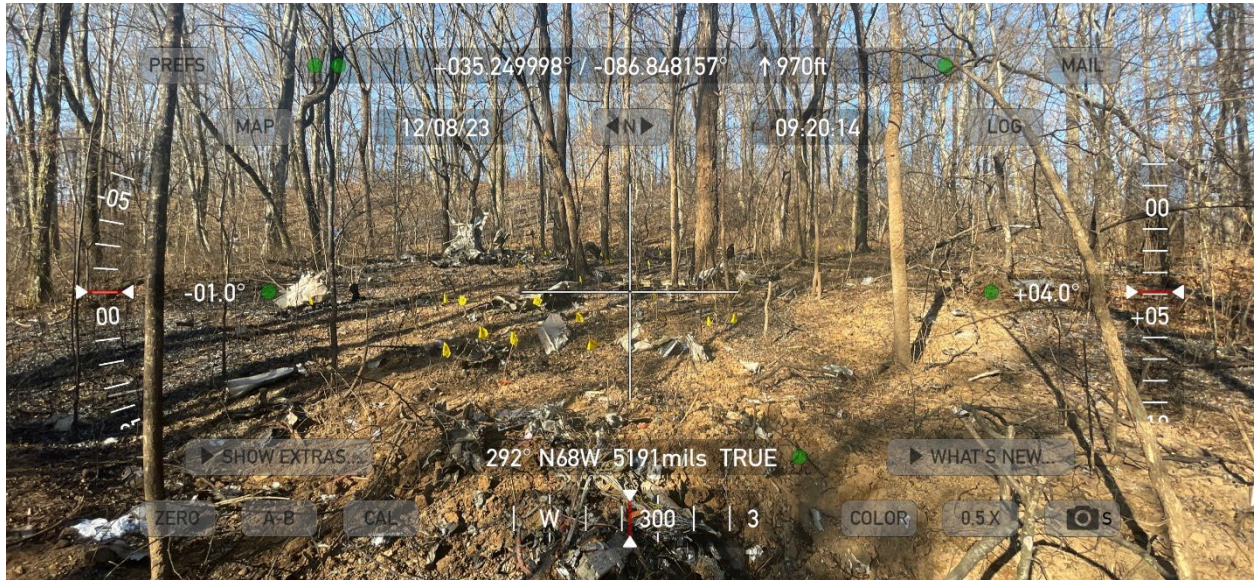
Foothills near Pulaski, TN. Steep terrain on a 18° slope. The airplane struck hilly wooded terrain, at an elevation of about 962 ft with the wreckage path oriented on a magnetic heading of about 290°. The wreckage was highly fragmented. The debris field extended out in a fan-like pattern about 250 feet from the primary terrain impact site which was a crater about 5-feet deep by 8-feet wide. It was a high energy impact. The tops of 6-8 trees leading up to the main wreckage were cut off at progressively lower heights. There was a post-crash fire and subsequent brush fire covering about

Figure 1 Photo taken by IIC from impact crater looking up the hill at the wreckage path.

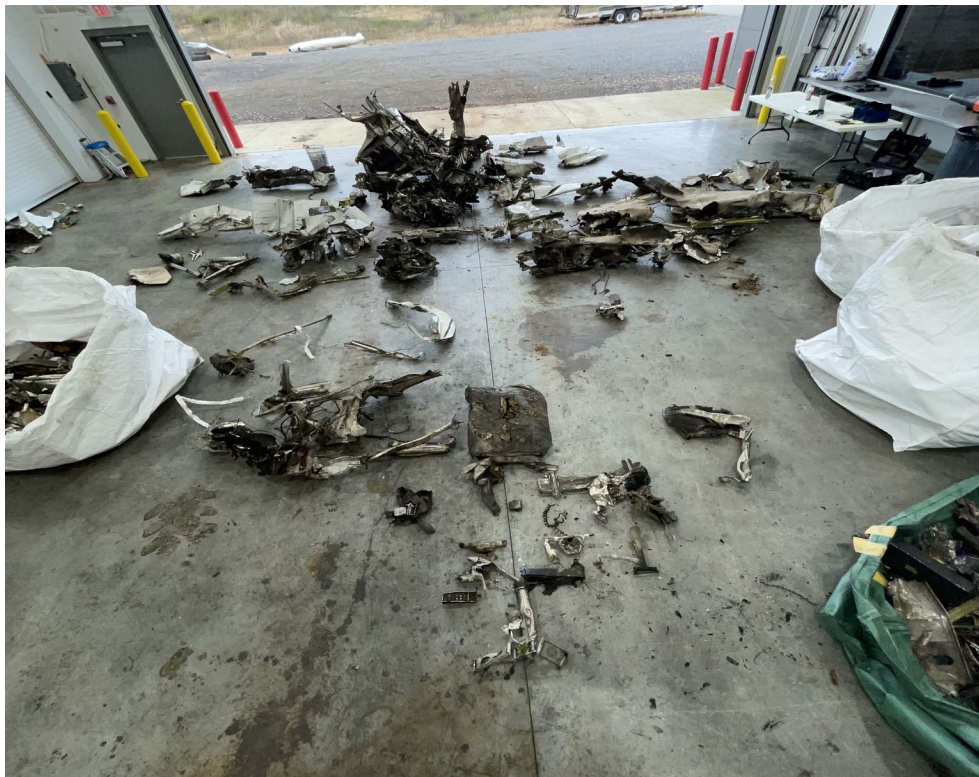
The airframe was 80% destroyed by impact and post impact fire. Fire was more pronounced on the left side of the airplane where the fuel tank in the left wing was compromised during impact with trees before it impacted the ground.

Figure 2. Wreckage layout looking from nose to tail.

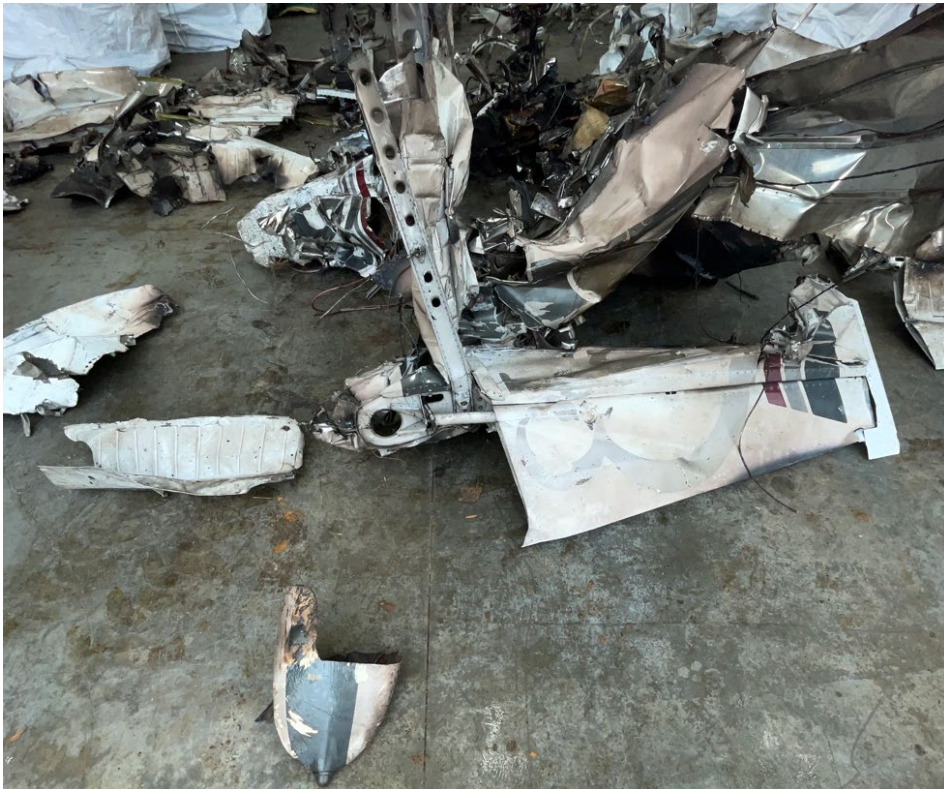
Empennage was the only piece of wreckage that survived the impact although severely damaged by impact. The rudder and vertical stabilizer remained attached. All control cables leading up to the flight controls overloaded by impact. The left stab and elevator remained attached, and the control surface moved freely when manually manipulated. The trim on the left elevator that separated during impact was measured, indicating a 5° trim tab down. The autopilot servos were impact and thermally damaged.

Figure 3. Rudder/Vert Stab horizontal on hangar floor.

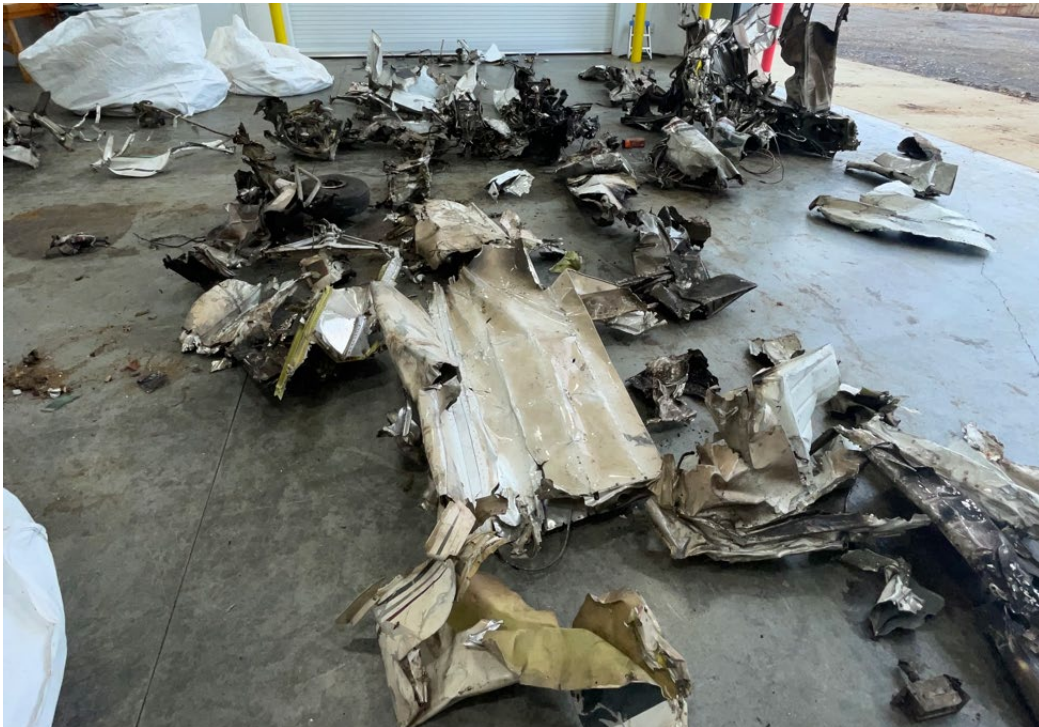
Left wing damaged by impact forms and fragmented. The left wing was exposed to the most intense fire due to thermal damage when compared to the opposing wing. The left aileron detached during impact and was crushed. The right wing was highly fragmented. Numerous pieces of wing and control surfaces from the left and the right exhibited half-moon shape crush marks due to impact with trees. One flap actuator was found loose in the wreckage but could not be attributed to the right or left side. It measured 1.7" which equates to flaps retracted.

Figure 4. Right wing looking towards fuselage.

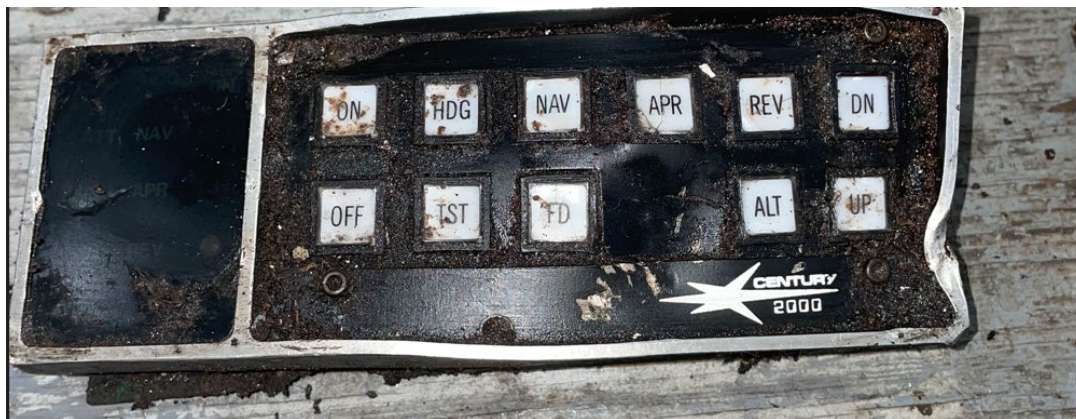
There was extreme damage to the instrument panel. All gauges and instrumentation were severely damaged, and the readings/settings could not be determined. There were no survivable displays or gauges. The Century 2000 autopilot faceplate was discovered in the wreckage. After cleaning, the buttons/settings could not be determined. The flight controls were fragmented. The

Figure 5: Century 2000 AP control panel after cleaning.

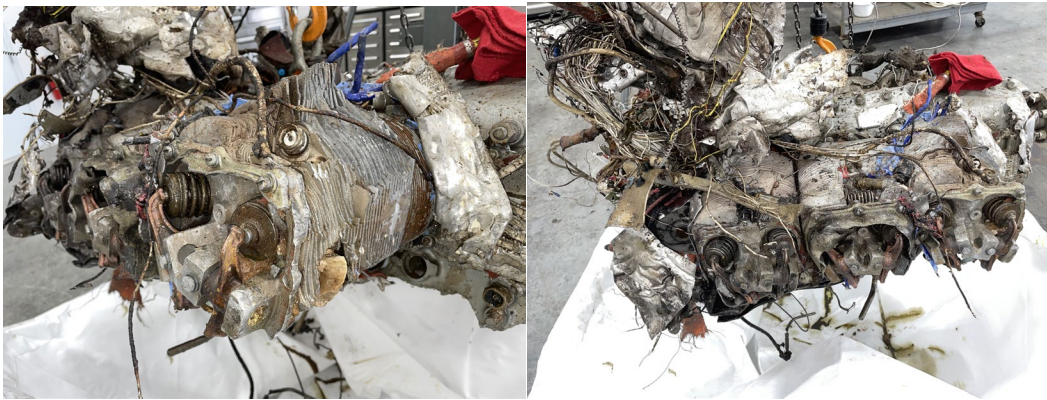
The engine was a Continental IO-470-N with 260 horsepower. The engine was discovered partially buried in the impact crater. Compression, suction and valvetrain continuity were unable to be performed due to impact damage on the case and cylinders. Impact forces damaged the cylinders exposing the valve covers, rocker arms, and pushrods. The right side of the engine sustained the most impact damage displacing the cylinders aft.

Figure 6. Engine views.

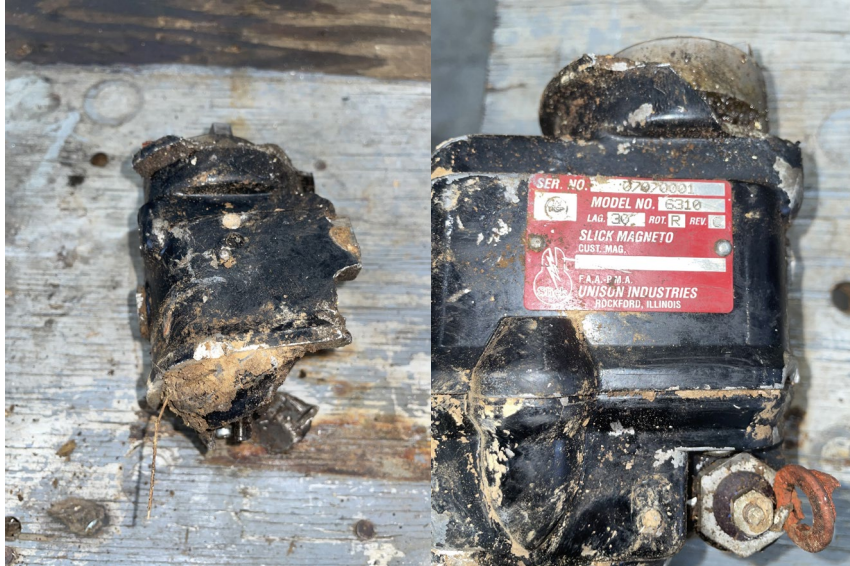
Both magnetos separated from the engine during the accident sequence and were damaged by impact forces and could not be functionally tested.

Figure 7. Left and Right Magnetos

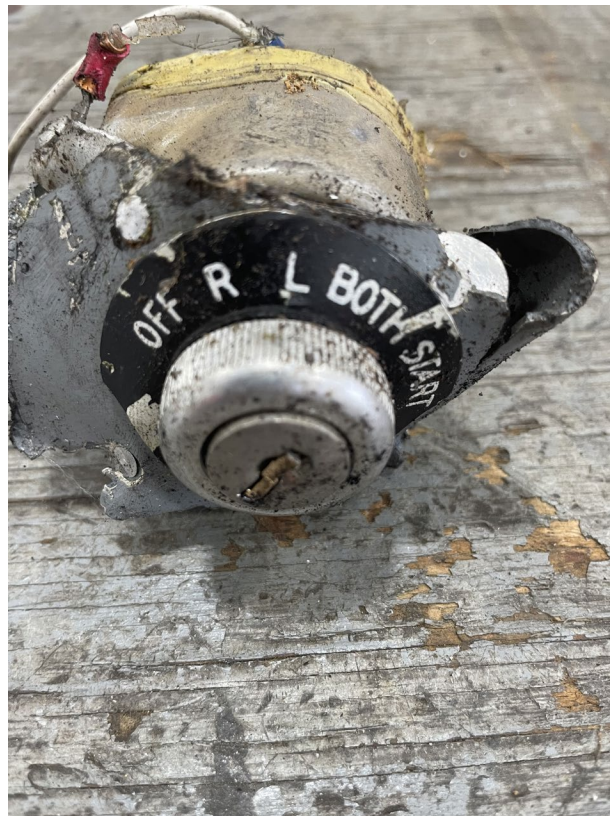
The magneto key was broken off in the switch and set on "Both."

Figure 8. Mag key switch set to both.

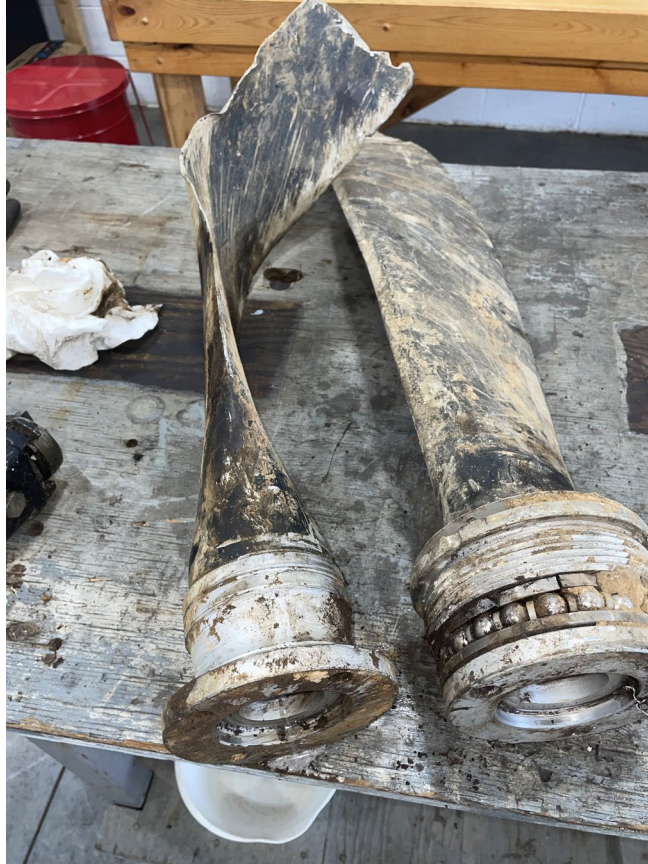
The metal 2 blade McCauley propeller (2A36C23-DCE / Serial # 652954) separated from the flange and hub at impact. One blade was buried in the impact crater and exhibited an s-bend with chordwise scraping and leading-edge gouges with 6 inches of the blade tip missing. The opposing blade was discovered about 30 feet west of the crater and had a slight bend with chordwise scraping and leading-edge damage.

Figure 9. Propeller damage.
