National Transportation Safety Board

RRD25FR006

SURVIVAL FACTORS- CRASHWORTHINESS

Group Chair's Factual Report

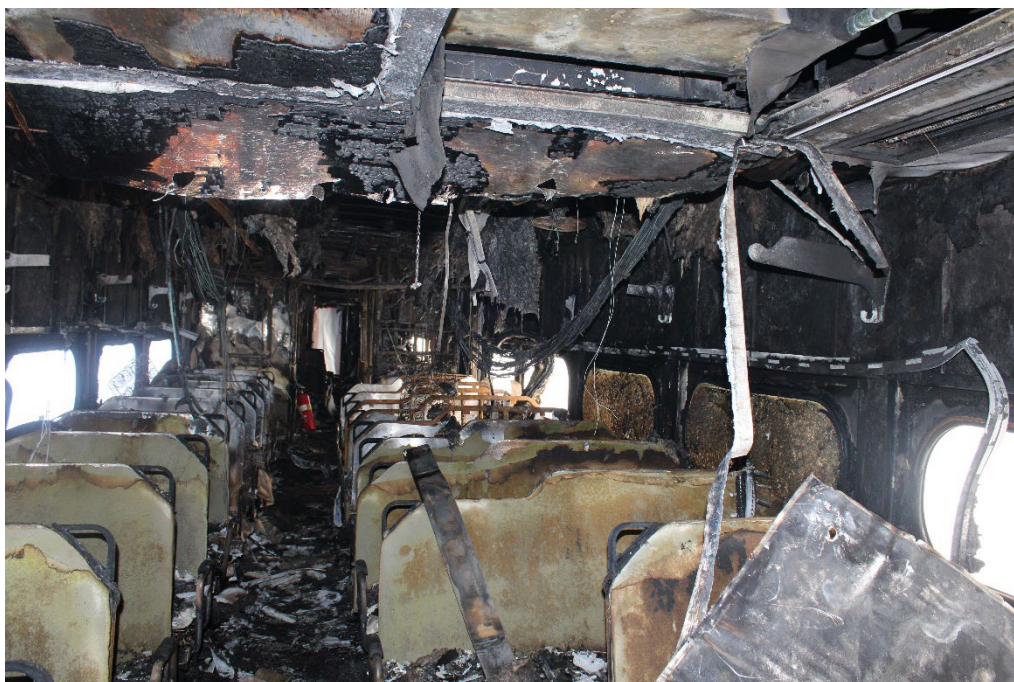
SEATS	Distance across the top of the seats	2 Feet 9 ½ inches			
	L1 and L2		All material padding burned away but metal support frame for seat back and seat pan still present		
	Between Seat L3- L6	S/A	No deviation		L3- L5 seat padding burned away but metal frame for seat back and seat pan still present.
	Between L6- L7	S/A	2 Feet 7 inches	- 2 ½ inches	Seat L6 bowed towards L7 and the left side, middle of the train. L6 padding and support frame for seat are burned away.
	Between L7- L8	S/A	2 Feet 6 ¾ inches	-2 ¾ inches	L7 bowed back towards L8. Both L7 and L8 seat padding and metal support frame for seat back and seat pan are burned away.
	Between L8- L9	S/A	2 Feet 6 ¼ inches	-3 ¼ inches	L8 bowed back towards L9. Both sustained loss of padding and metal support frames.
	L9- L10	S/A	2 Feet 6 1/8 inch	- 3 3/8 inches	Seat L9 bowed back towards L10. No padding or seat back or seat pan metal support frame is left on L9. L10. Padding has been burned away but a portion of the metal seat frame is still present.

L11	Obvious signs of deformation	N/A		The seat bowed back into partition space LP2. Partition has been burned away.
	R1- R2		No deviation		Padding burned away but metal support for seat back and seat pan still present
	R3- R4	S/A	No deviation	N/A	S/A
	R4- R5	S/A	2 Feet 7 inches	-2 ½ inches	S/A
	R5- R6	S/A	2 Feet 7 inches	- 2 ½ inches	S/A

R6- R11	S/A	No deviation	N/A	S/A
	R12		No deviation		S/A
MIDDLE SECTION					
	Left side double seat facing "B-end"	Obvious signs of deformation			Seatback is bowed back into the space where the partition behind the seat was burned away. Extensive fire and heat damage with both padding and metal frame burned/melted away.
	Right side double seat facing "B-end"	N/A	N/A		No signs of deformation. Padding and metal support for seatback and seat pan have been burned/melted away.
					Facing "A- end"
	R13	Obvious deformation to seatback	N/A		Seatback bowed backward towards the middle of the train car and encroached into partition space RP2 which had been burned away.
WINDOWS					Facing "B-ending"
LW-1	Adjacent L2		Missing- out of frame		Partial remnant of melted window found on train car seat.
LW-2	Between L3 and L4		Extreme melting- still in frame		Exposure to extreme heat
LW-3	Between L5 and L6		S/A		S/A

LW-4	Between L7- L8		Exposure to extreme heat- melted away		Remnant of window found adjacent to frame. Deformation due to heat on the exterior roof over top window.
LW-5	Between L9- L10		Exposure to extreme heat- out of frame		The window found intact lying on seat L9. Deformation due to heat exposure to exterior of train car roof located directly above window.

MIDDLE SECTION					Facing "B- end" and direction of travel of train
LW-6	Adjacent to left side double seat in the middle of car		Missing- out of frame		Signs of significant heat and fire damage to the window frame and exterior roof directly above window.
RW-6	Adjacent to right side double seat in middle of train car		Missing- out of frame		Signs of heat exposure but no real damage to window frame
					Facing "A- end"
RW-1	Between seat R3 and R4		Missing- out of frame		
RW-2	Between R5 and R6		Missing- out of frame		
RW-3	Between R7 and R8		S/A		
RW-4	Between R9-10		S/A		
RW-5 Emergency exit window	Between R11- and R12		S/A		Signs of extreme heat exposure was observed on the exterior roof of train car directly above window.
LW-1 Emergency exit window	Between seats L3 and L4		Missing		
LW-2	Between L5 and L6		S/A		
LW-3	Between L7 and L8		S/A		
LW-4	Between L9 and L10		S/A		
LW-5	Between L11- L12		S/A

Figure 4 Photograph of the burned-out interior of Car 132. (Source: NTSB)

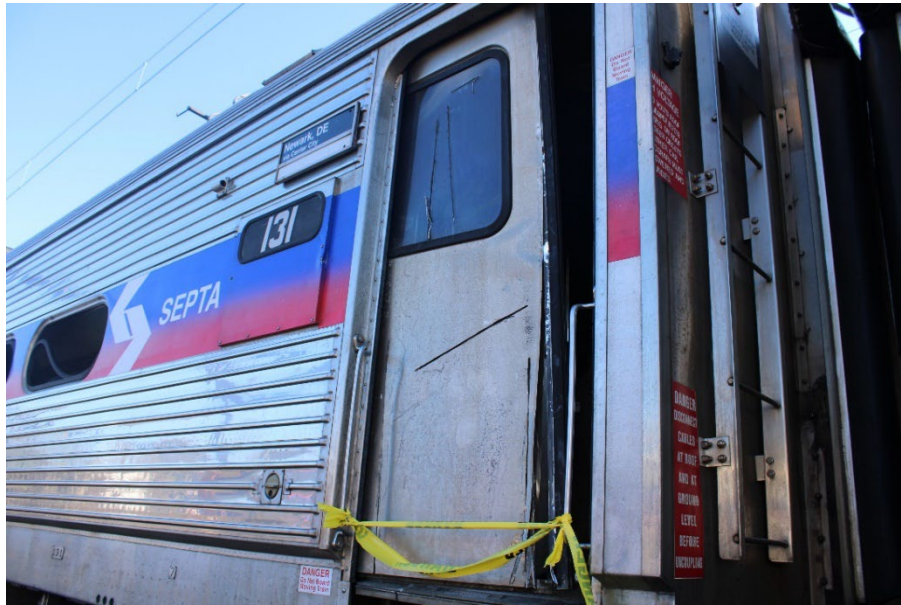
The investigation also explored the challenges faced by the emergency responders during the incident and the potential effects on survivability of the train occupants. One issue that was discussed by both the emergency responders and representatives from SEPTA was the inability to access the interior of the train cars from the exterior without a key. Unlike other equipment in SEPTA's fleet, the design and age of the Silver Liner IV train cars, resulted in the cars not being equipped with an exterior emergency door release mechanism. SEPTA provides the information about their system and the details on their equipment to emergency responders through training material made available to the various agencies as well as hands-on training opportunities during training sessions when conducted by the transit agency. SEPTA representatives advise that keys are not provided to emergency responders prophylactically. During the post-incident examination of the various train cars, evidence of forcible entry by the fire department was found on Door 4 on Car 131 where a reciprocating saw and prying tools were used to access the car. Additional evidence of forcible entry was found on Door 3 in Car 278 and Door 2 in Car 407. The emergency door release handles were pulled for Door 4 in Car 278 and Car 407 and for Door 3 in Car 288. It was undetermined whether the door release mechanisms were activated by the emergency responders during the rescue and fire suppression operations or by the occupants of the train. Door 2 in Car 287 was found open at the time of the inspection. **Figure 5** is a photograph of Door 4 on Car 131 and shows the damaged resulting from the forcible entry operation by the fire department.

Figure 5 Photograph of the platform door on Car 131 damaged during the fire department's forcible entry into the train car. (Source: NTSB)

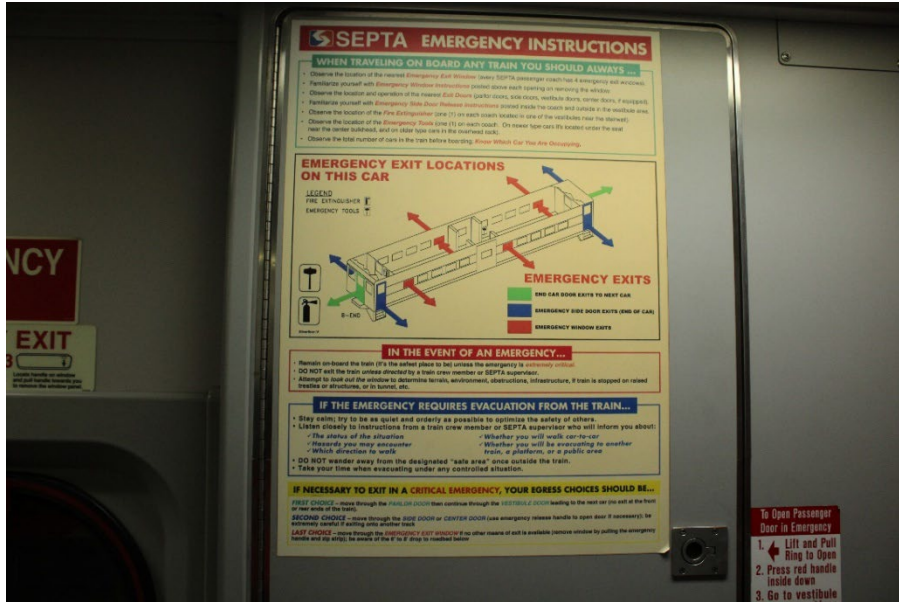
49 Code of Federal Regulation 238.125 outlines the requirement for "Markings and Instructions for Emergency Egress and Rescue Access" for passenger rail cars. The regulation requires that signage be posted in each passenger car and provide emergency instructions such as providing information about emergency egress and potential hazards to the occupants. An examination of the train cars found the required signage was present in each car end and was clearly visible to passengers. This included emergency instructions to passengers on how to operate the platform doors during a power failure and where to find the various access panels. **Figure 6** is a photograph of the emergency instruction signage located at the end of each train car. **Figure 7** is a photograph showing the emergency instructions and location of the emergency train car door release.

Figure 6 shows the posted emergency instructions found on each end of the train car. (Source: NTSB)

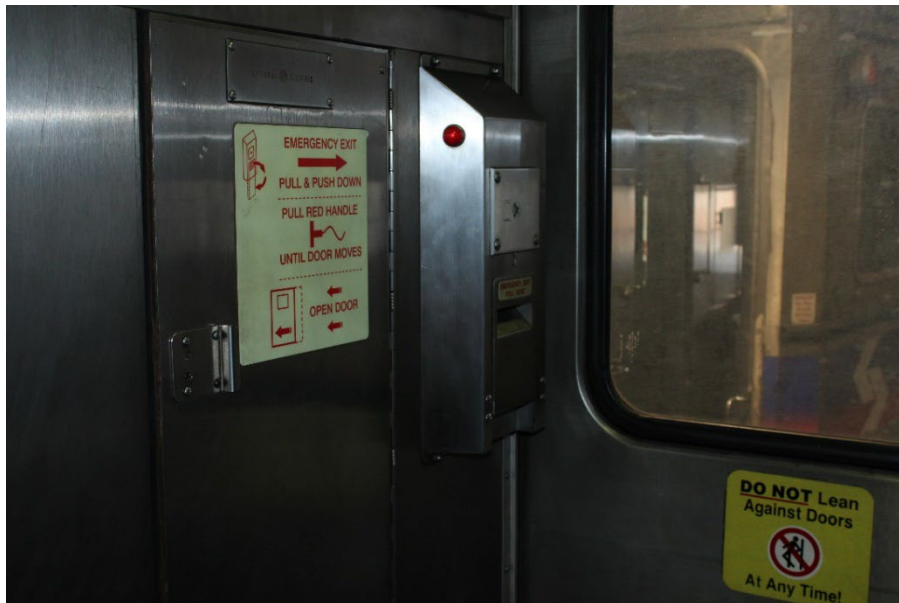
Figure 7 Photograph of the emergency instructions and the emergency door release inside one of the train cars. (Source: NTSB)

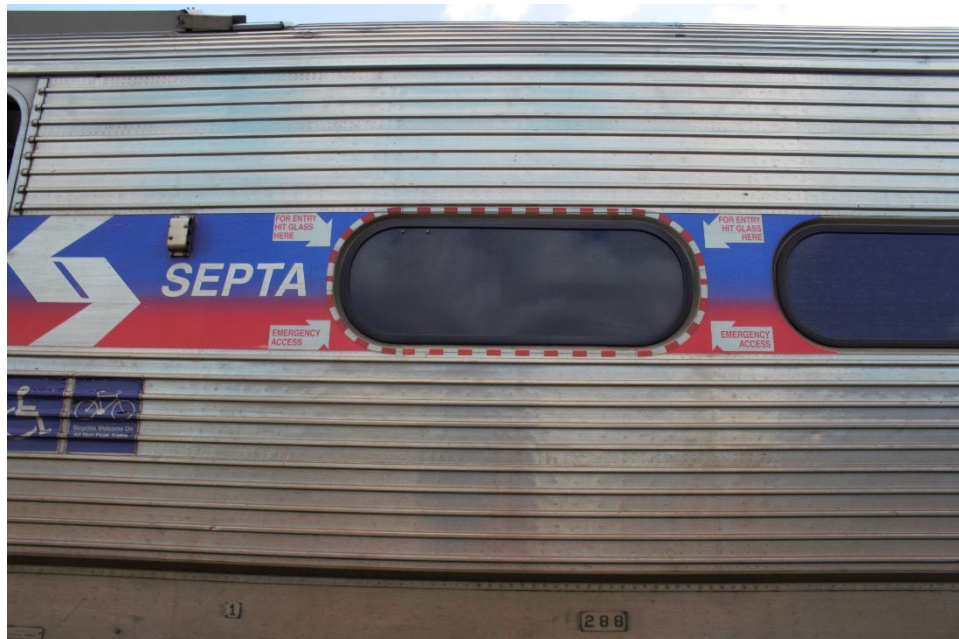
The examination of the exterior of the train cars found that on each side of the train car two windows are designated for emergency egress. The windows were found to be clearly and appropriately marked. On the interior, the front and rear

Figure 8 Photograph showing the emergency exit window markings as seen from the exterior of the train. (Source: NTSB)

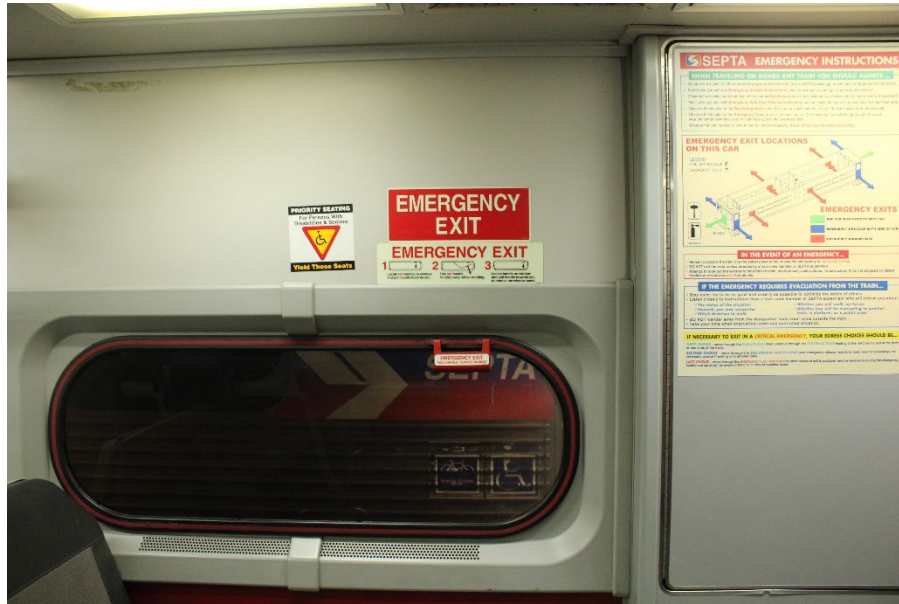
sections of the train have two emergency exit windows, located on opposite sides of that car end, one located in the front and the other one in the rear on the opposite side of the aisle. Facing the A-end of the train, the emergency exit windows were located adjacent to seats L3 and L4 (left side) and seats R11 and R12 (on the right). In the rear section of the car, the emergency windows are located adjacent to the American with Disabilities Act seat R2 and L10 and L11 when facing the A-End of the train car. The windows located in the middle section of the train cars are not emergency exit windows. **Figures 8** and **9** show the markings for the windows designed as an emergency exit window as displayed on the exterior and the interior of the train car.

Figure 9 Photograph of the emergency exit window markings as seen from the interior of the train car. (Source: NTSB)
