National Transportation Safety Board

RRD25FR006

OPERATIONS GROUP

Group Chair's Factual Report

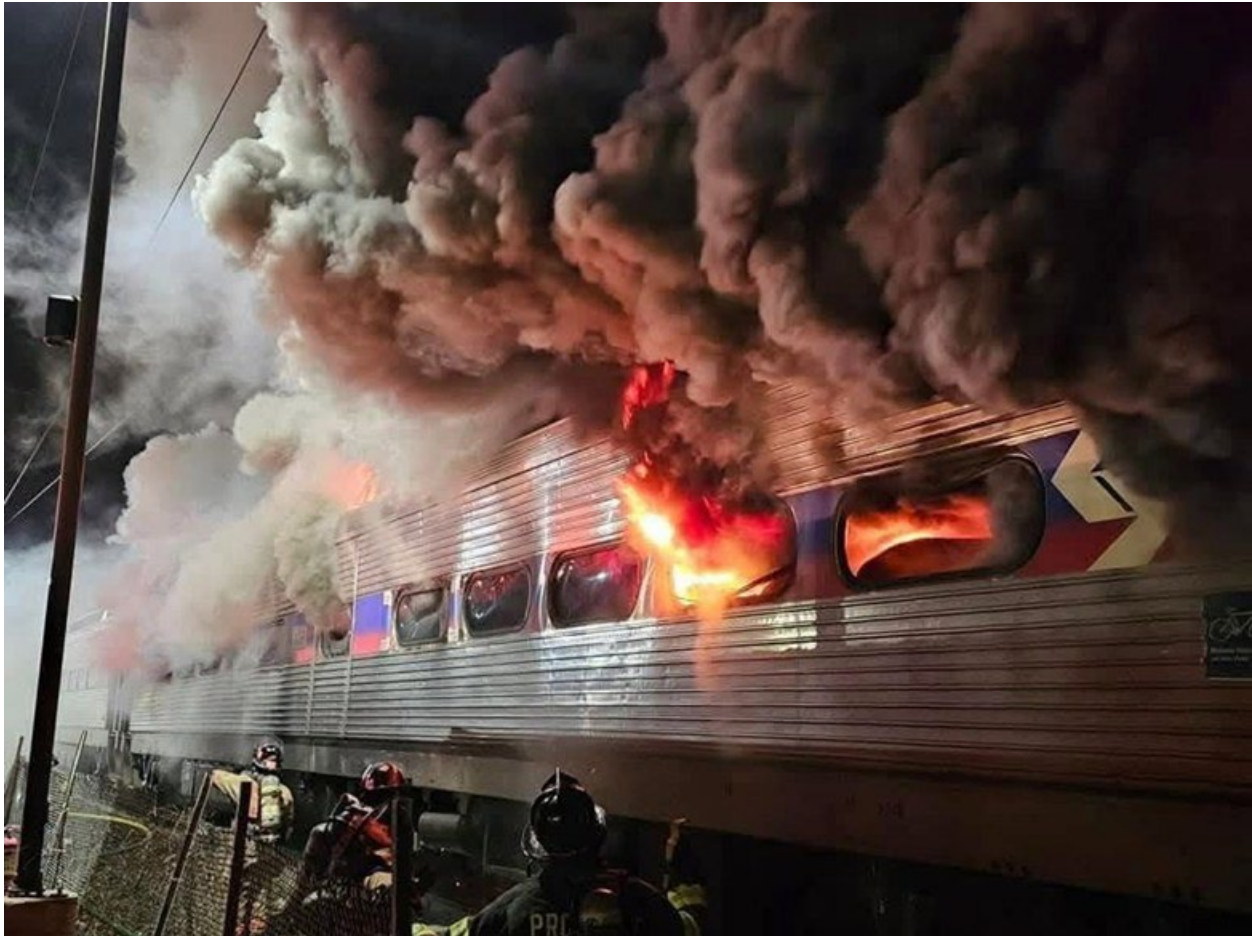
Figure 1: Photo of Train 3223's lead car (MU132). (Source-SEPTA)

When the train reached Crum Lynne, the engineer noticed some haze when he looked back along the train. The assistant conductor informed the engineer a few times that the smell was getting worse in the railcars. The engineer decided that he needed to inspect the equipment but needed to get to a station with enough space to see the train, such as Eddystone Station. Additionally, the engineer and conductor decided to move the passengers out of the first railcar into the second railcar, since the smell was strongest in the first car.

17:57:48 CETC-4 who is calling. Engineer 3223: Our lead car #132 is on fire. We're just short of the Baldwin Interlocking and we're moving everyone to the rear.

17:59:26 Train 3223 to CETC-4, middle of the, underneath the first part of 132, there is a fire burning. Dispatcher: Burning under the first car. Engineer: That is a roger. Dispatcher: Should I get the fire department there then. Engineer: Yeah, that's a roger, we may need a fire department. Dispatcher: What is your location. Engineer: Two Cat poles north of Baldwin Interlocking, home signal. Engineer: Just north of Baldwin, roger that.

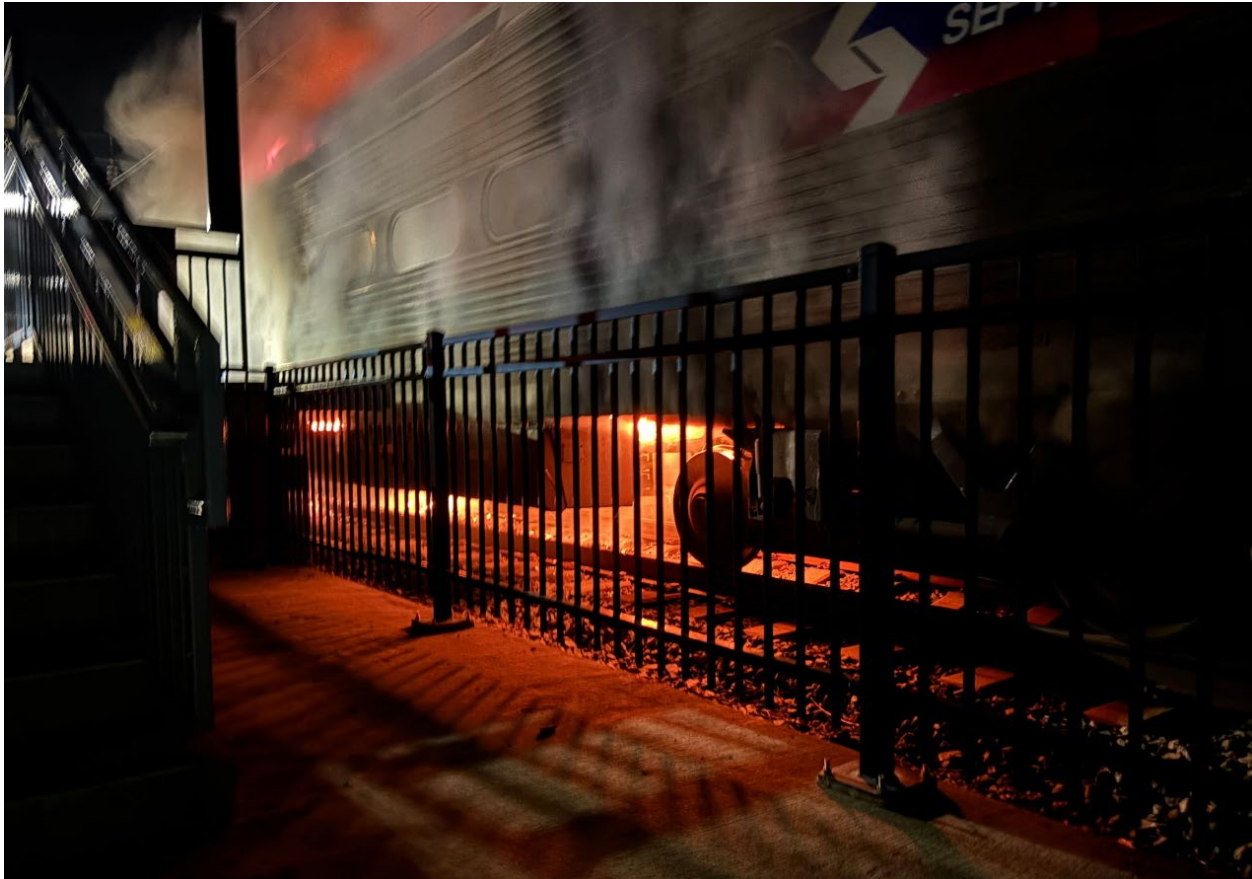
Figure 6: Photo of Train 3553's fifth car (MU114). (Source-SEPTA)

The conductor stated that they experienced sluggish acceleration starting near West Trenton/Yardley. The conductor stated in his interview that he reset the "no power" fault on car 113 twice: once near Yardley and again between Noble and Jenkintown. He also said he reset a fault on the second married pair near Elkins Park. No improvement in performance was noted after resets.

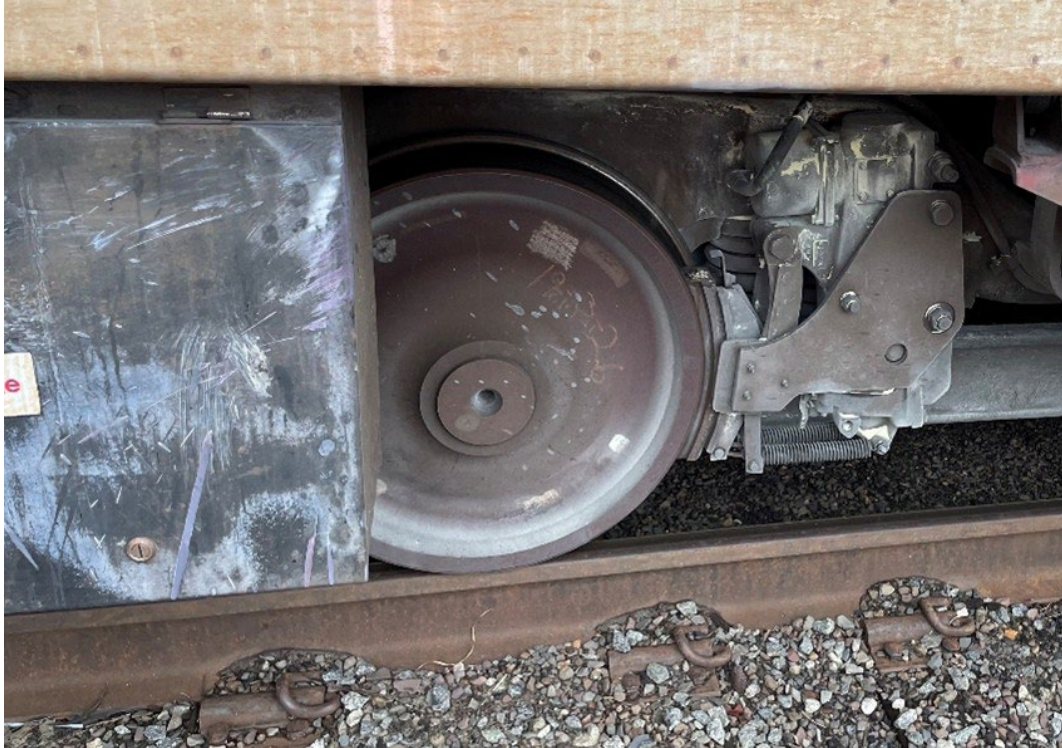
On September 25, 2025, SEPTA Train #705 experienced a traction motor fire while arriving at Gravers Station in Philadelphia, Pennsylvania. The incident occurred at approximately 7:05 AM, when smoke was observed coming from the B-end truck of Car #396, the second car in a five-car consist (281, 396, 397, 184, and 183). The crew, consisting of an engineer, conductor, and engineer trainee, reported the fire at 7:12 AM and used a fire extinguisher to subdue it. A post-incident inspection revealed that the #2 traction motor had suffered a catastrophic internal failure, with motor windings separating inside the housing and causing a friction fire. Visual signs of "bird nesting" indicated disintegration of the windings, and both the ground relay (GR) and reset ground relay (RGR) were tripped, disabling motive power and illuminating a fault light in the operating cabin.

Figure 8: SEPTA Car 396 Traction Motor

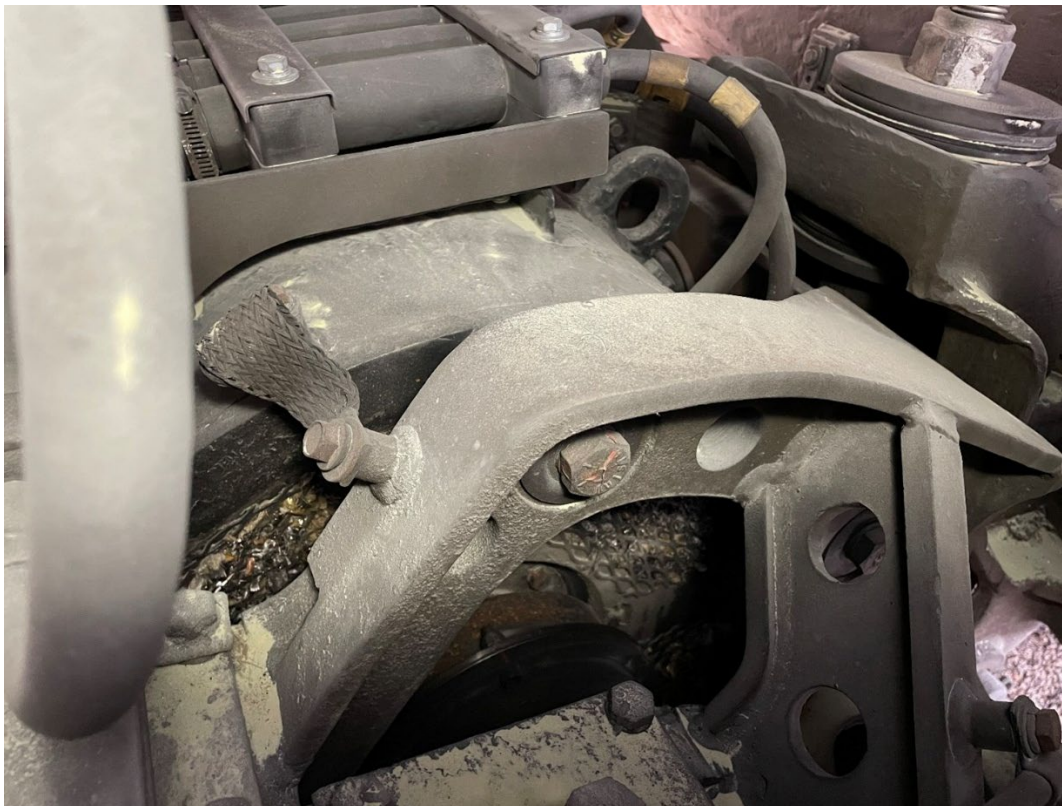
Figure 9: SEPTA Car 396 Traction Motor Close-up
