# National Transportation Safety Board

Office of Research and Engineering

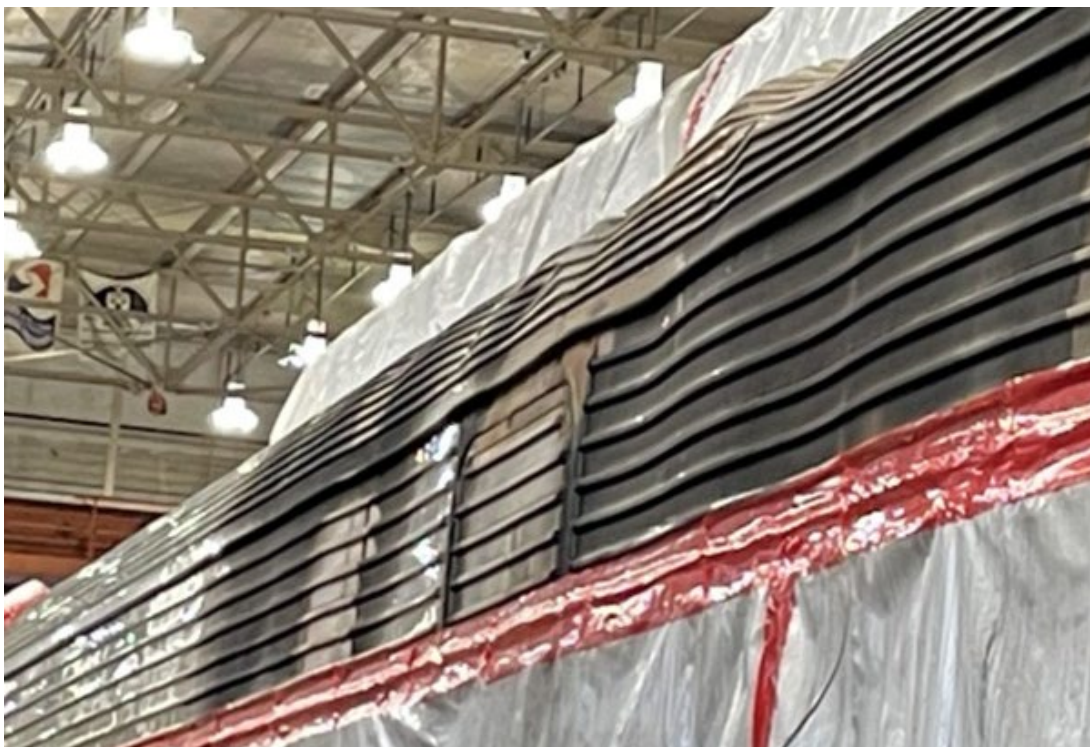
**Figure 5.** Roofline warping damage. (NTSB)

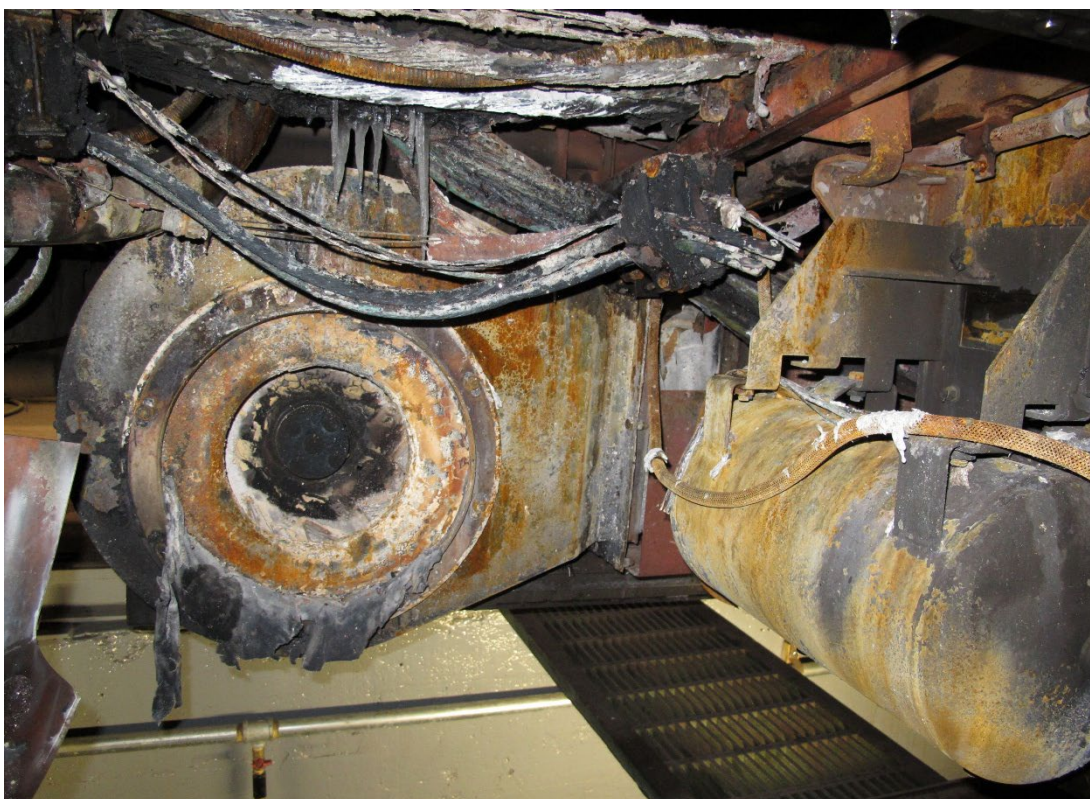
**Figure 6.** Undercarriage around the blowers. (NTSB)

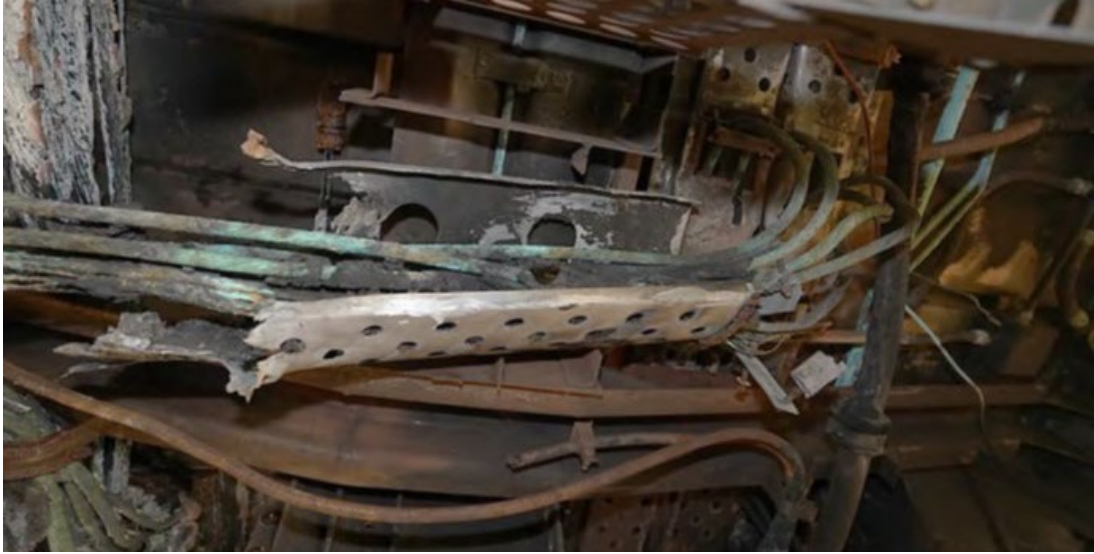
**Figure 7.** Thermal damage to aluminum cable trays. (SEPTA)

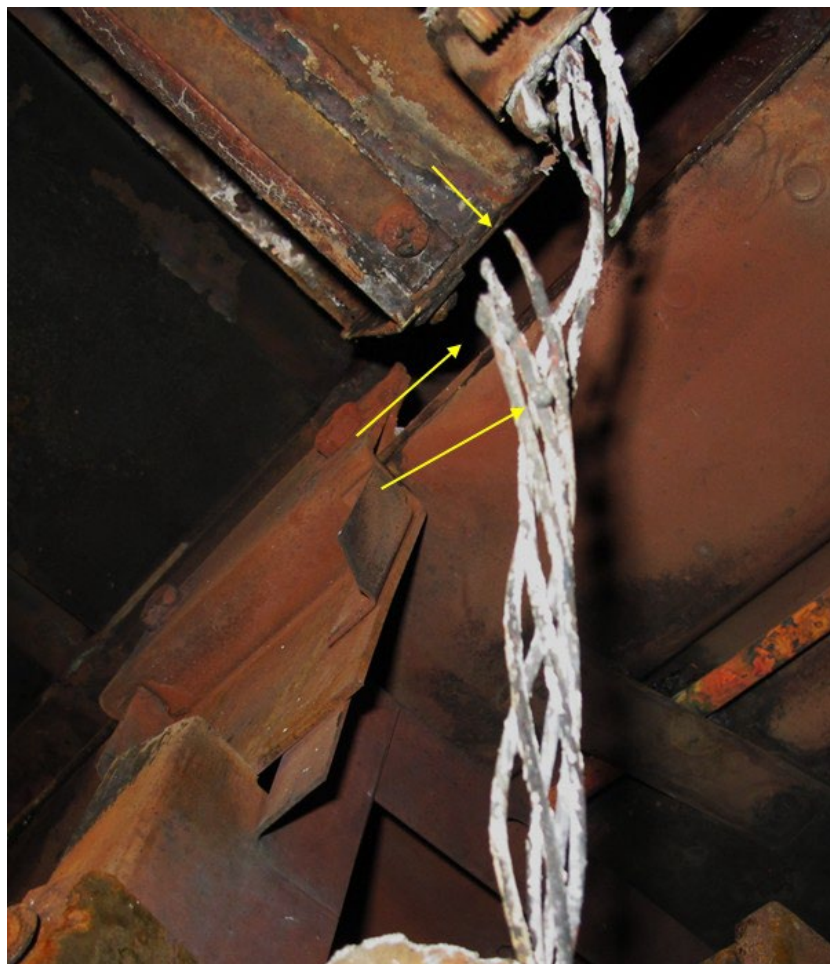
**Figure 8.** Beading (indicated by yellow arrows) on electrical conductor ends found on the left side of the undercarriage. (NTSB)

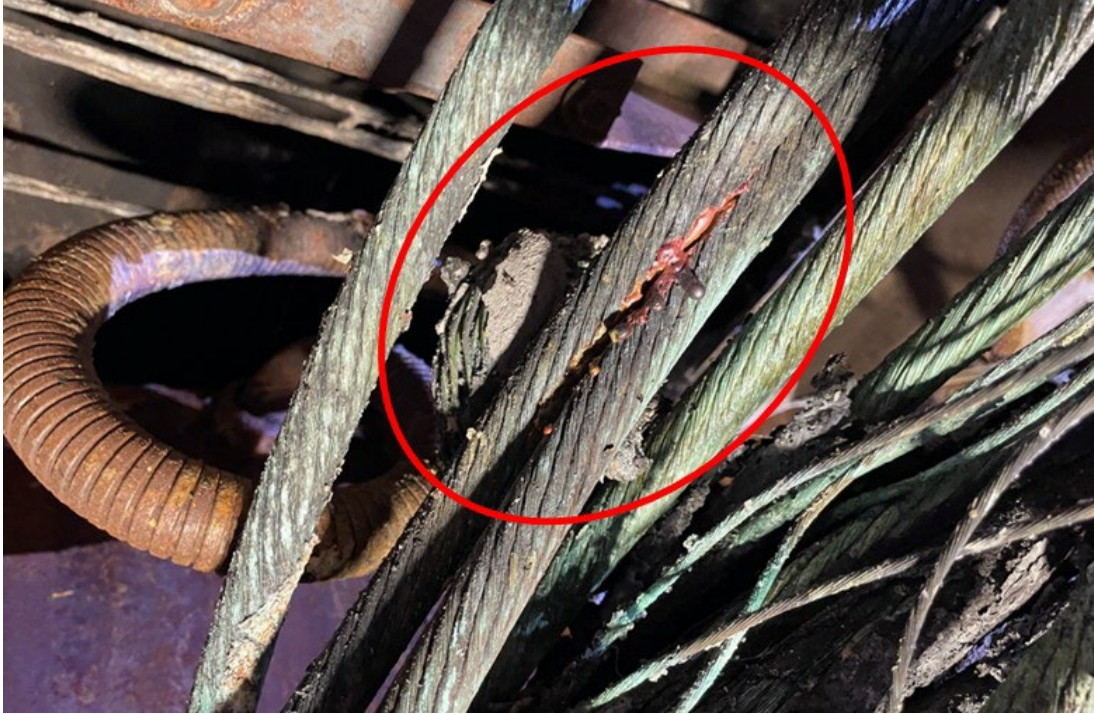
**Figure 9.** Arcing damage (circled in red) on the 31MD (motor #1 field winding) and 31MA (motor #1 armature winding) wires, found in an area aft of the intake to the double-end blower on the left side of the car. (NTSB)

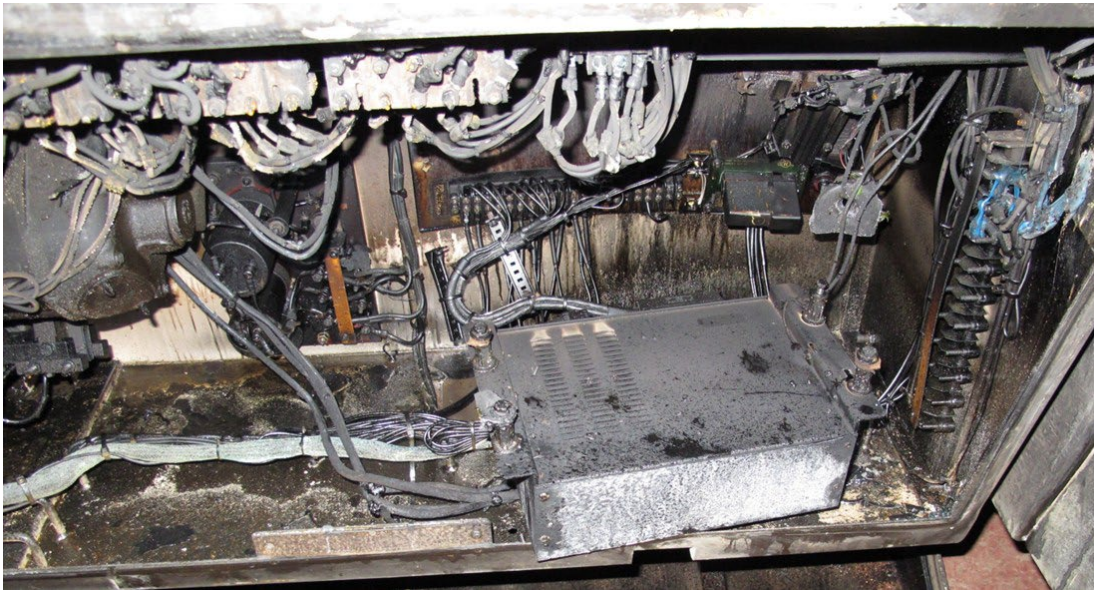
**Figure 10.** Thermal damage to adjacent control equipment. (NTSB)

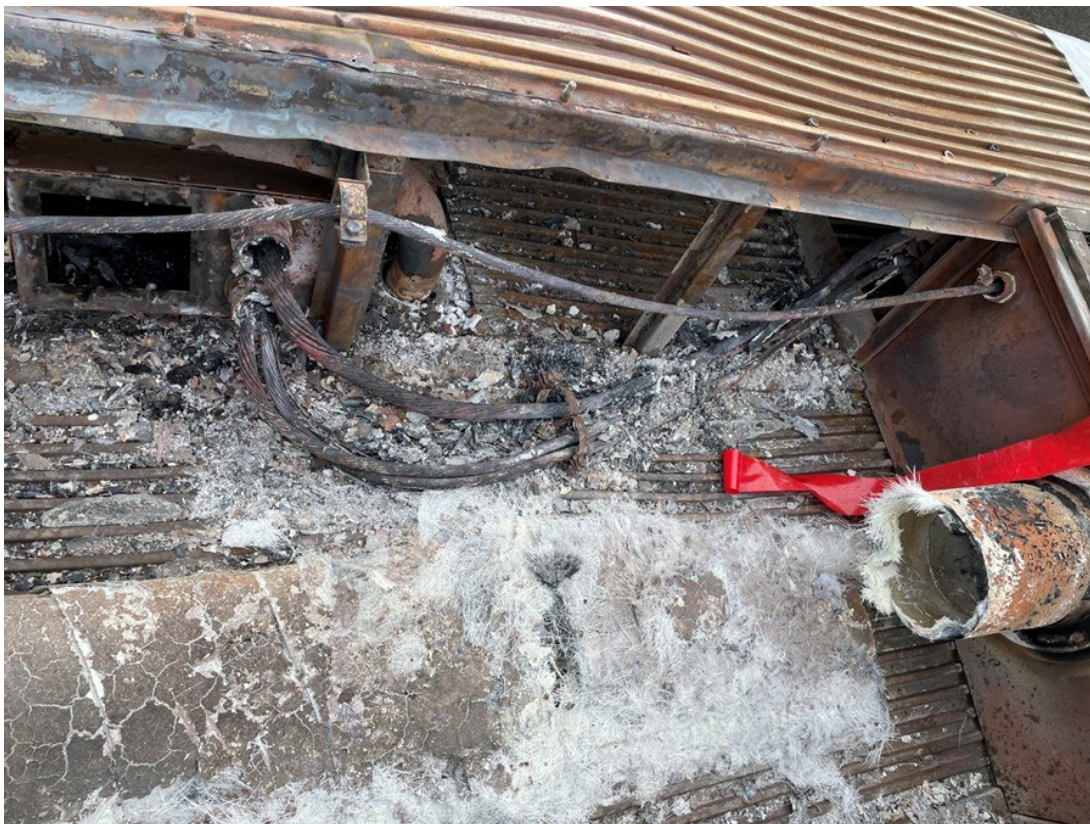
**Figure 11.** Damage to ducting and wiring found on the roof of Car 132. (FRA)

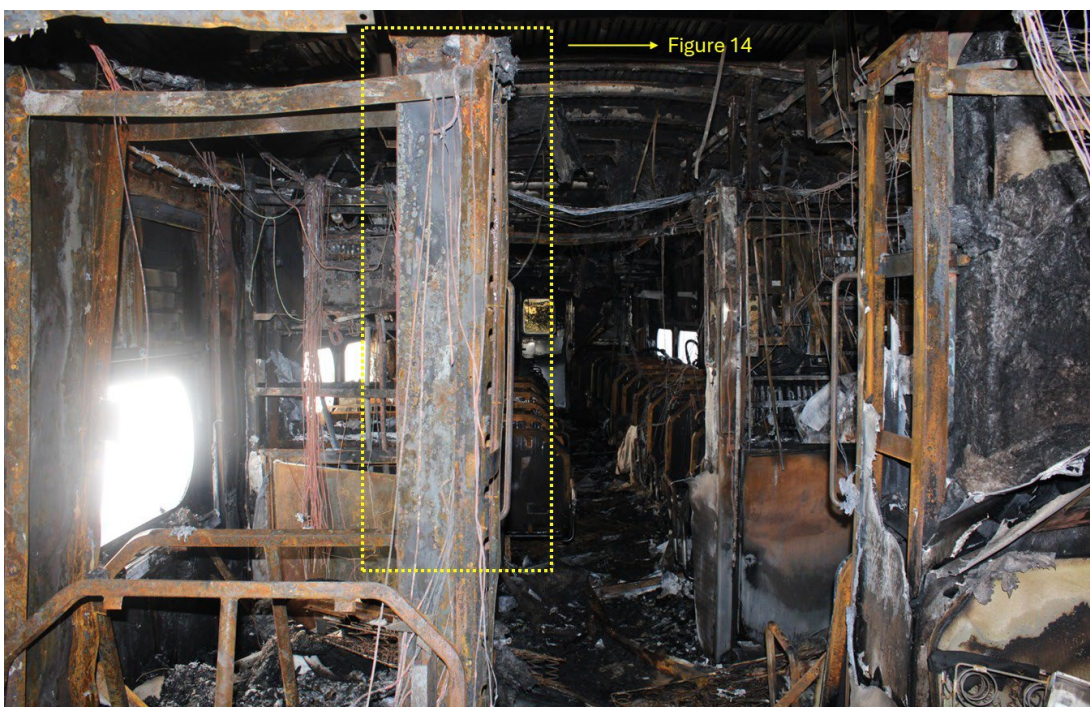
**Figure 12.** Damage to interior of Car 132 approximately centerline (facing forward). (NTSB)

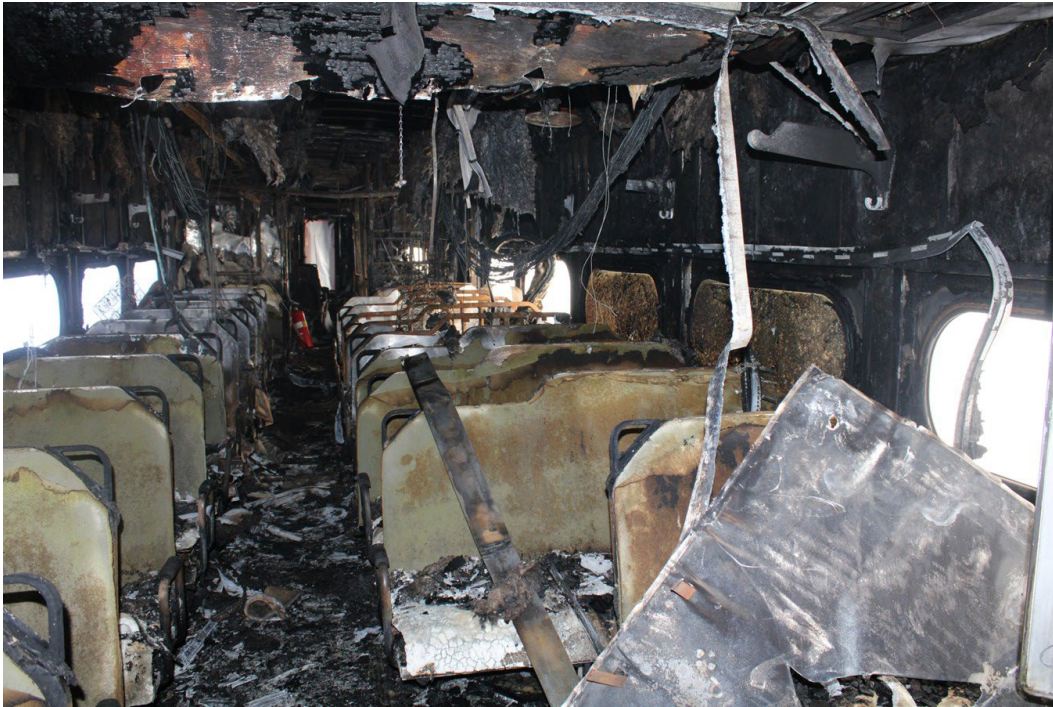
**Figure 13.** Damage to interior of Car 132 approximately centerline (facing forward). (NTSB)

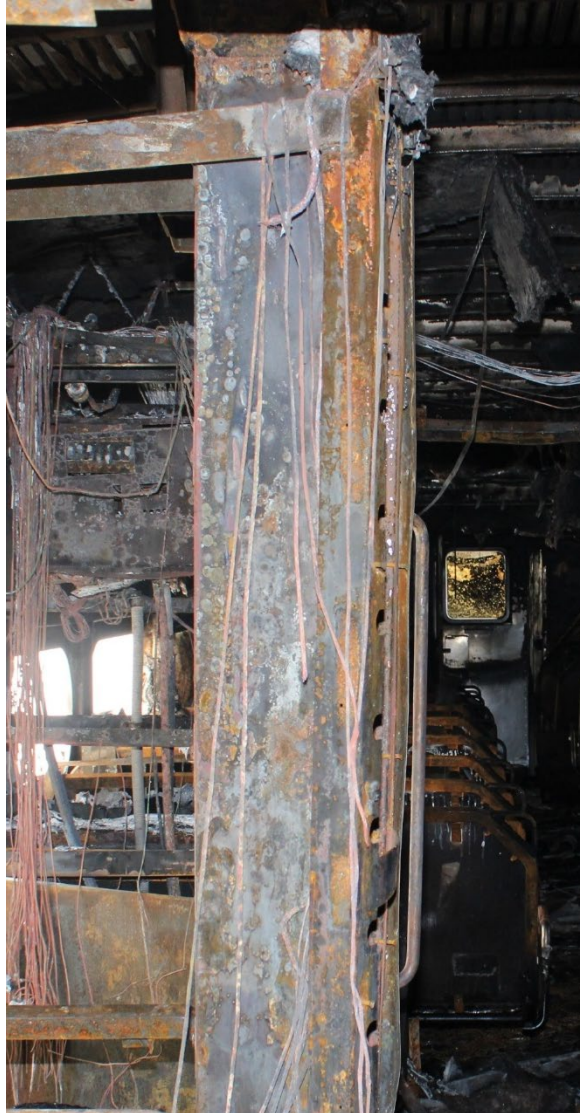
**Figure 14.** Thermal damage to power cable cabinet (location in car shown in Figure 12). (NTSB)

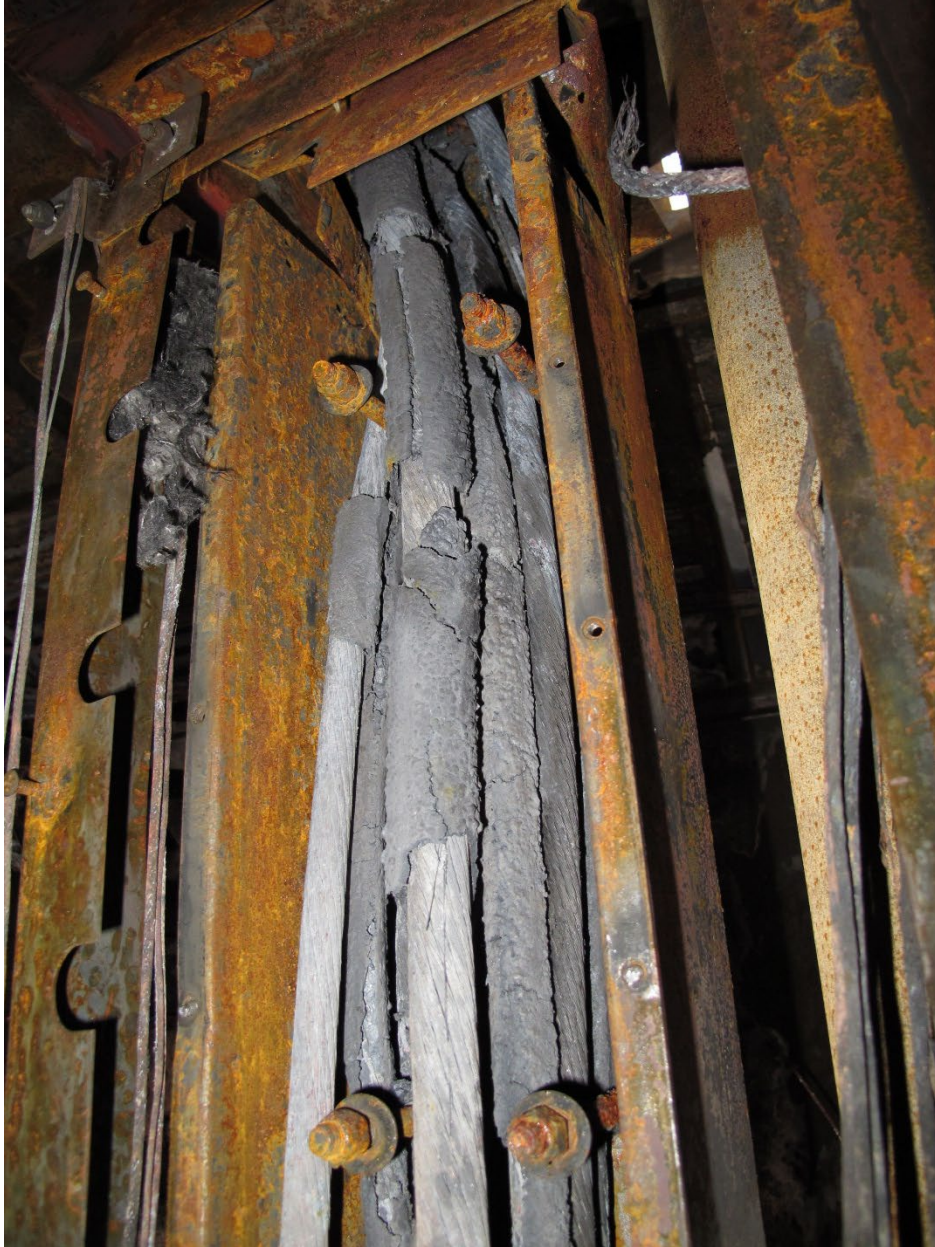
**Figure 15.** Electrical cabling found within power cable cabinet shown in Figure 14.  
(NTSB)

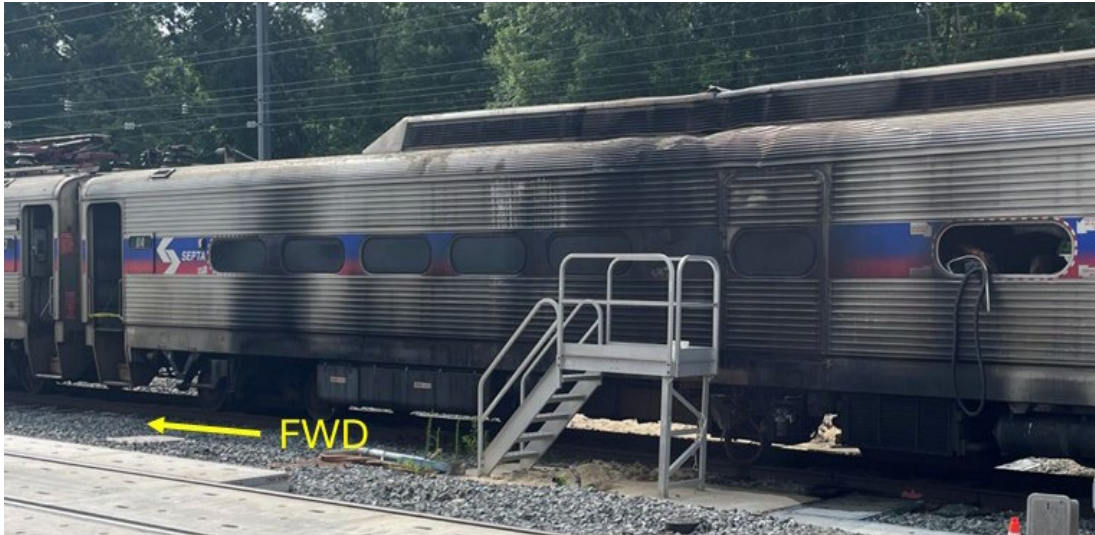
**Figure 16.** Left side of Car 114. (NTSB)

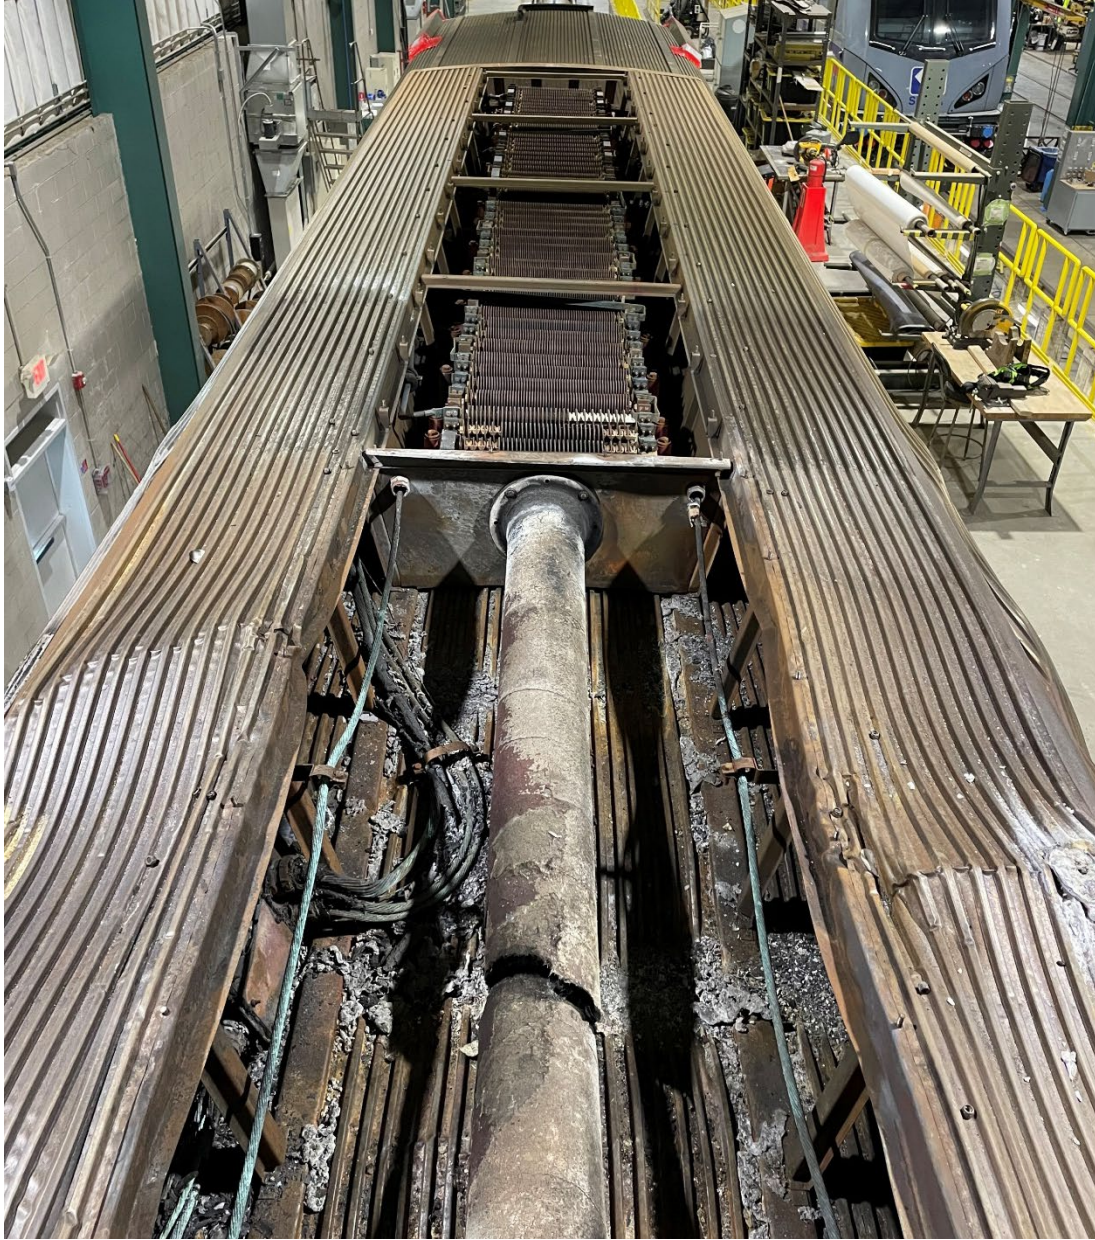
**Figure 18.** Rooftop damage to Car 114. (NTSB)

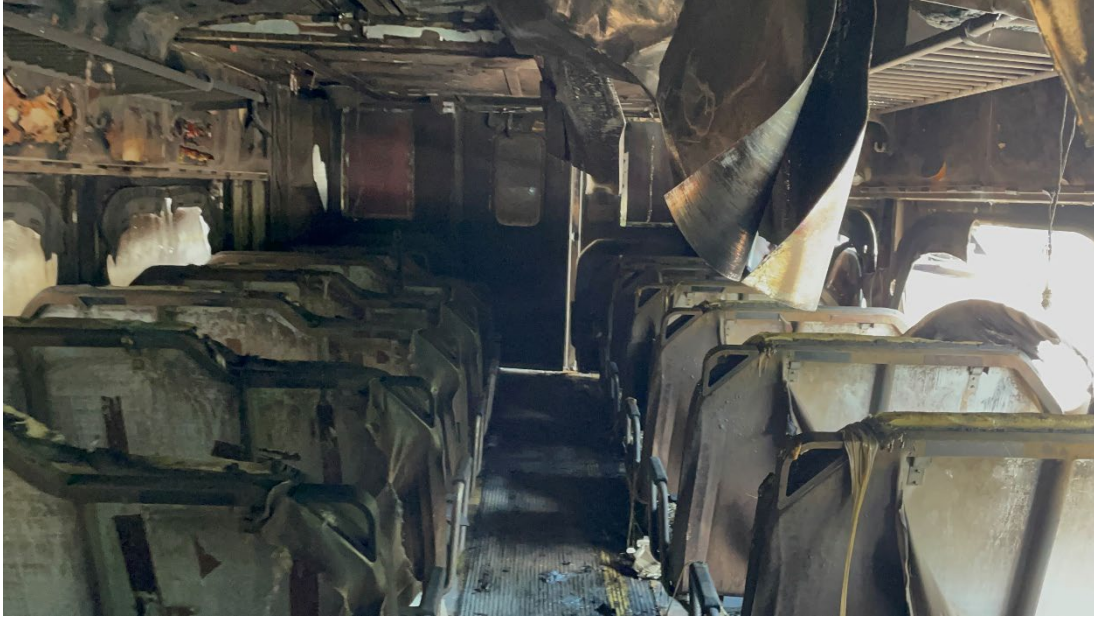
**Figure 19.** Interior damage to Car 114 (facing forward). (NTSB)

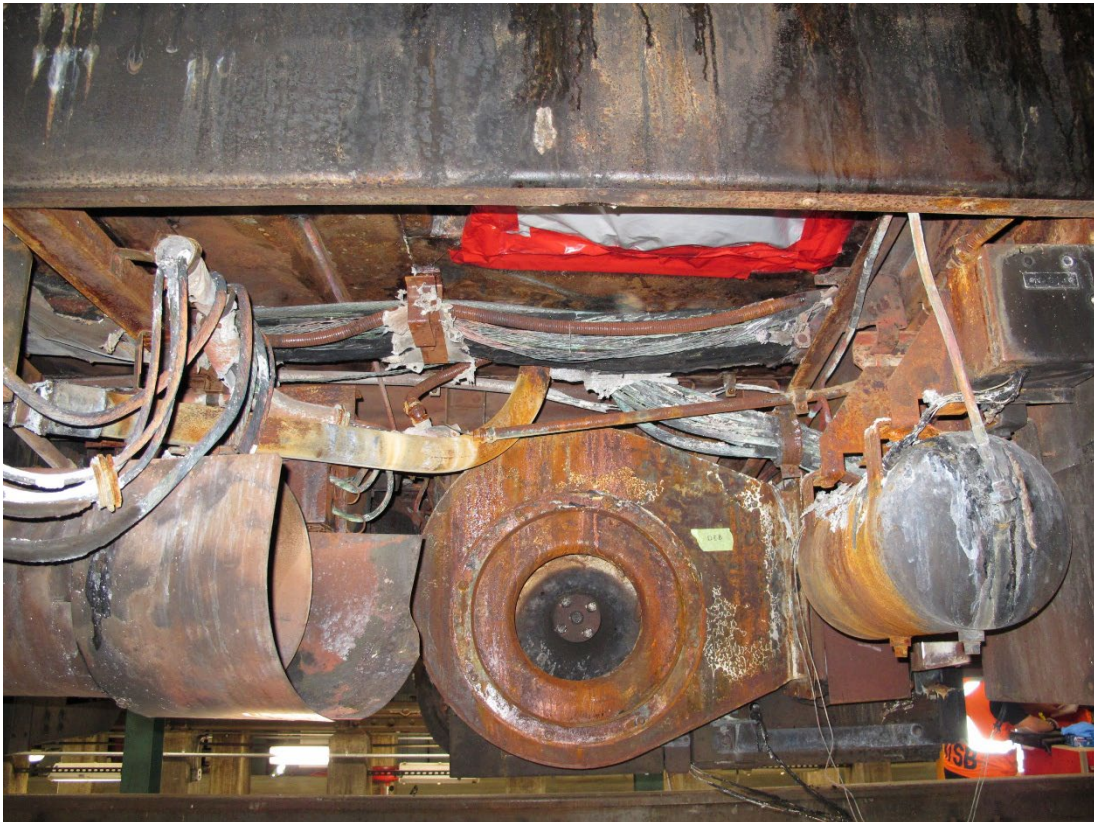
**Figure 20.** Thermal damage to undercarriage approximately centerline. (NTSB)

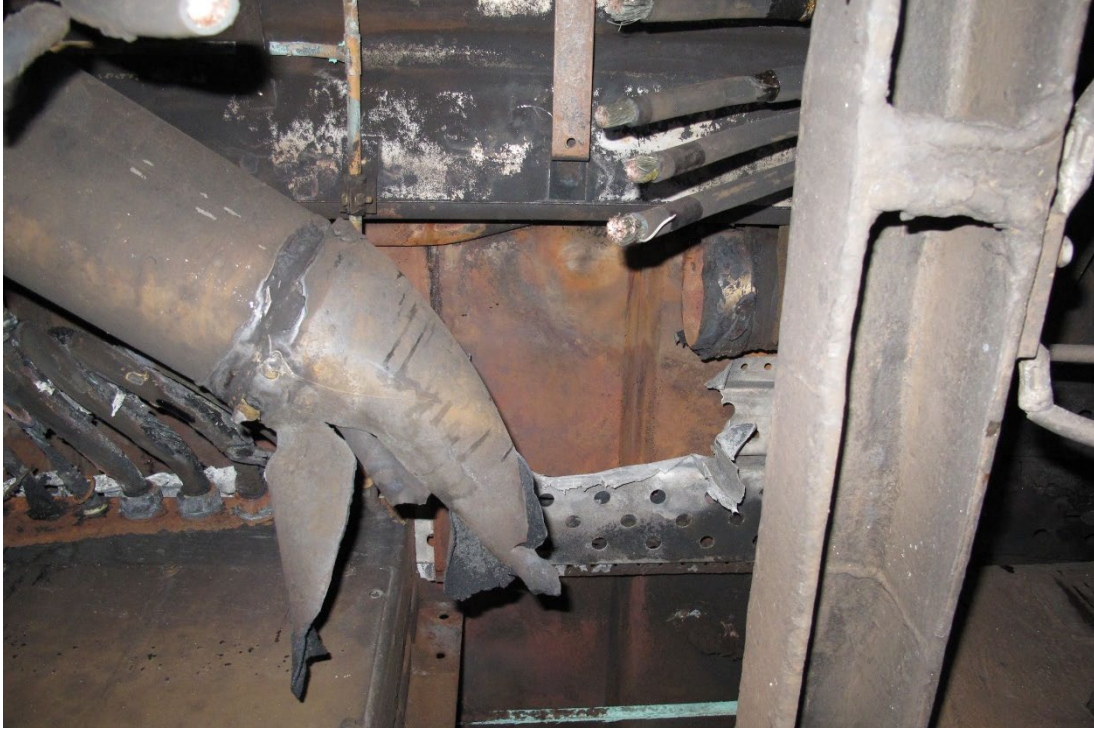
**Figure 21.** Thermal damage to polymeric and aluminum components found in the undercarriage approximately centerline. (NTSB)

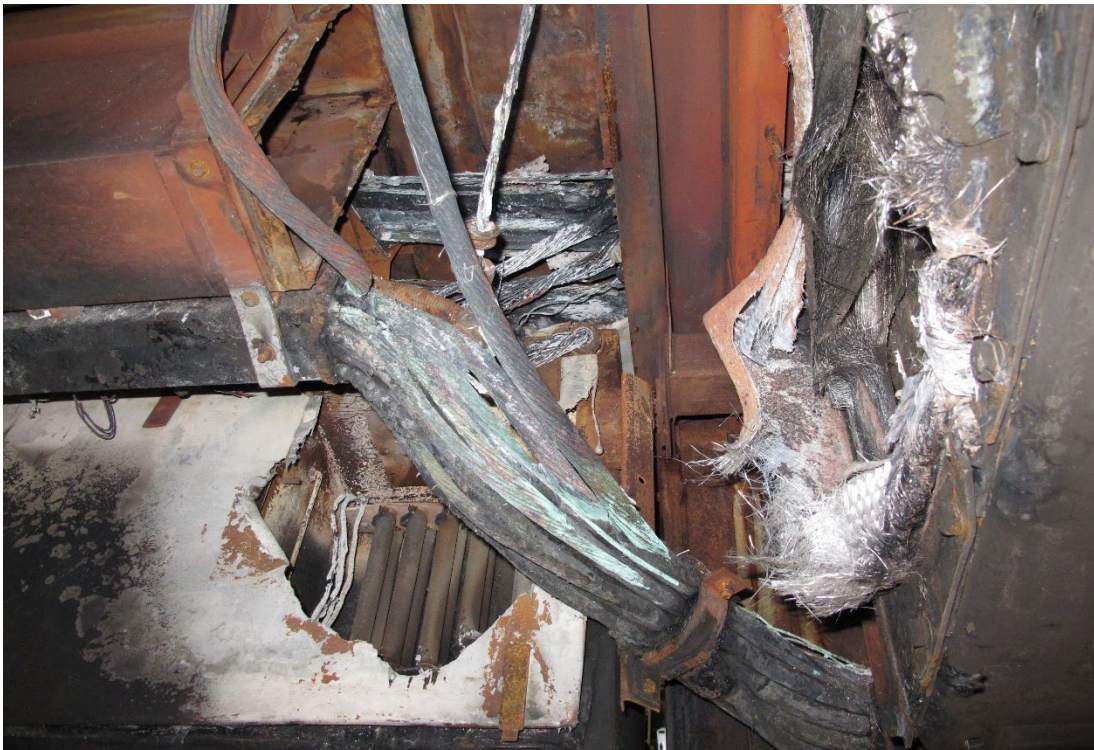
**Figure 22.** Section of thermal damage to wiring underneath Car 114.

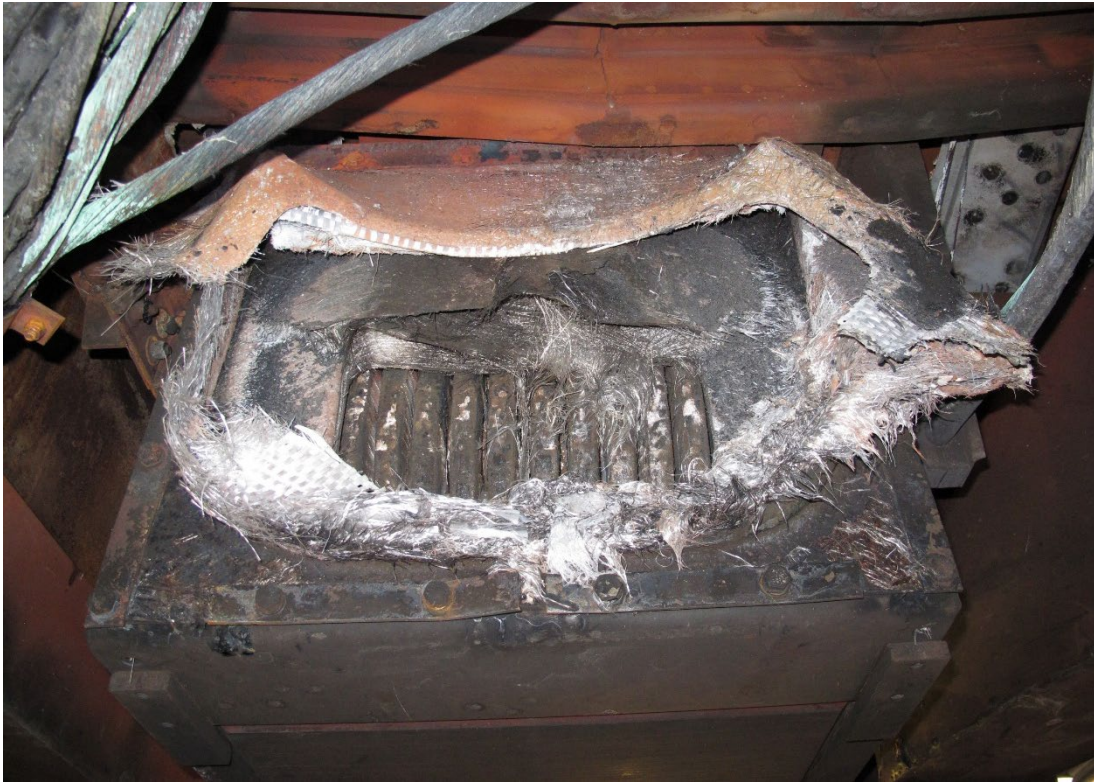
**Figure 23.** Damage to smoothing reactor cooling coil insulation. (NTSB)
