Failure Analysis Report Main Smoothing reactors 9/3/2025

We visited the SEPTA Overbrook facility on Wednesday September 3rd to inspect two GE manufactured Main Smoothing reactors (EX54) that had been exposed to fire damage.

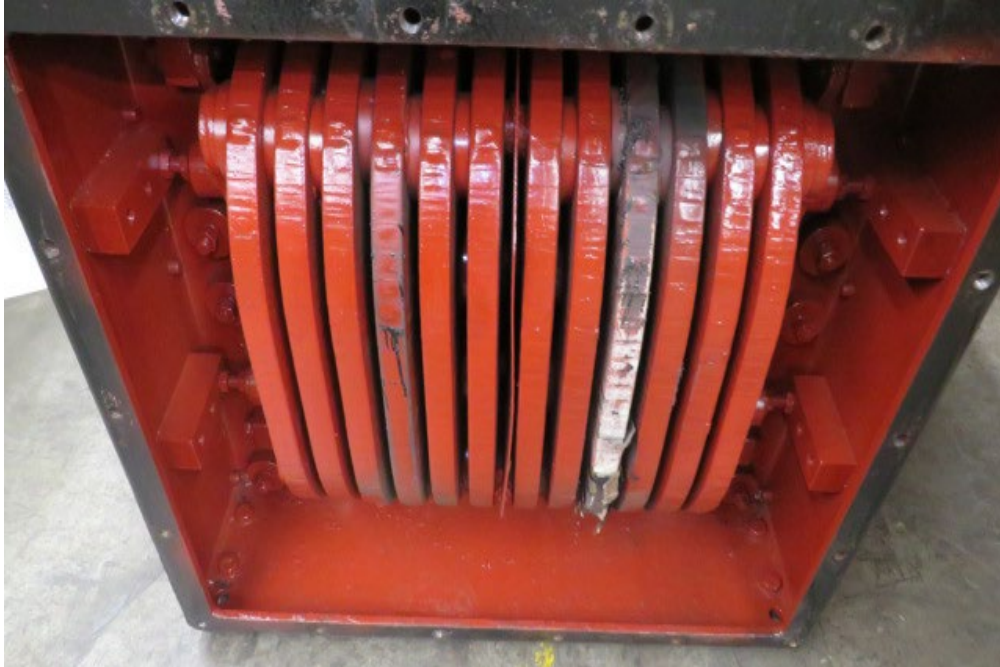
From our 15-year repair history of these units, we have found the main reason for failure of these reactors is when the interturn insulation between the copper conductors starts to break down. This creates short circuits and subsequent overheating in the coil itself. If the reactor remains in operation at this point, the coil will eventually burn itself out and the adjacent coils will also begin to fail. Ideally, the reactor is taken out of service at this point and shipped to us. Then we see a reactor with one of the 12 coils obviously burnt, with darkened and burnt insulation while the other 11 coils are visually undamaged. (see a sample picture below for an example)
