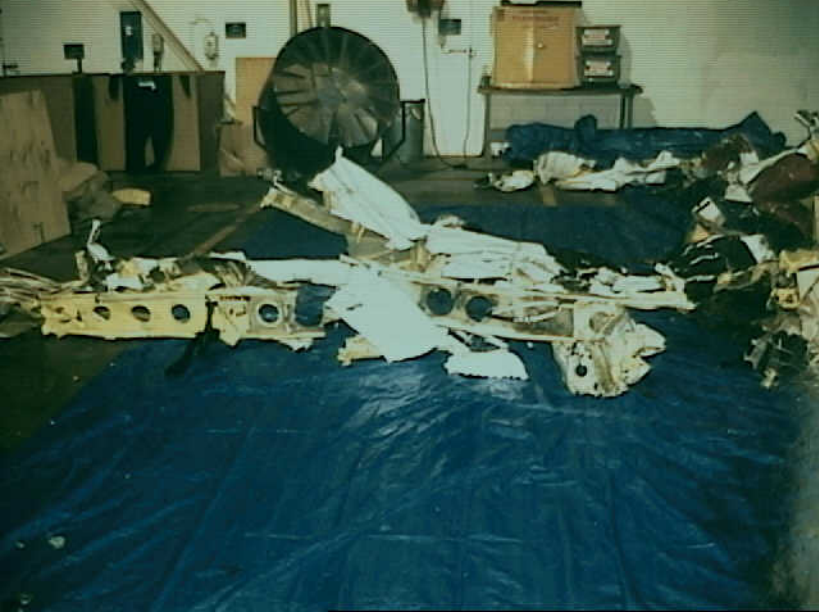
Airworthiness - Photo 4. Close-up view of the outboard portion of the right wing (view from forward looking aft). Note aftward accordion crush damage of the leading edge skin. (NTSB-C13)
