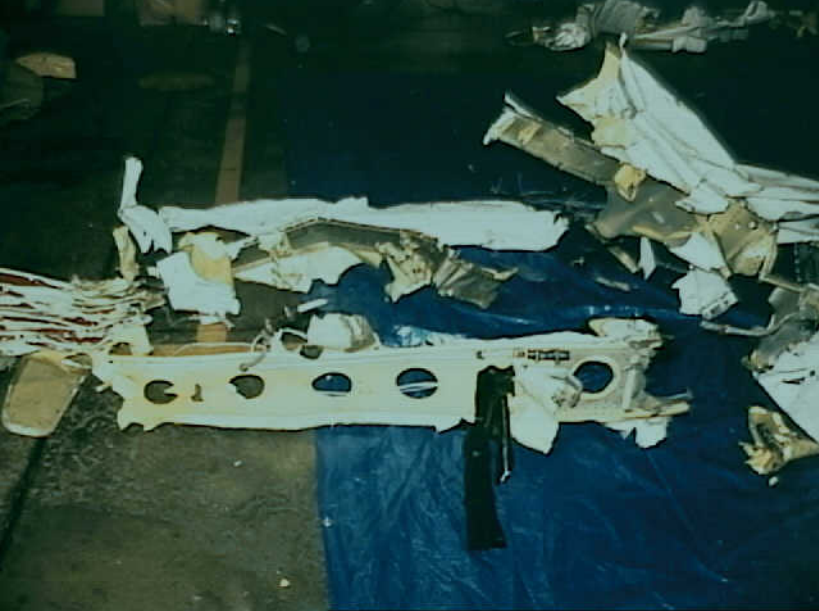
Airworthiness - Photo 5. View of the inboard section of the right wing (view from aft looking forward). Note damage to main spar (background). Also note entire left flap (foreground) and lack of bulging or bowing
