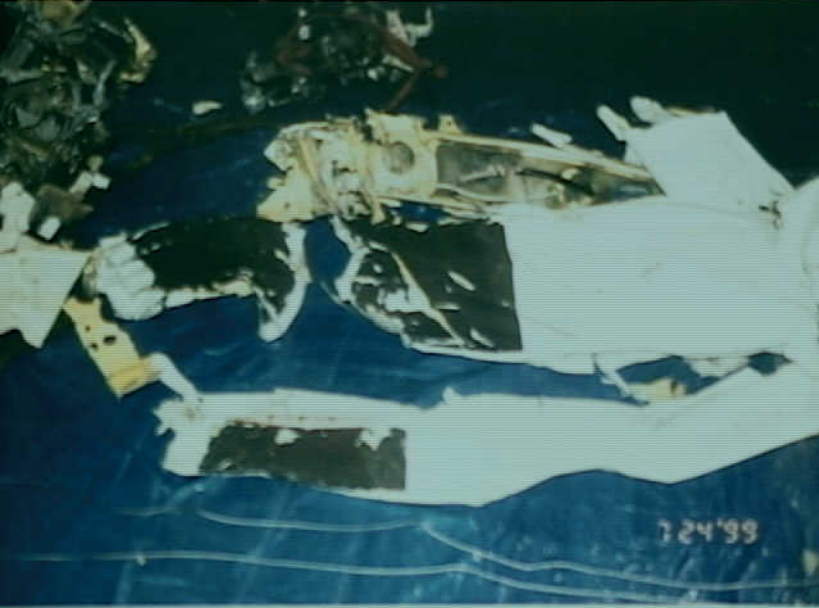
Airworthiness - Photo 6. View off the inboard section of the right wing (view from forward looking aft). Note damage to main spar and the 90-degree forward bend (foreground) (NTSB-C14)
