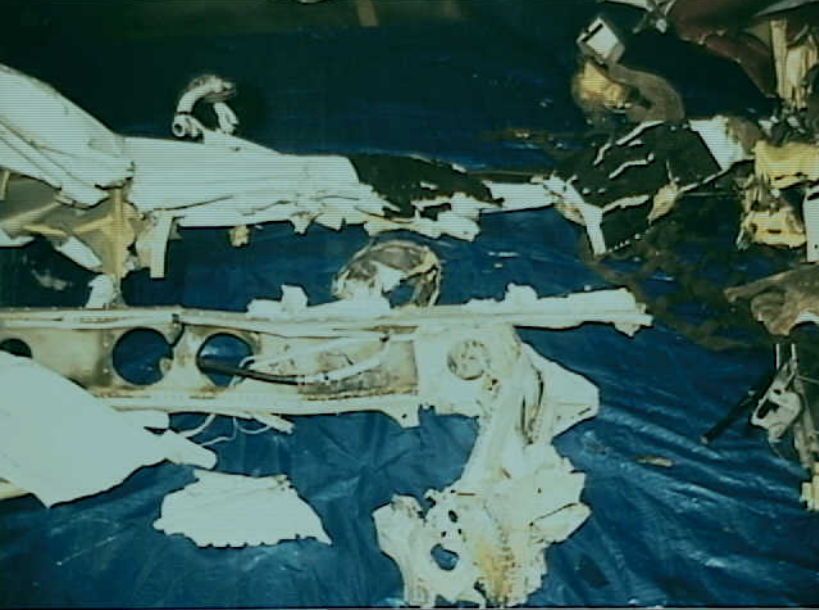
Airworthiness - Photo 7. Close-up view of the right wing spar area near 90-degree forward bend. Right main landing gear trunion (shown in foreground) is normally installed in this area. Note damage to the spar web in this area. (NTSB-I22)
