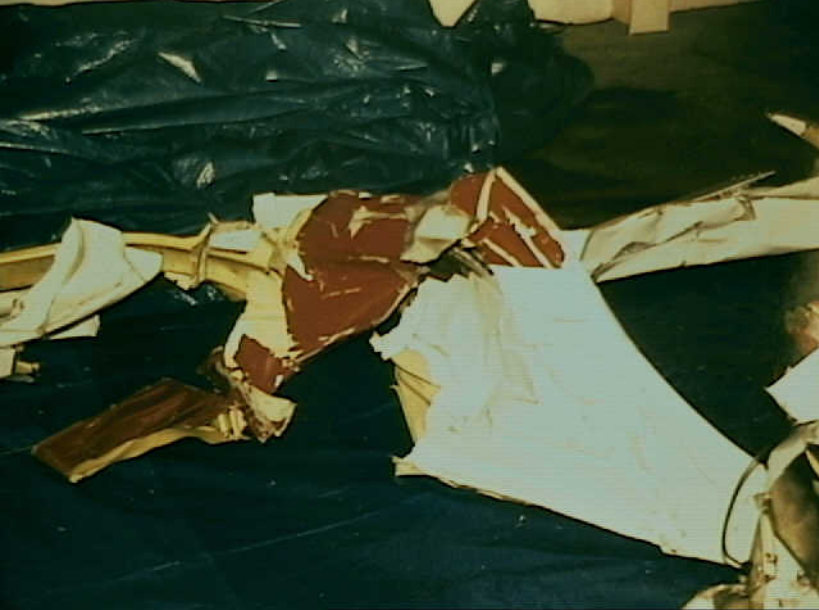
Airworthiness - Photo 14. View of stabilator damage and upper structure of mating tail cone (denoted by arrow). Note bowing deformation of the tail cone and the rudder adjacent to it, and impact damage of the left stabilator. (NTSB-B10)
