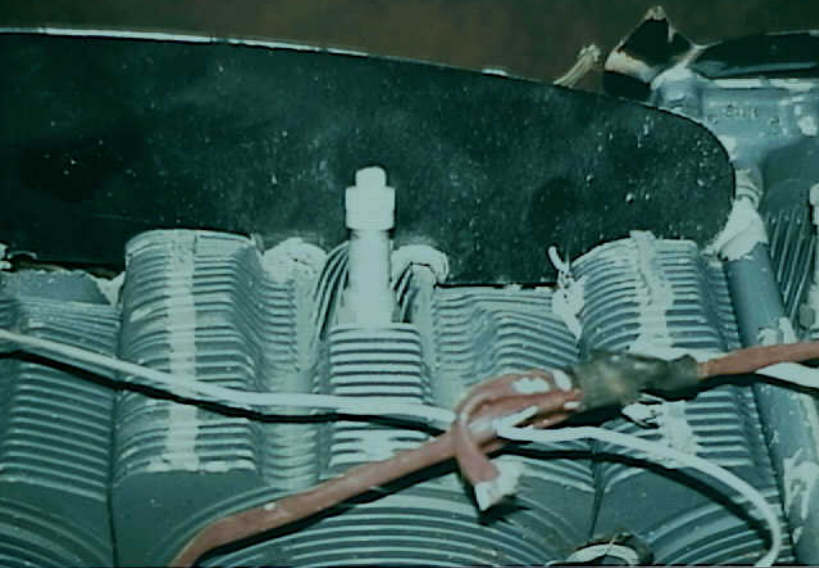
Airworthiness - Photo 28. Close-up view of the top of the no. 1 cylinder head section (view looking inboard) with propeller blade no. 1 resting next to it. Note consistent locations of blade damage with the cylinder damage. (NTSB-AA)
