# NATIONAL TRANSPORTATION SAFETY BOARD

MATERIALS LABORATORY FACTUAL REPORT

Report No. 10-103

Place : Grey Summit, Missouri  
Date : August 2, 2010  
Vehicle : 2007 Volvo Truck Tractor  
NTSB No. : HWY10MH018  
Investigator : Jennifer Morrison  
NTSB-OHS

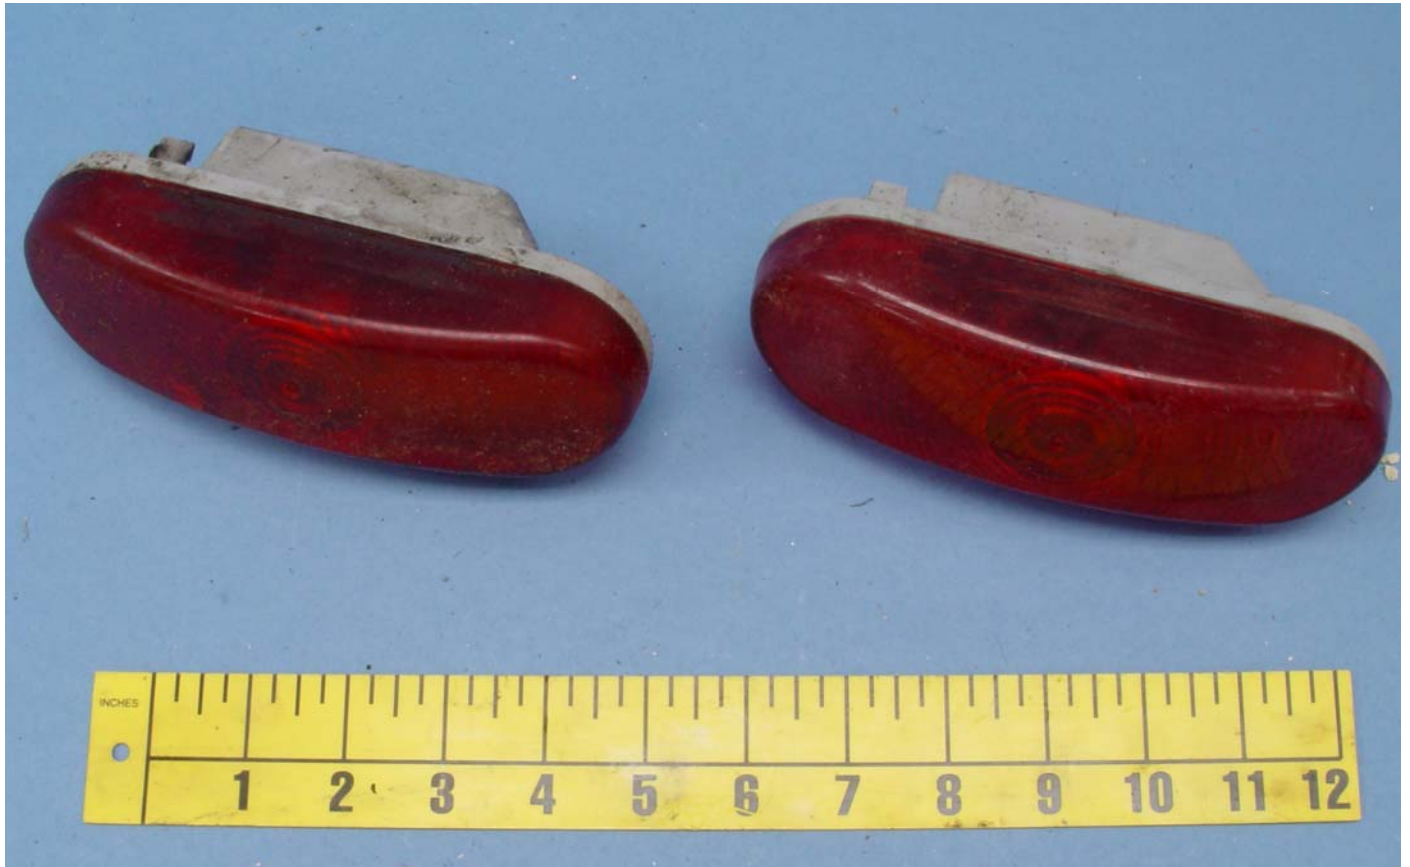
Two brake lights, shown in Figure 1, were submitted to the NTSB Materials Laboratory to determine if there was hot stretching relaxation of the coils in the filaments of the light bulbs. The lights were labeled Light #1 and Light #2 randomly by the analyst. The filament for Light #1 is shown in Figure 2 and the filament for Light #2. The filaments of both light bulbs showed no evidence of hot stretching of the filament coils.

**Figure 1. Overall picture of brake lights**

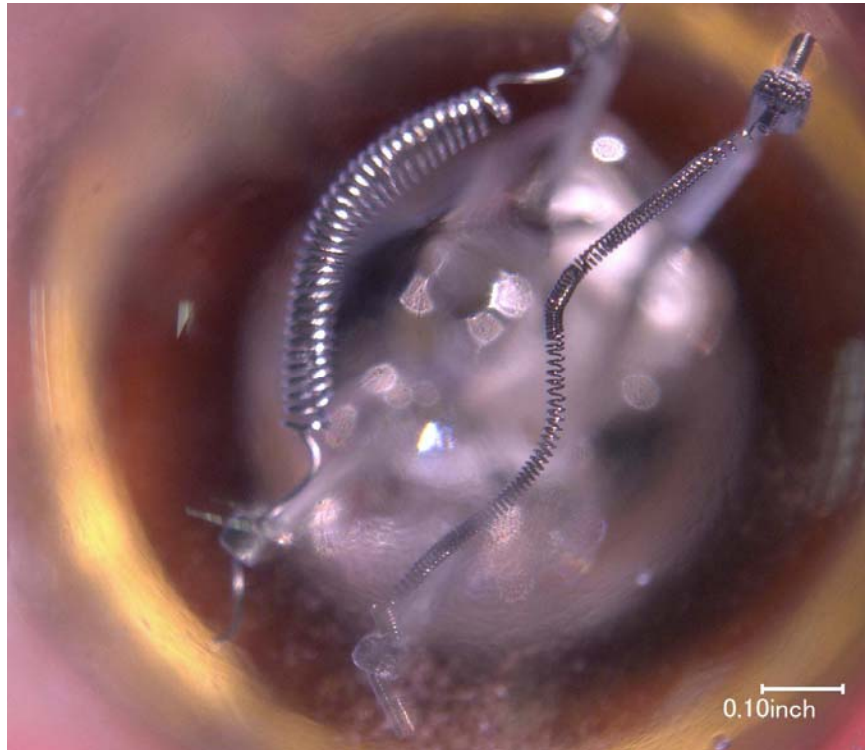
**Figure 2. Filament of Light #1**

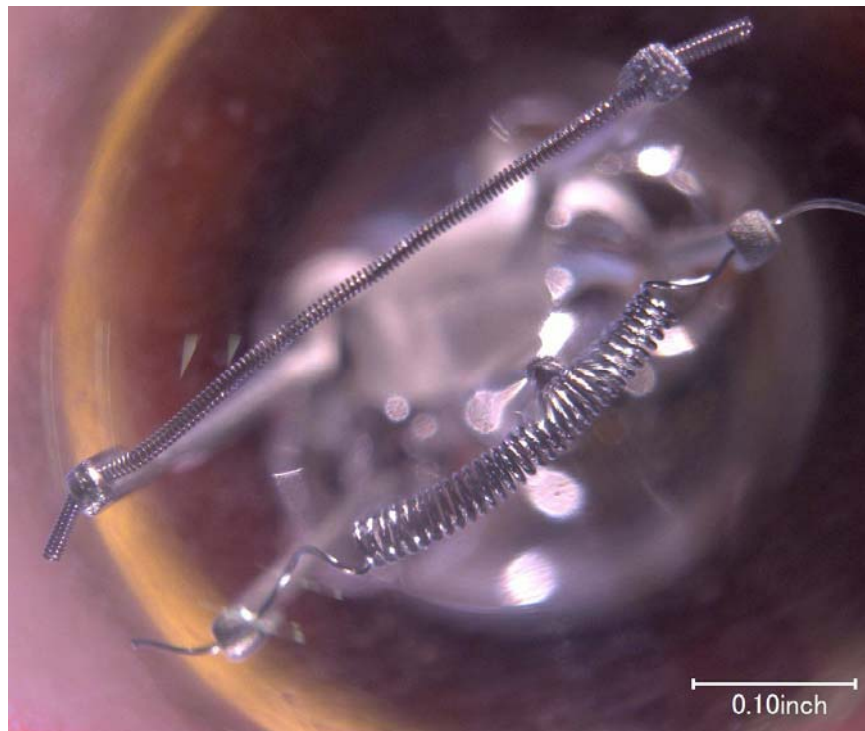
**Figure 3. Filament of Light #2**
