# NATIONAL TRANSPORTATION SAFETY BOARD

MATERIALS LABORATORY FACTUAL REPORT

Report No. 11-006

Place : Gray Summit, Missouri  
Date : August 5, 2010  
Vehicle : 2003 Blue Bird school bus  
NTSB No. : HWY10MH018  
Investigator : Jennifer Morrison  
HS-20

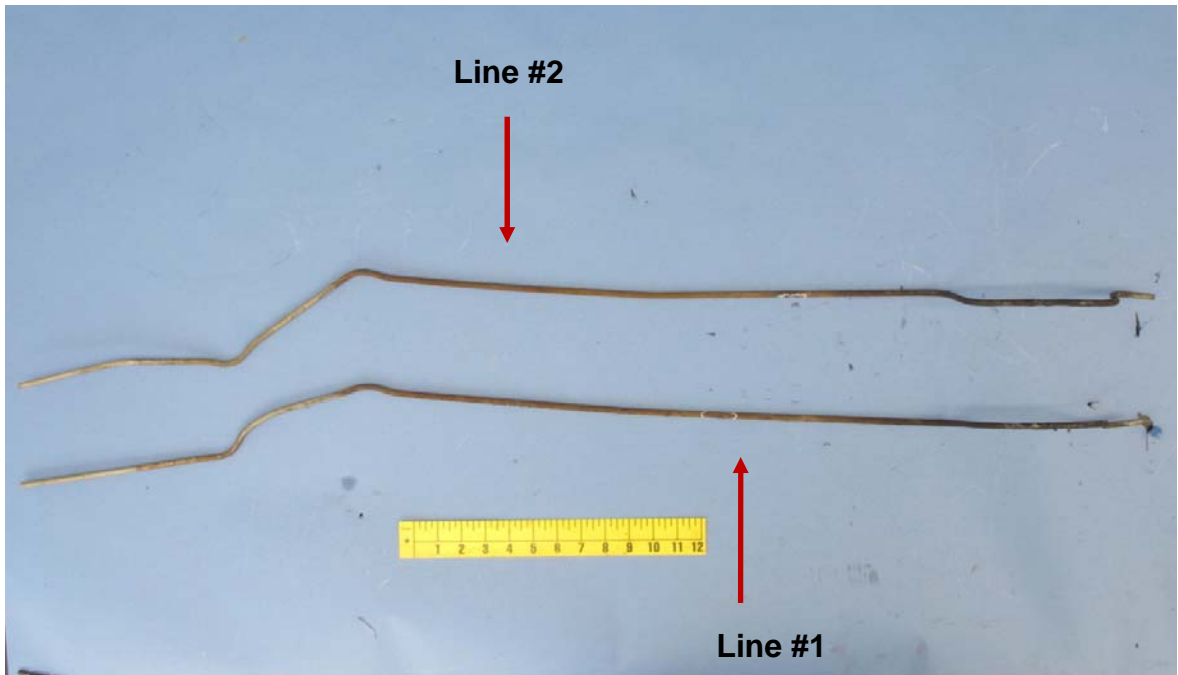
Two hydraulic brake lines, found leaking upon inspection after the accident, were submitted for examination. The brake lines are shown in Figure 1. The lines were brazed; double wall low-carbon steel tubing<sup>1</sup>. X-ray fluorescence analysis determined the brake lines were zinc coated for corrosion protection. The lines did not have any unique identifiers so the lines were label Line #1 and Line #2 by the Material Laboratory examiner.

Figure 1. Overall photograph of Line #1 and Line #2.

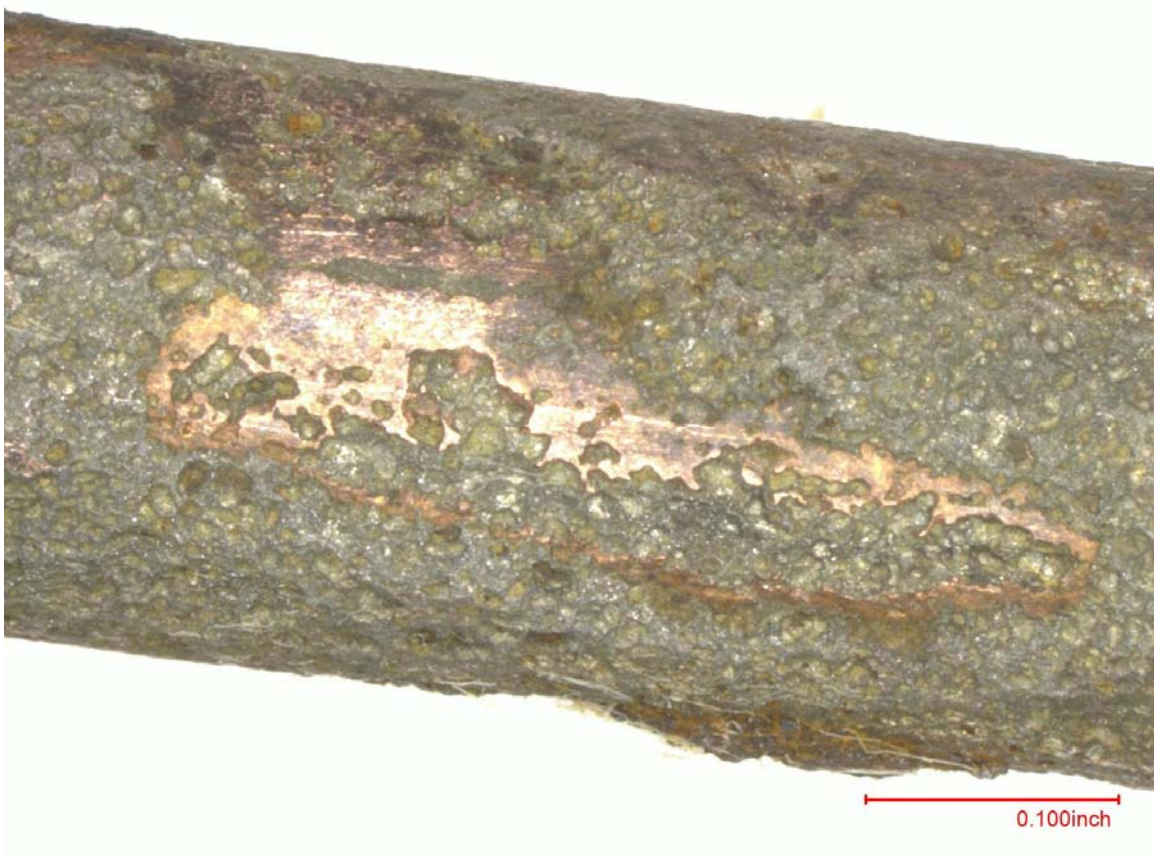
The visual examination of Line #1 found the exterior surface of the line to be discolored with several areas of loosely adhering corrosion scale. The corrosion scale was cleaned from the line in accordance with ASTM G1 designation C3.5 and then reexamined. It was determined that corrosion did not full penetrate wall thickness of the line; however, the copper brazing was exposed in several spots as shown in Figure 2.

Figure 2. Area with corrosion on Line #1.

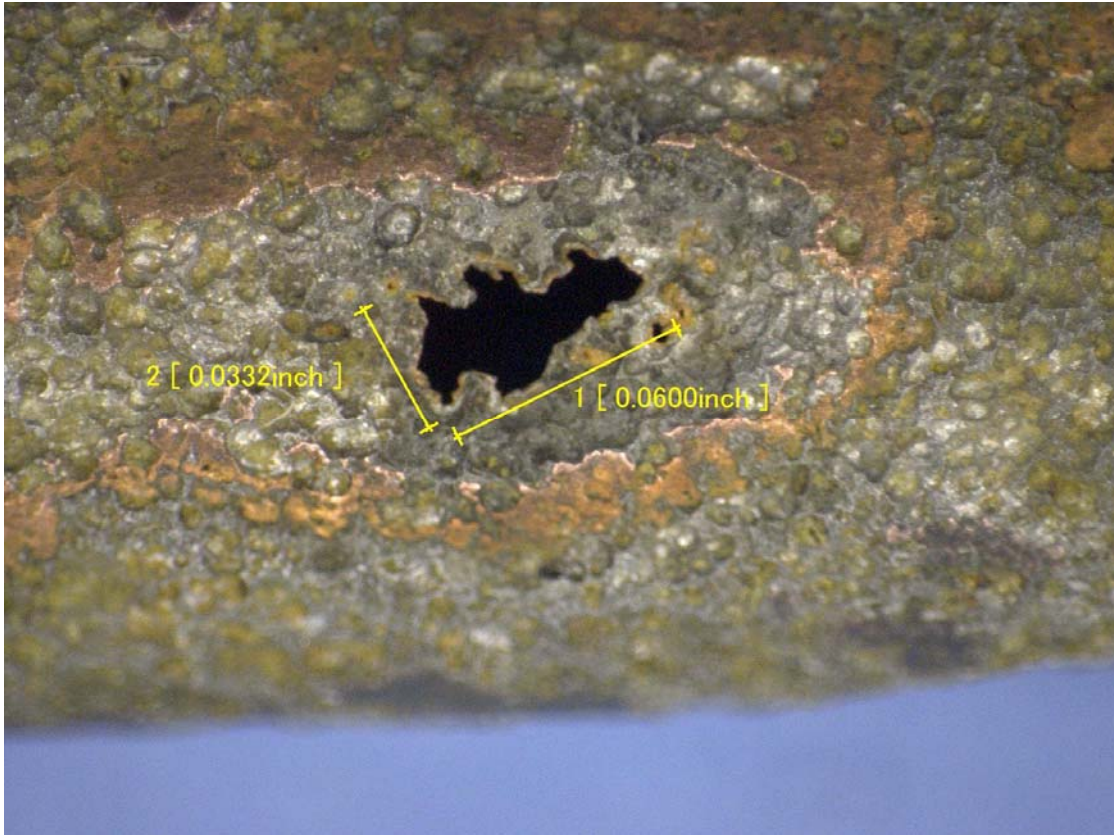
The visual examination of Line #2 found the exterior surface of the line to be discolored with several areas of loosely adhering corrosion scale similar to that found on Line #1. Visual examination revealed a full-penetration hole in the line due to corrosion. After the line was cleaned in accordance with ASTM G1-designation C.3.5, the hole in the line was measured and found to be 0.06 inch in length and 0.03 inch in width as shown in

Figure 3. Other areas of corrosion on Line #2 partially penetrated the line wall thickness exposing copper brazing similar to that found on Line #1.

**Figure 3. Hole in Line #2.**
