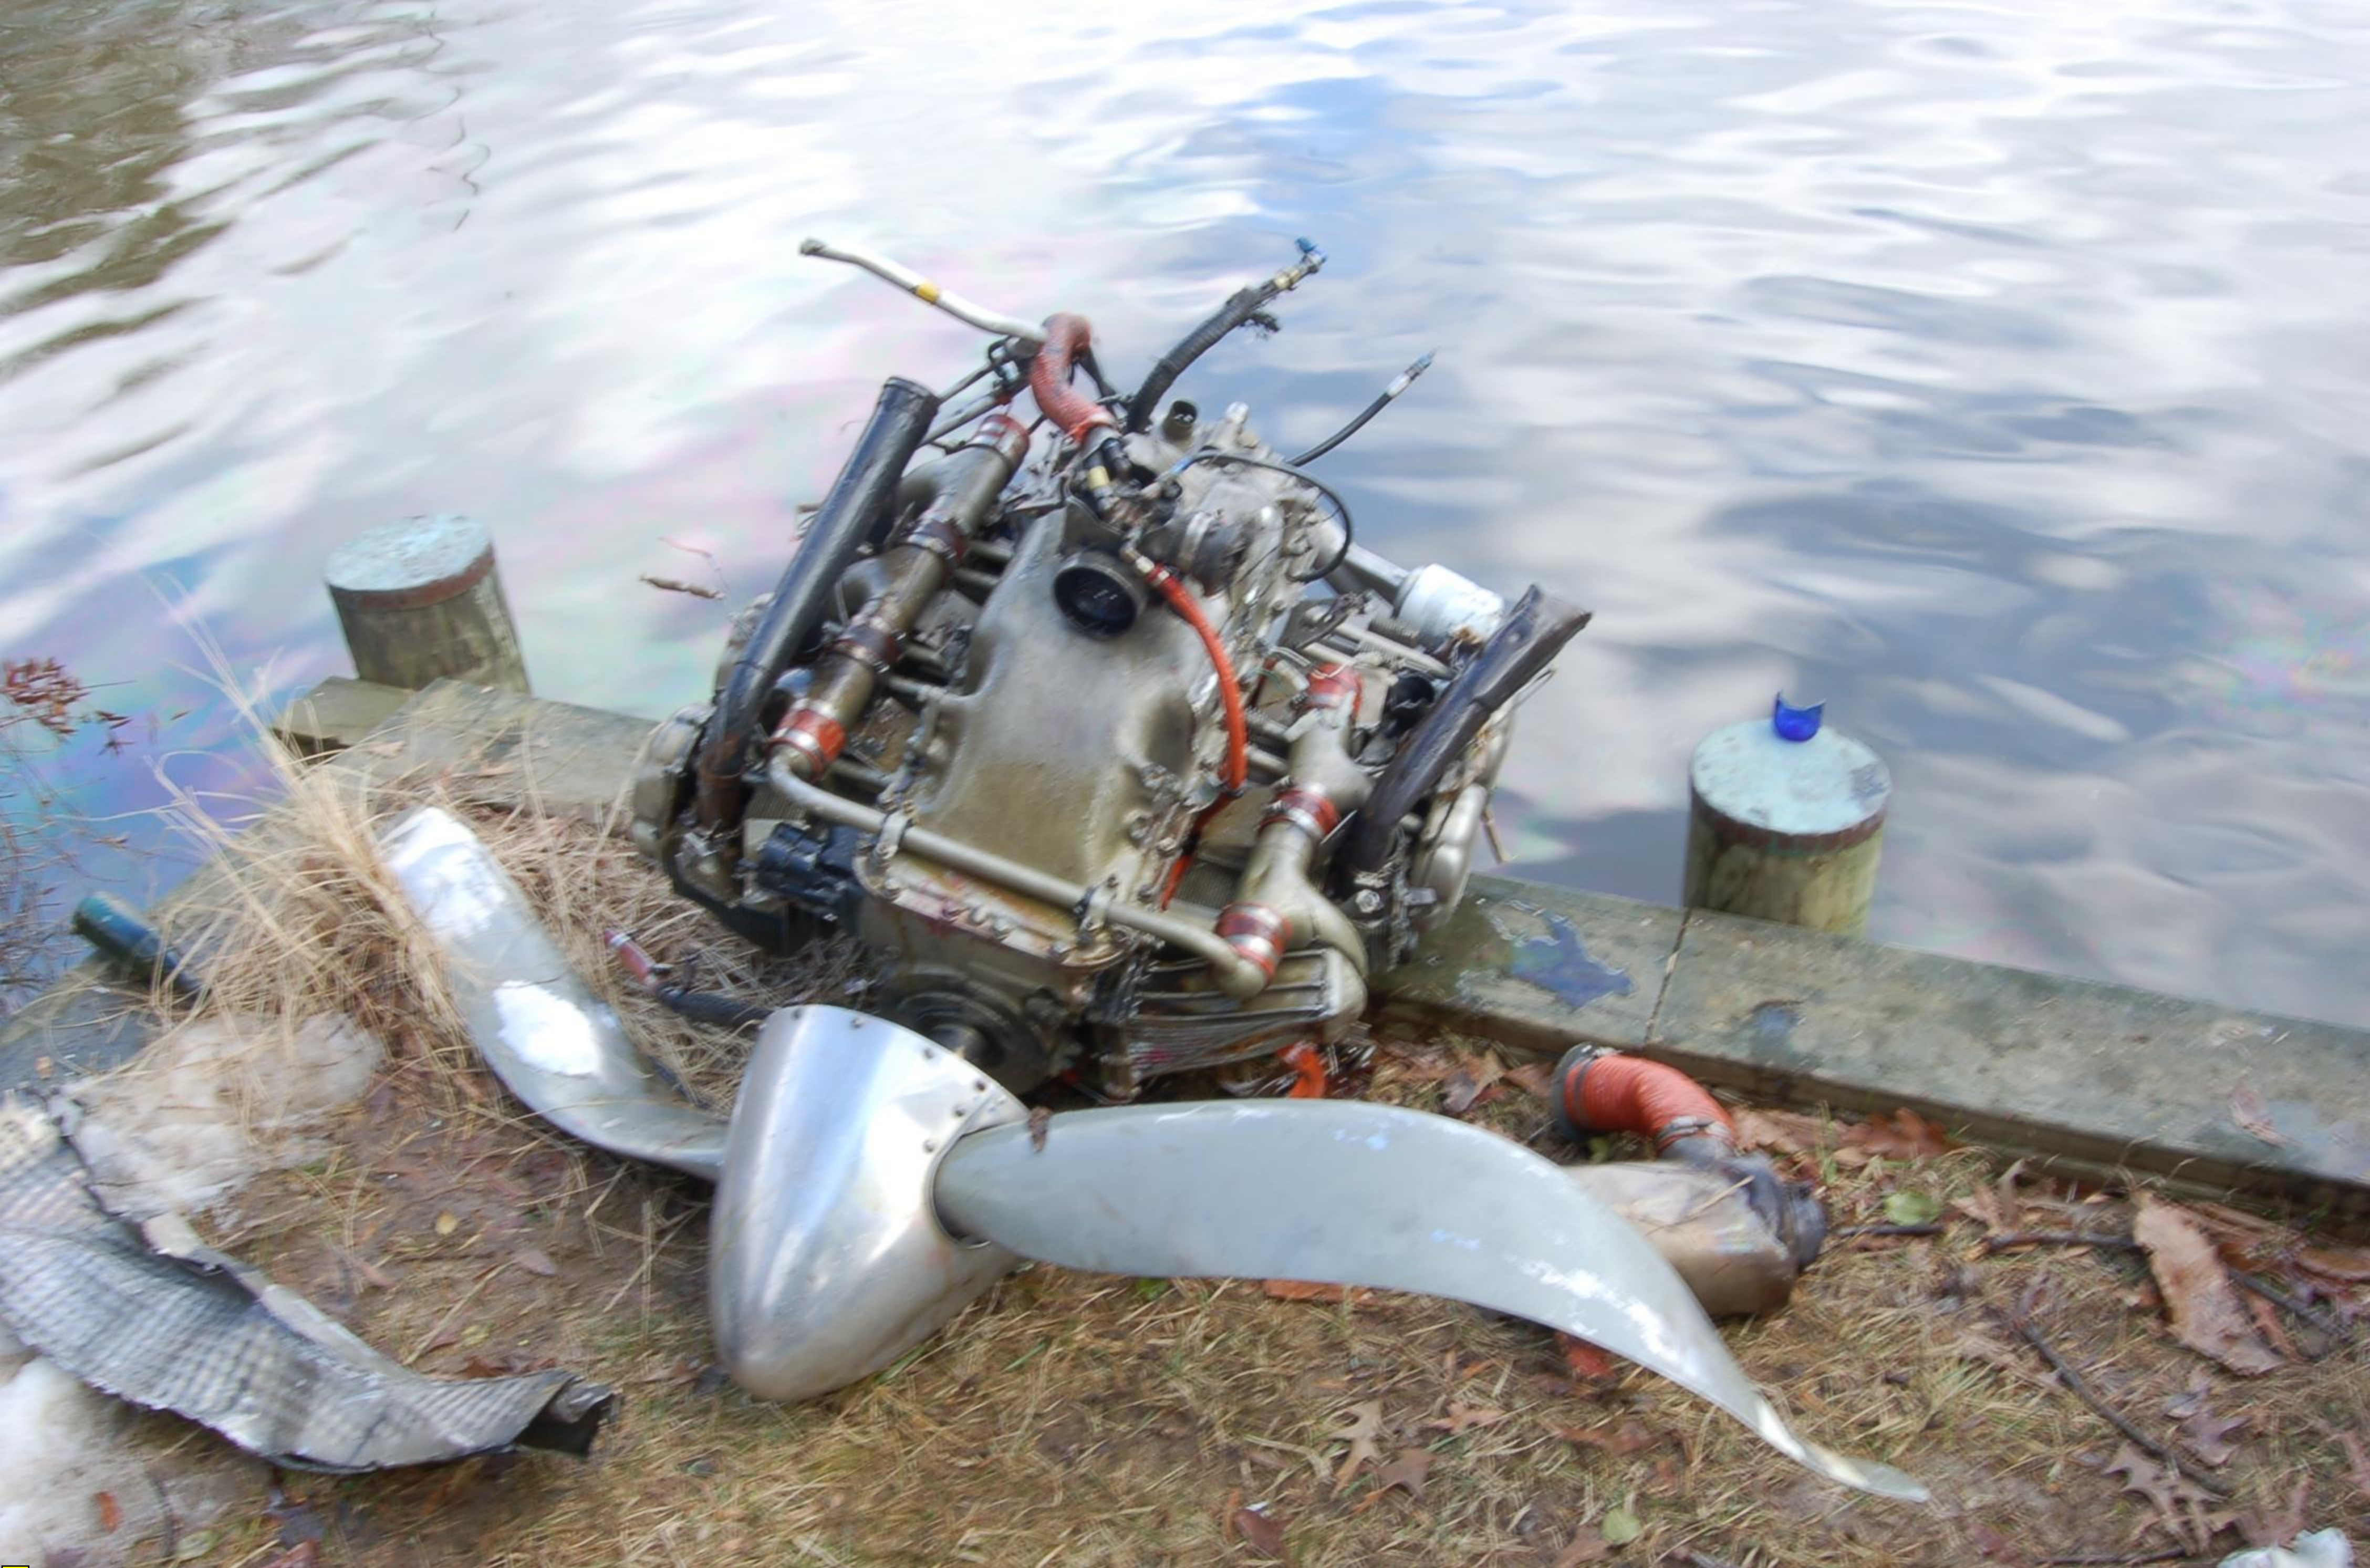
Photograph # 3 – View of engine after it was recovered from the water.
