**Survival Factors Group Chairman's
Gray Summit, MO.
Factual Report**

Survival Factors Group Chairman's Factual Report

Type: Truck Tractor, Pickup, School Bus Multivehicle Accident
Date and Time: August 5, 2010, 10:11AM. CDT
Location: Interstate 44 Eastbound West of Milepost 250.6
Gray Summit, Franklin County, Missouri
Vehicle #1: 2007 Volvo Truck Tractor
Motor Carrier: Climate Express
Vehicle #2: 2007 GMC Sierra
Vehicle #3: 2003 Bluebird, 71-Passenger School Bus
Motor Carrier: Copeland Bus Services, LLC
Vehicle #4: 2001 Bluebird, 72-Passenger Bus
Motor Carrier: Copeland Bus Services, LLC
Fatalities: 02
Injuries: 38

NTSB #: **HWY-10-MH-018**

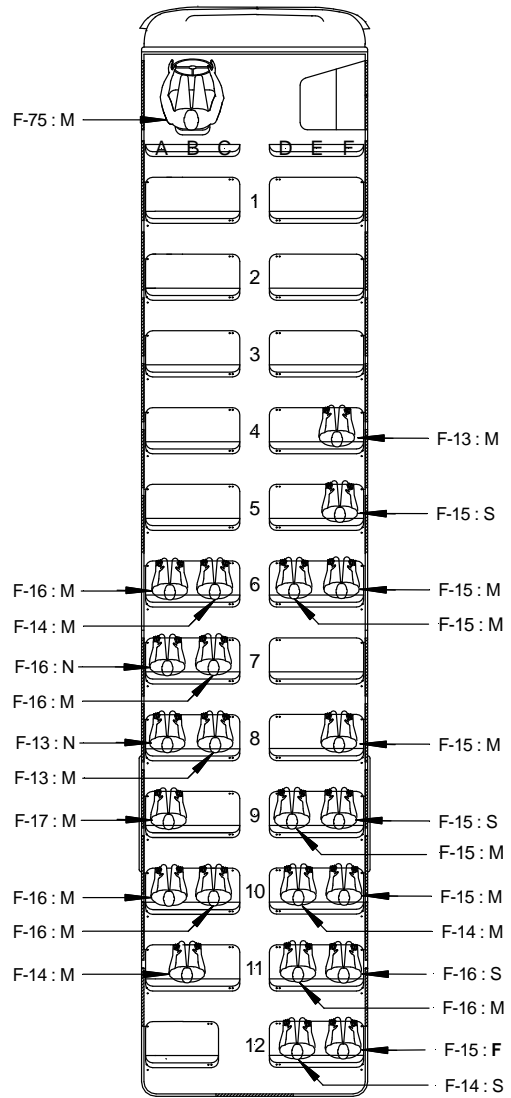
3.3 Seating Chart For 2003 Bluebird School Bus

Seating positions based on occupant interviews with nineteen of the twenty-four occupants and a seating chart supplied by the St. James High School.

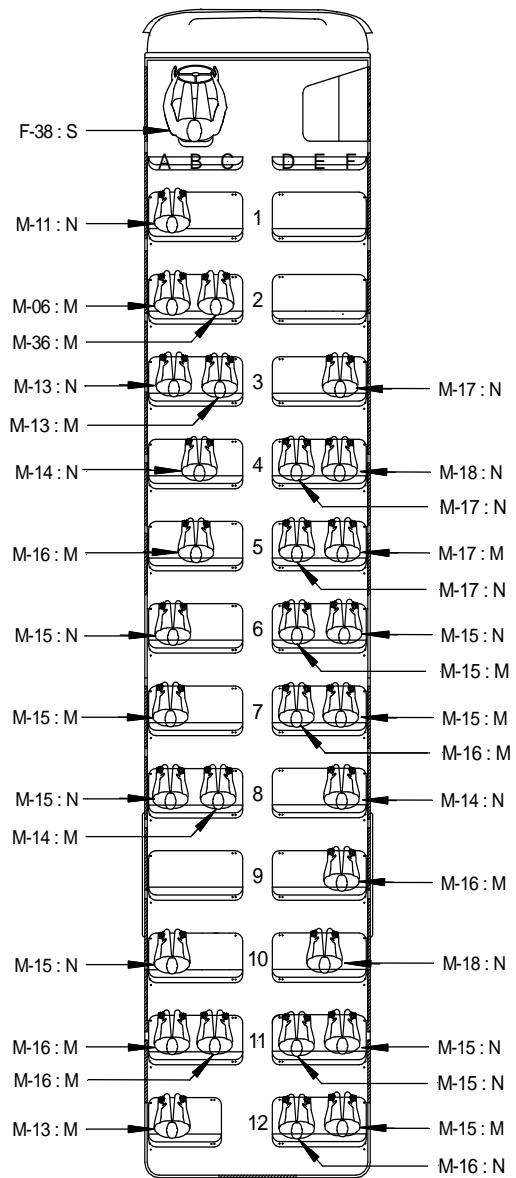
4.3 Seating Chart For 2001 Bluebird School Bus

Seating positions based on occupant interviews with nineteen of the thirty-two occupants and a seating chart supplied by the St. James High School.
