Highway Accident Report

Multivehicle Collision
Interstate 44 Eastbound, Gray Summit, Missouri
August 5, 2010

**National
Transportation
Safety Board**

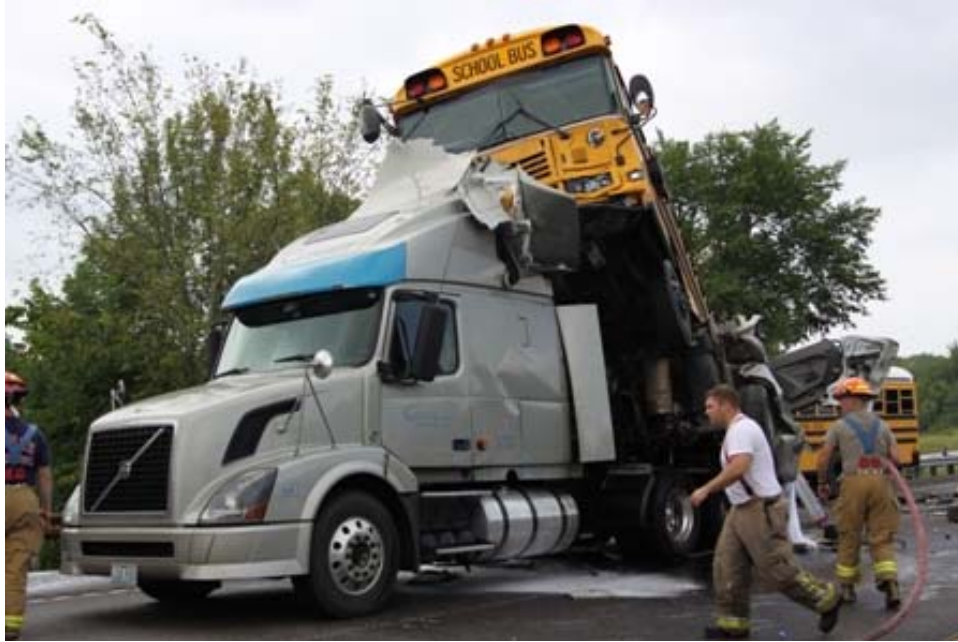
1 **Figure 3.** Gray Summit accident scene, showing Volvo tractor and lead school bus. GMC
2 pickup is located between the two vehicles and acted as a ramp for the school bus. The
3 following school bus is located at right rear of photo. (Courtesy of Boles Fire Protection District)

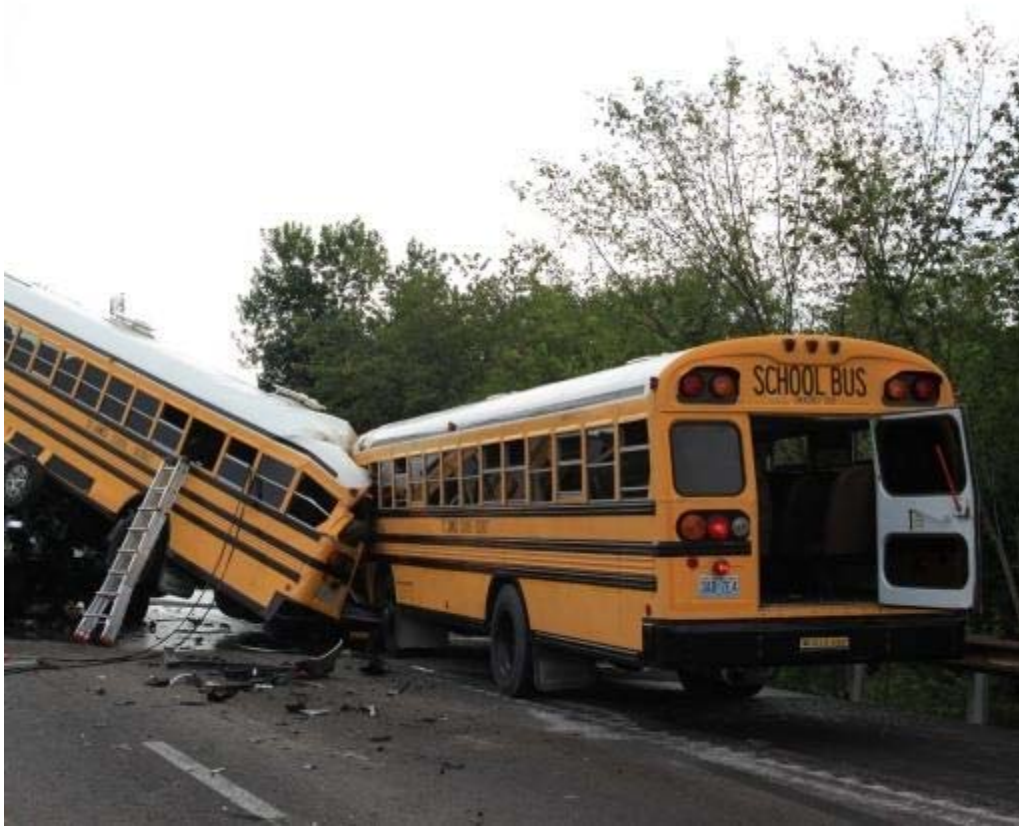
- 1 **Figure 4.** Override and intrusion of following school bus into lead school bus. (Courtesy of Boles
- 2 Fire Protection District)
- 3 *Alt text: Photograph looking onto the accident scene from the rear, showing the extent of*
- 4 *override and intrusion of the following school bus into the back of the lead school bus.*

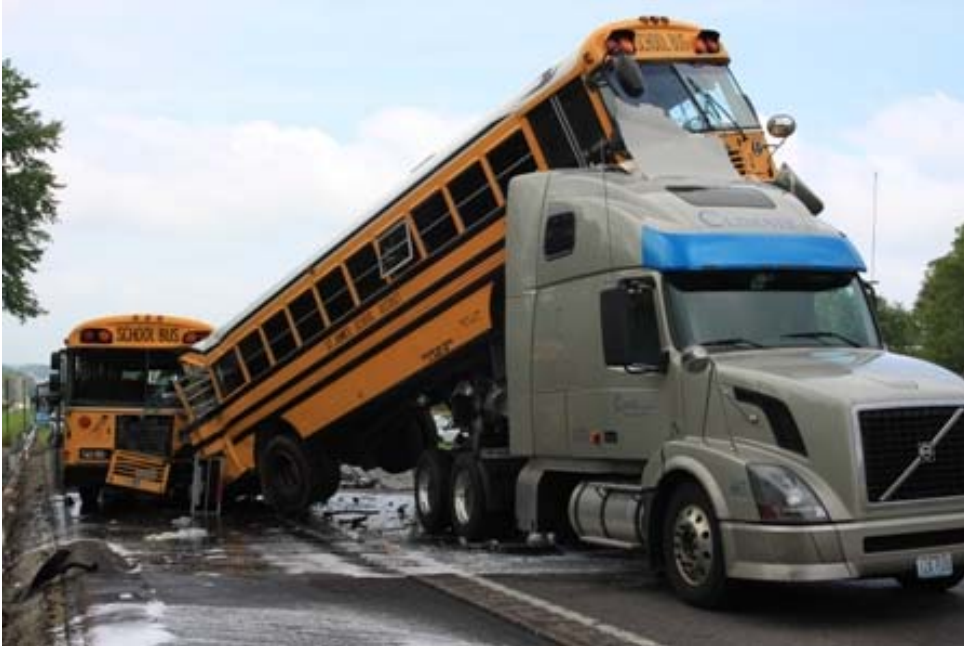
1 **Figure 5.** Position of accident vehicles at rest, with GMC pickup located between lead school
2 bus and top of rear wheels of Volvo tractor. (Courtesy of Boles Fire Protection District)

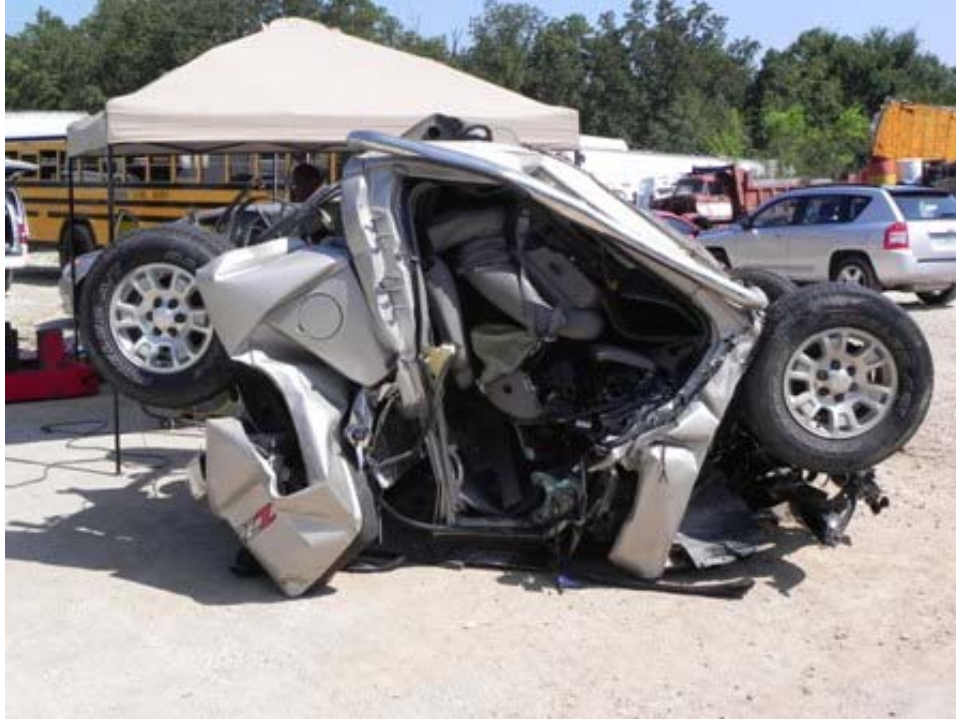
1 The GMC pickup was taken to an impound lot in Saint Clair, Missouri, where it was
2 examined by NTSB investigators. The damage to the exterior and interior was catastrophic. The
3 front end of the pickup was severely damaged due to its impact with the rear of the Volvo
4 tractor. The subsequent impact by the lead school bus resulted in the pickup overriding the back
5 of the Volvo tractor and its undercarriage being folded into a “U” shape. During the accident
6 sequence, the pickup’s high-density polyethylene gasoline tank was torn and released fuel at the
7 site. (See figures 8 and 9.)

- 1 **Figure 8.** GMC pickup in an inverted “U” shape, with its rear at left and its front at right.
- 2 Undercarriage of pickup forms exterior of “U” shape.
- 3 *Alt text: Photograph showing the extent of damage to the GMC pickup. The vehicle’s*
- 4 *undercarriage is in an inverted “U” shape, with its rear to the left and its front to the right.*

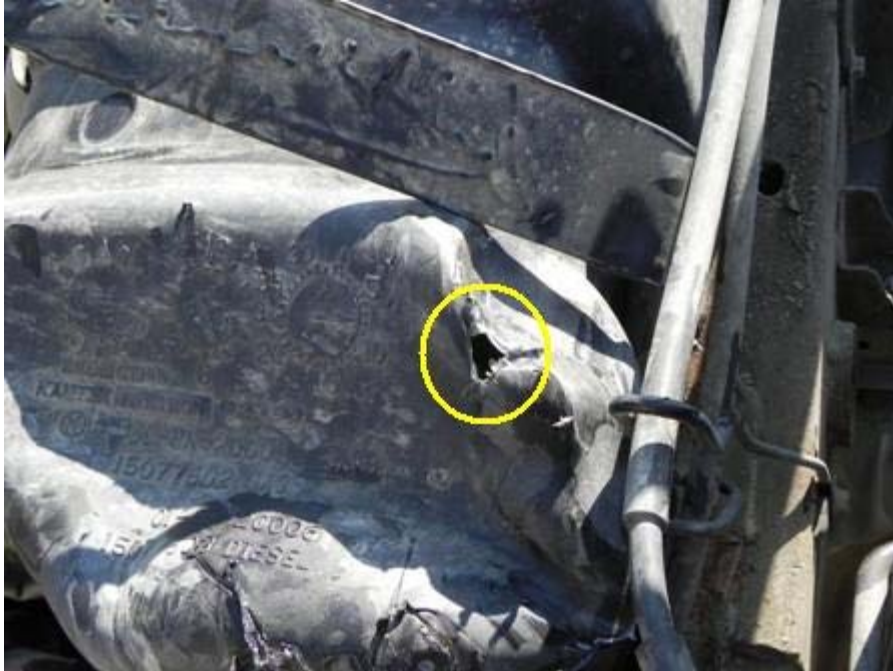
- 1 **Figure 9.** Gas tank tear in GMC pickup.
- 2 *Alt text: Photograph showing a tear in the gas tank of the GMC pickup.*

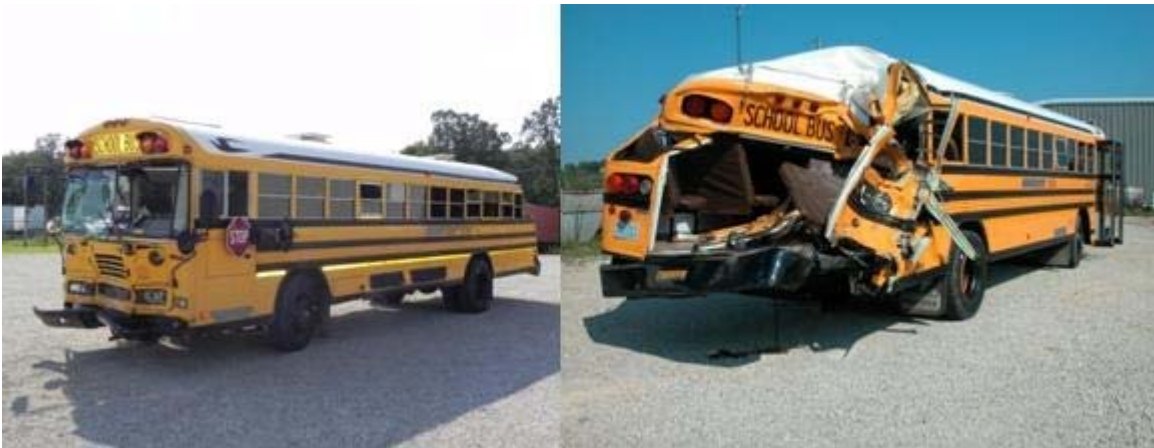
1 The lead school bus sustained moderate front-end damage from hitting the back of the
2 GMC pickup and undercarriage damage from overriding the pickup and the sleeper berth of the
3 Volvo tractor. The rear of the bus was seriously damaged as a result of being overridden by the
4 following school bus. (See figure 10.)

5 **Figure 10.** Front and rear views of lead school bus. Emergency door supports and several roof
6 pillars were cut to extricate an entrapped passenger.

8 The impact from the following school bus severely damaged the rear of the lead school
9 bus. Direct damage to the rear bumper was primarily on the right side and spanned a width of
10 35 inches. The bumper was crushed inward 6 inches at its maximum point. The maximum
11 residual crush into the passenger compartment was 62 inches. The override impact crushed the
12 rear emergency door and rear wall inward, and caused the roof to buckle and crush inward and
13 upward. In addition, the right outside side wall was crushed inward and to the right. The
14 emergency door supports and several roof pillars were cut to extricate a passenger.

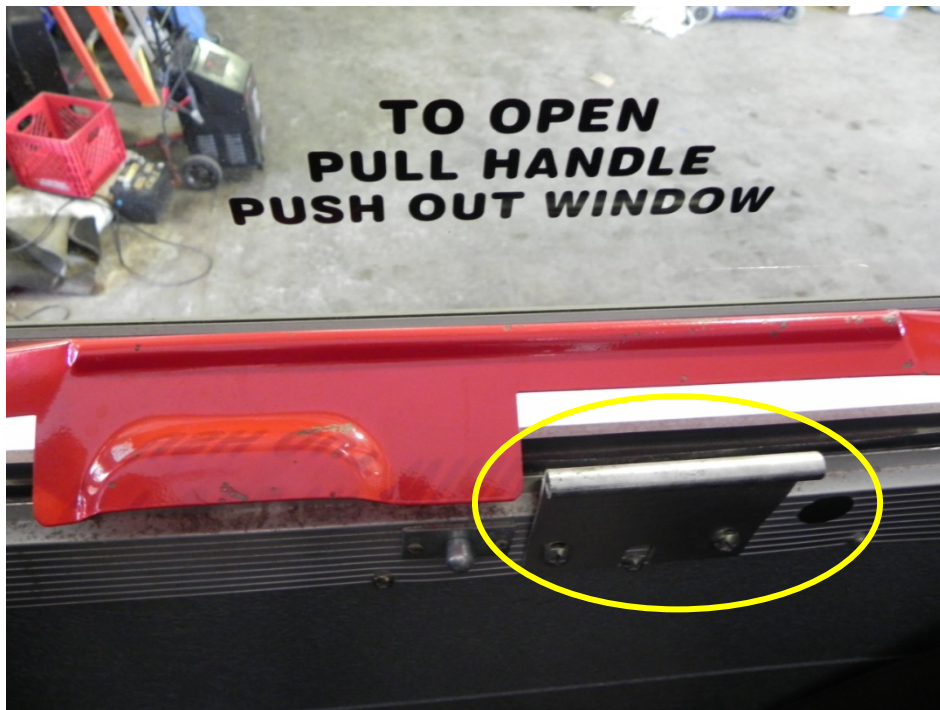
13 According to emergency responders and passengers in the lead school bus, evacuation
14 was hindered by the design of the emergency window. The latch plate that protruded from the
15 bottom of the window snagged the clothing of several passengers. (See figure 11.) Additionally,
16 one person had to hold the hinged emergency window open so that another bus occupant could
17 exit unimpeded. According to the Blue Bird representative, the company had changed the design
18 of its newly manufactured^h emergency exit windows in 2005 so that the hinges are now
19 vertically positioned, instead of horizontally, as in the accident buses.⁶ In addition, Blue Bird

- 3 **Figure 11.** Raised emergency release latch plate (circled) at bottom of emergency exit window,
- 4 lead school bus.

3 FMVSS 217 and the accompanying test procedures also fail to address other emergency
4 exit design characteristics that could affect egress safety, such as the latch plate protrusion found
5 on the lead school bus. The Gray Summit accident did not require an expedited evacuation
6 because the spilled fuel from the GMC pickup was managed by first responders and did not catch
7 fire, and because several people assisted in the evacuation. Although, in this case, the latch plate
8 only snagged clothing, the NTSB is concerned that any protrusion into a space of egress may act
9 as an injury source and delay egress, especially during more urgent evacuation scenarios.

10 The NTSB concludes that components of emergency exit windows, such as protruding
11 latch plates, could cause delays or injuries during school bus evacuation. **[Conclusion]**
12 Therefore, the NTSB recommends that NHTSA modify FMVSS 217 or the corresponding
13 laboratory test procedure to eliminate the potential for objects such as latch plates to protrude
14 into the emergency exit window opening space even when that protrusion still allows the exit
15 window to meet the opening size requirements. **[Recommendation]** To cover the interim period
16 until FMVSS 217 is modified, the NTSB also recommends that NHTSA provide the states with
17 guidance on how to minimize potential evacuation delays that could be caused by protruding
18 latch mechanisms on emergency exit windows and by exit windows that require additional
19 manual assistance to remain open during egress. **[Recommendation]**

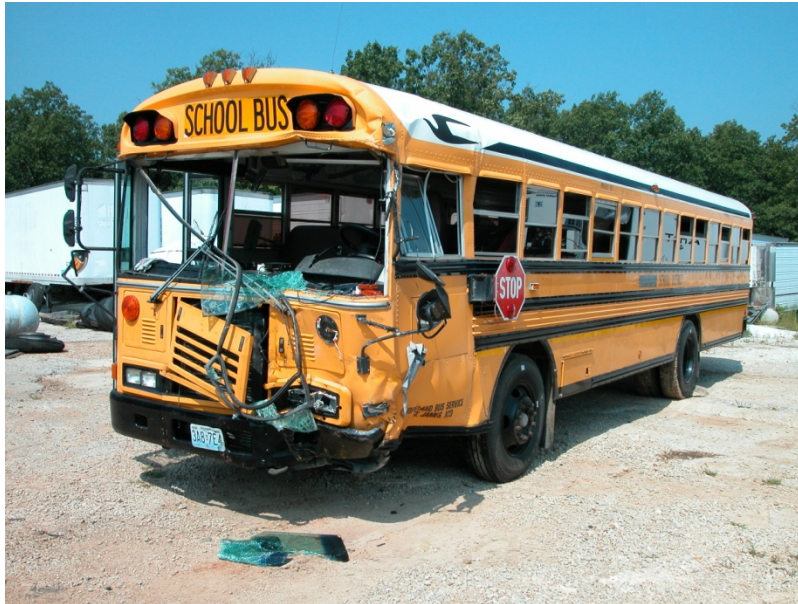
1 The following school bus sustained moderate front-end damage from hitting the back of
2 the lead school bus. (See figure 12.) According to manufacturer specifications, the following bus
3 had an original overall length of 420 inches, an overall width of 94 inches, and a wheelbase of
4 190 inches. The frontal impact damage began at the left corner and extended to the right
5 64.5 inches. The damage also extended vertically to the roof. Maximum crush to the left front
6 bumper was 13.5 inches. Damage to the left side of the bus extended approximately 49.5 inches,
7 detaching the side rearview mirror and shattering the driver's window. Both windshield panes
8 were also shattered. Postaccident measurement of the wheelbase showed the left side to be
9 189.5 inches and the right side 190.25 inches.

1 **Figure 12.** Front view of following school bus.
