NATIONAL TRANSPORTATION SAFETY BOARD
Vehicle Recorder Division
Washington, DC 20594

Cockpit Voice Recorder

Specialist's Factual Report
By Bill Tuccio

Location: Pueblo, Colorado
Date: February 02, 2012, 1915 Mountain Standard Time (MST)
Aircraft: Gates Learjet 35, N31WS
Operator: Travel Aire Services Incorporated
NTSB Number: CEN12FA151

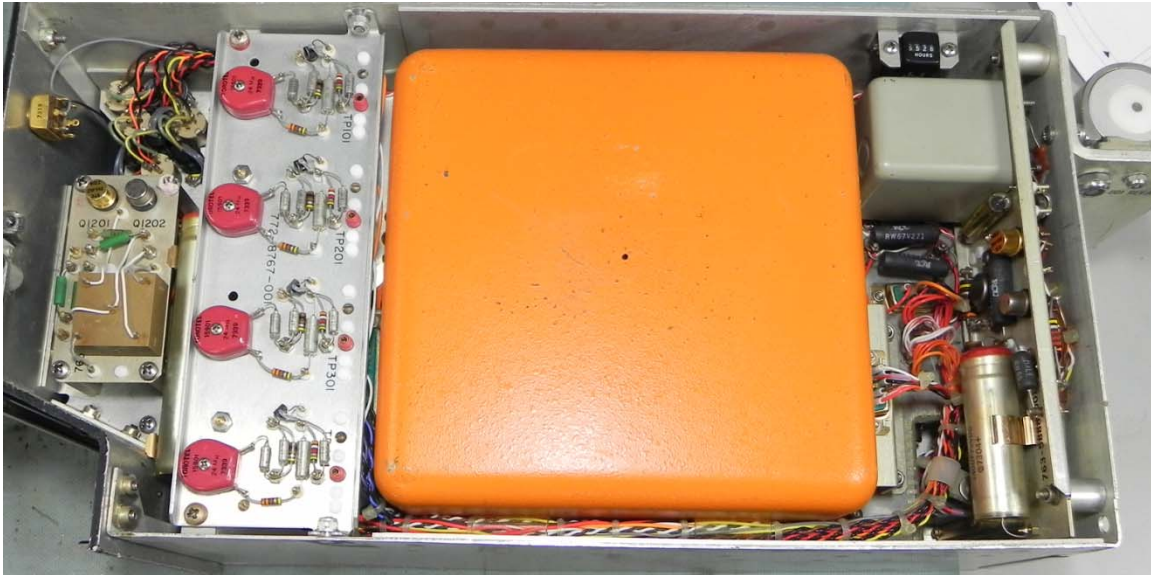
Upon arrival at the audio laboratory, it was evident that the CVR had not sustained any heat or structural damage. The recorder had a sticker on the unit indicating it had been overhauled on January 14, 2011. When the unit was opened to access the tape, it was discovered the tape was tangled around the final spool. Figure 1 through 6 show the disassembly process. Figure 1 shows the undamaged crash protected tape housing. Figure 2 shows folding of the tape on the initial feed spindle. Figures 3 and 4 show the final spindle with the tape tensioner still in place, with evidence of the tangle. Figure 5 shows multiple layers of tape on the spindle, after the tensioner was removed; and figure 6 shows the tangled tape after removal from the spindle.

Figure 1. Interior of unit showing crash protected tape housing.

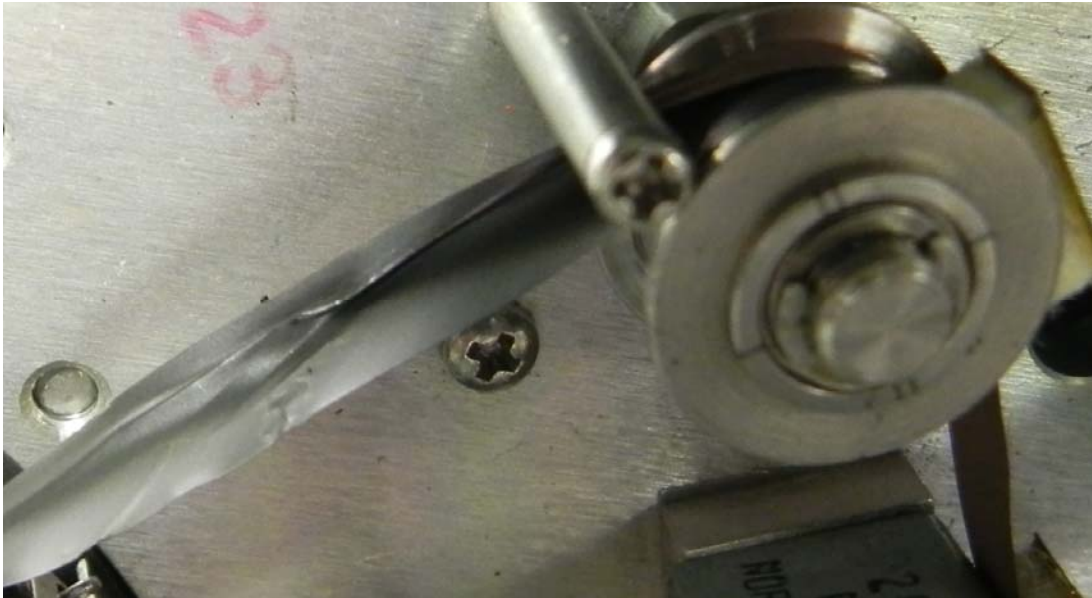
Figure 2. Fold in tape on feed spindle.

- Physical damage to the tape caused by the tape feed assembly (figures 2 through 6), with no damage to the CVR exterior housing;
- Inconsistent recording speed on the recorded contents;
- Large areas of silence;
- Conversations not consistent with the accident event or post-accident events.

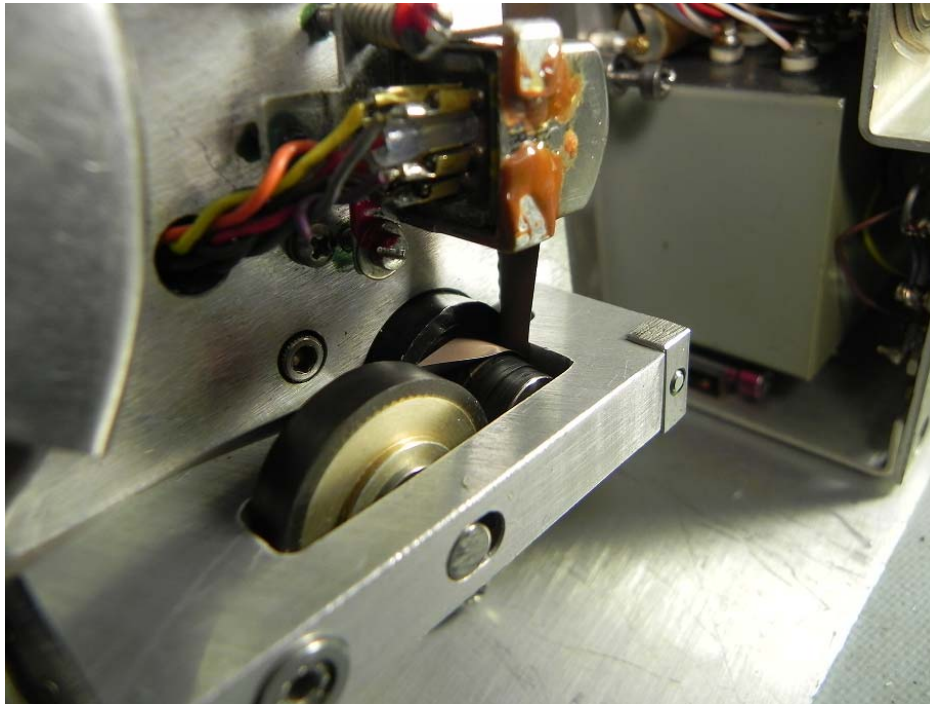
Figure 3. Final tape spindle, tangled.

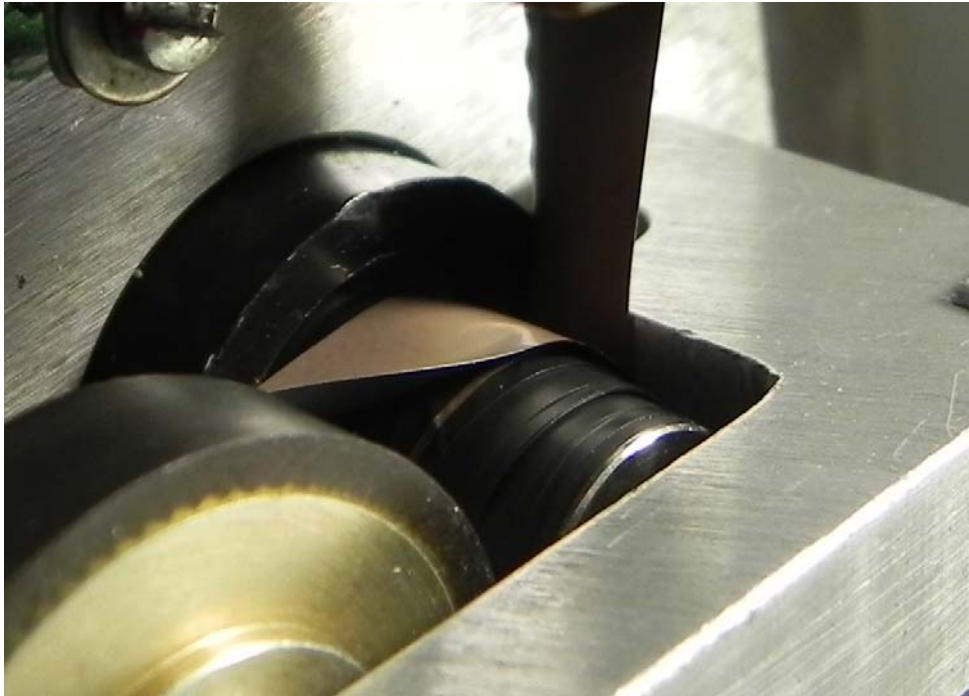
Figure 4. Close up of final tape spindle tangle.

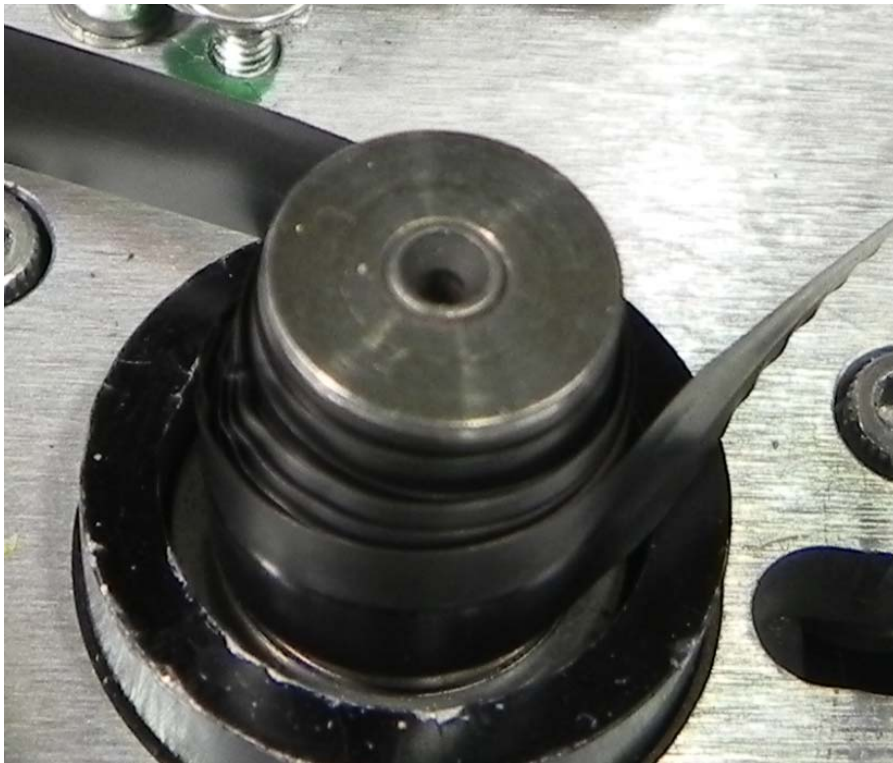
Figure 5. Final spindle with tape tensioner removed.

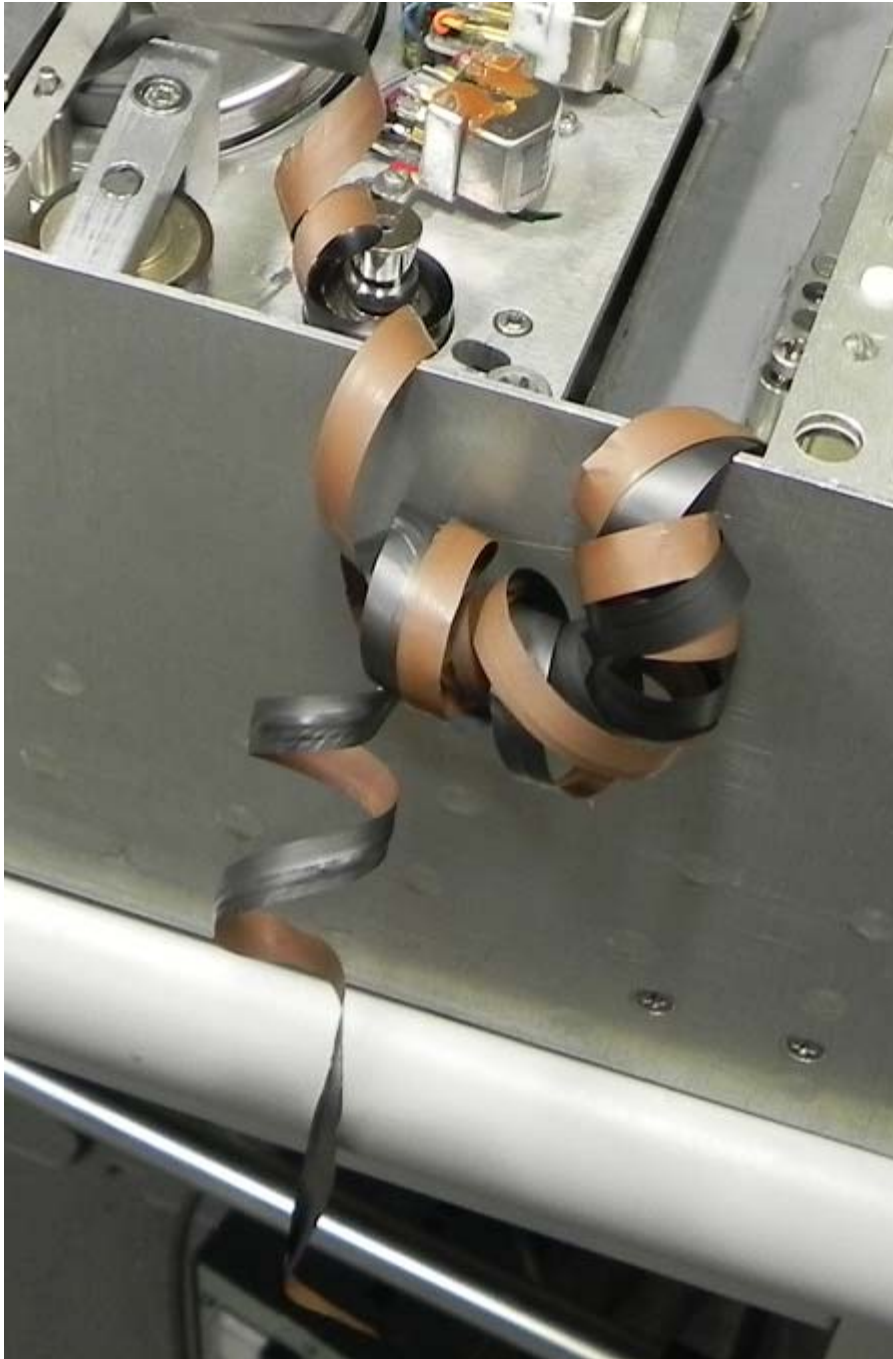
Figure 6. Amount of tape in final spindle tangle.
