NATIONAL TRANSPORTATION SAFETY BOARD

Cockpit Voice Recorder

Specialist's Factual Report

Location: Houston, Texas
Date: March 4, 2011, 0400 Central Standard Time (CST)
Aircraft: Learjet 25D, XA-TWH
Operator: Personas y Paquetes Por Aire, S.A. de C.V.
NTSB Number: CEN11LA223

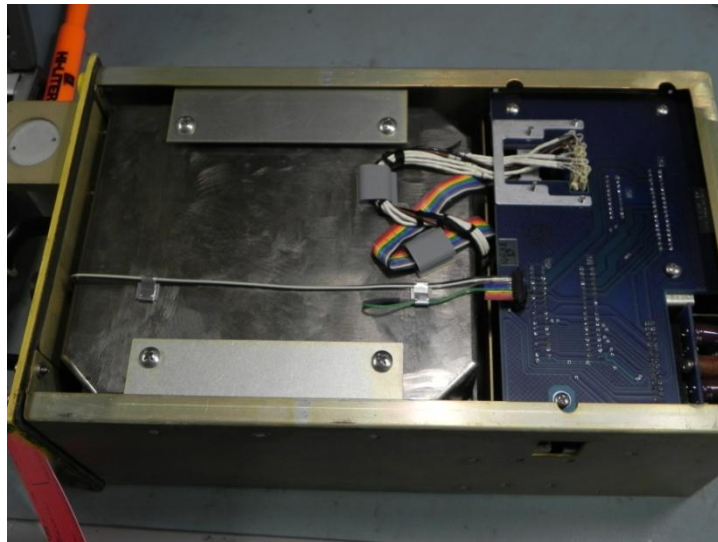
PHOTO 1

Upon arrival at the audio laboratory, it was evident that the CVR had not sustained any heat or structural damage. However, upon inspection of the tape inside the undamaged, protected housing, it was evident the tape mechanism was damaged. Photos 1 through 7 show the damage evidenced during disassembly. In particular, photo 4 and 6 show tangling of the tape on a feeder spool. Despite the damaged tape assembly, it was possible to recover audio from the extracted tape shown in Photo 7.
