NATIONAL TRANSPORTATION SAFETY BOARD
Vehicle Recorder Division
Washington, DC 20594

On Board Image Recorder

Specialist's Factual Report
By Bill Tuccio

Location: Fairbanks, Alaska
Date: July 26, 2012
Aircraft: Hawker Beechcraft F33A, N334DH
Operator: Private
NTSB Number: ANC12FA079

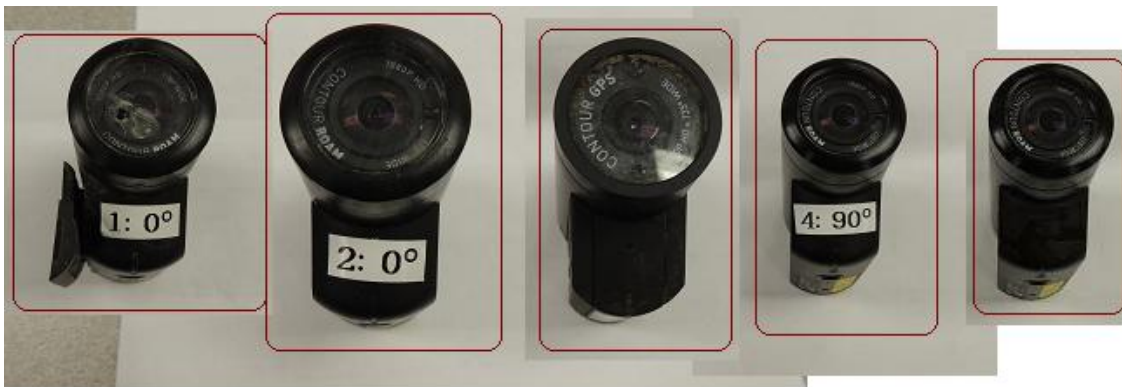
Upon arrival at the NTSB laboratory, it was evident that the cameras had sustained minor damage, as shown in figure 1. The 32 GB microSD cards were removed from each camera and the video and audio information was extracted from four of the five microSD cards normally, without difficulty. No video files were found on the Contour Roam 1400 GPS unit's microSD card.

Figure 1. Five Contour Roam cameras as received.
