## NATIONAL TRANSPORTATION SAFETY BOARD

### AIR TRAFFIC CONTROL SPECIALIST'S REPORT

CEN13FA192

**Location:** Grand Lake, Louisiana  
**Date:** March 15, 2013  
**Time:** 1147 central daylight time (CDT)  
**Aircraft:** N574EH, a Sikorsky S76A, call-sign ERA574

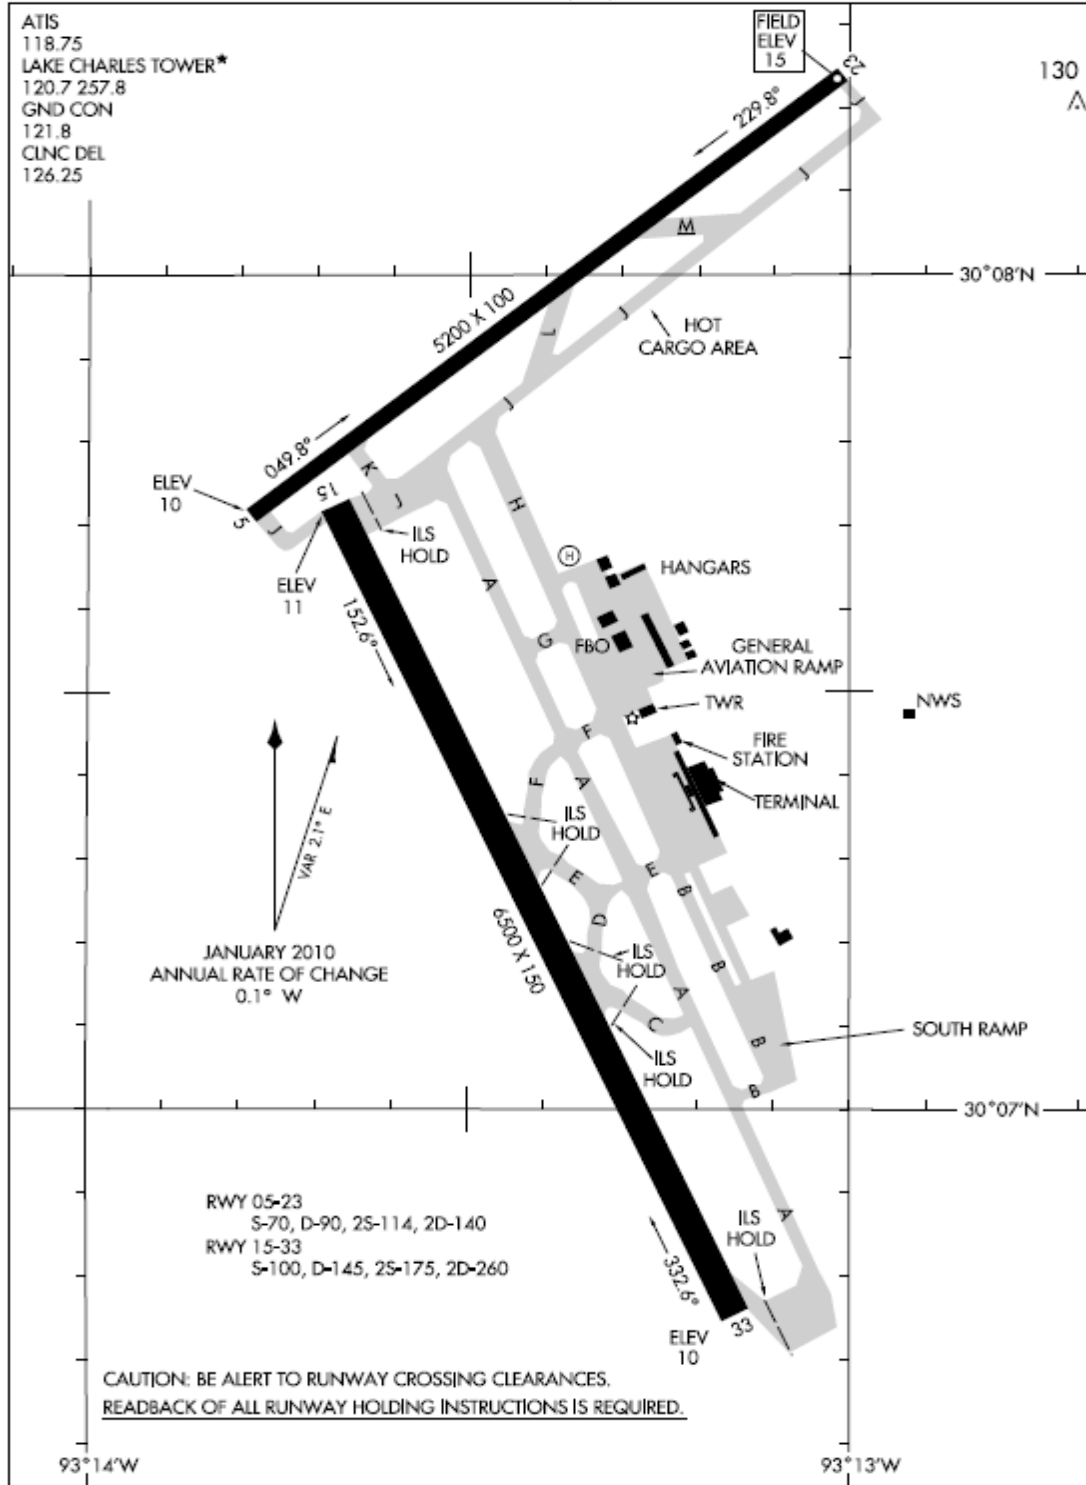
Figure 1 – Lake Charles Regional Airport Diagram

On March 15, 2013, at 1117, ERA574 called LCH ATC with ATIS<sup>1</sup> information Charlie, requesting permission to taxi on taxiway E to A for an offset departure to the south of the airport for a local area maintenance flight. The pilot stated that he intended to operate within 7 or 8 miles south of the airport at about 1,000 feet. LCH ATC directed ERA574 to squawk VFR<sup>2</sup>, to taxi via taxiway E to A, and to advise when ready for departure. ERA574 acknowledged. (See figure 1)

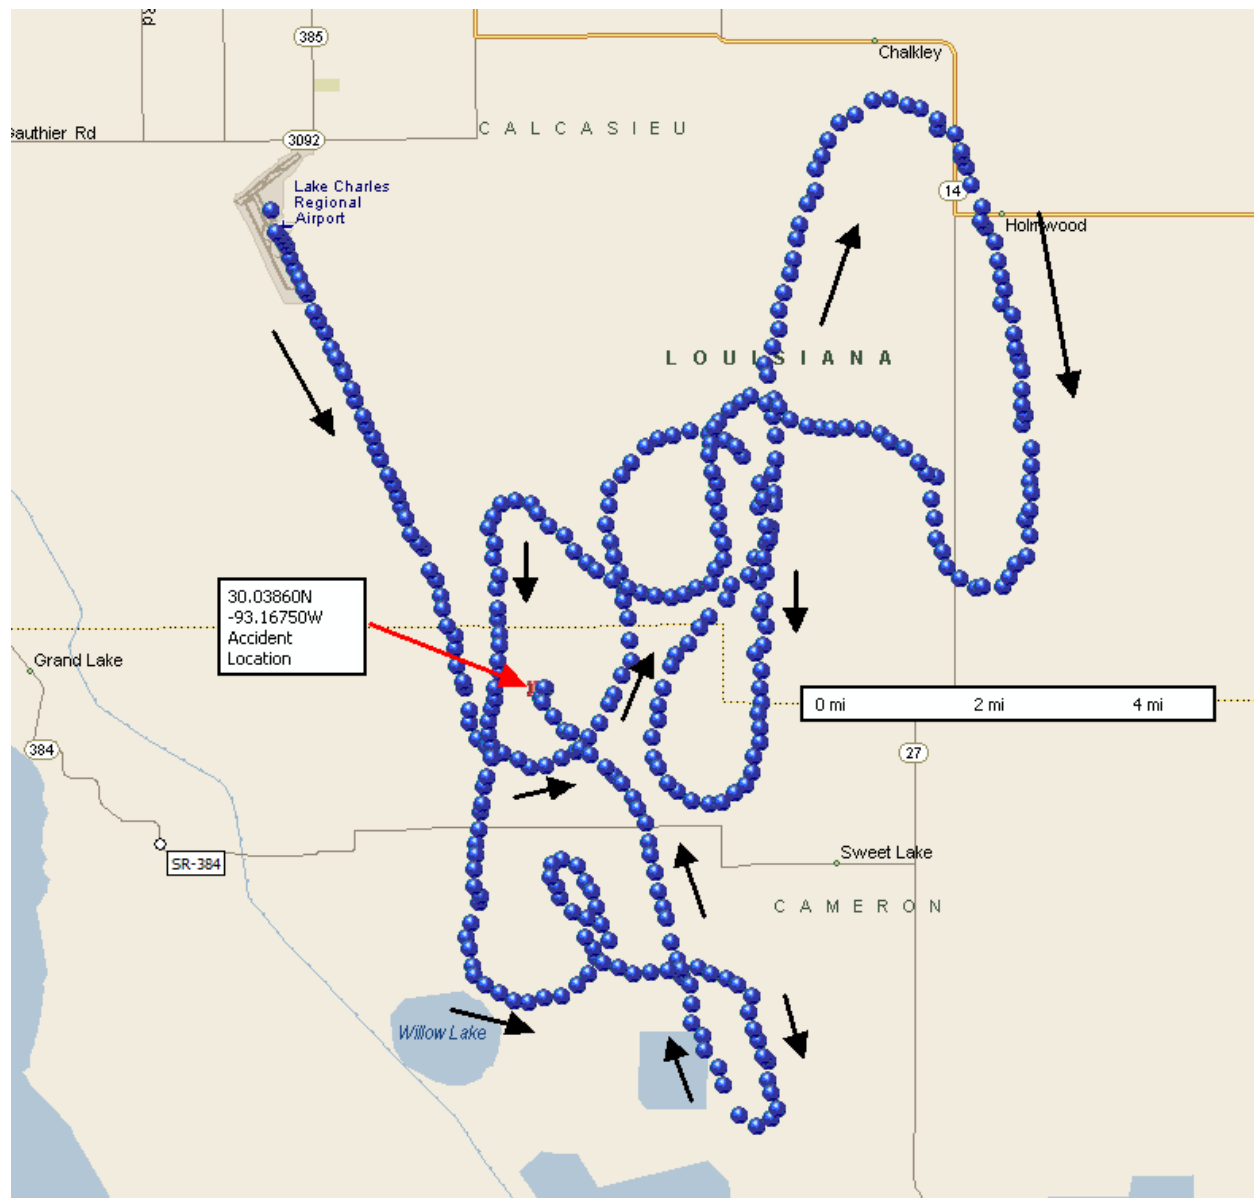
At 1145, the pilot of ERA574 advised LCH ATC that he was about 10 miles to the south and would be returning for landing. LCH ATC advised ERA574 that the wind was 190 degrees at 12 knots gusting to 16 knots. The controller cleared ERA574 to land on taxiway A north of taxiway E and reposition at pilot’s discretion. ERA574 acknowledged. (See figure 2)

Figure 2 – ERA574 radar flight track is indicated by blue dots. The direction of flight is indicated by black arrows. The accident site is indicated by a red pushpin.

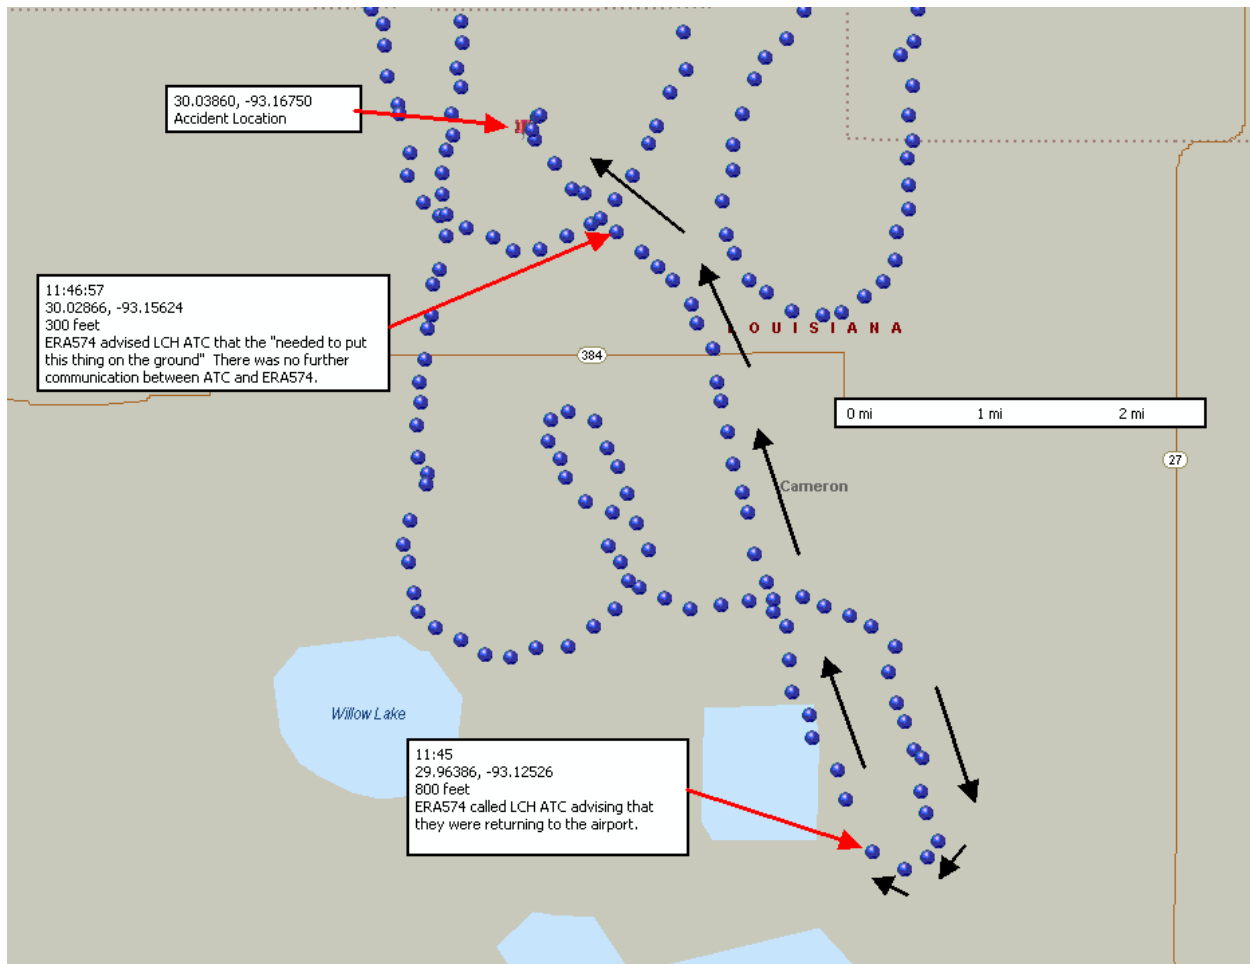
At 1146:57, ERA574 called LCH ATC and advised they had a problem and needed to “put this thing on the ground.” LCH ATC acknowledged and asked if the pilot was declaring an emergency. ERA574 acknowledged with “yes ma’am.” LCH ATC asked ERA574, when able, to say nature of emergency and if they needed assistance from Air Med or the fire truck. ERA574 did not respond. There were no further communications between ERA574 and LCH ATC. (See figures 3 and 4)

Figure 3 – ERA574 radar flight track is indicated by blue dots. The direction of flight is indicated by black arrows. The accident site is indicated by a red pushpin.

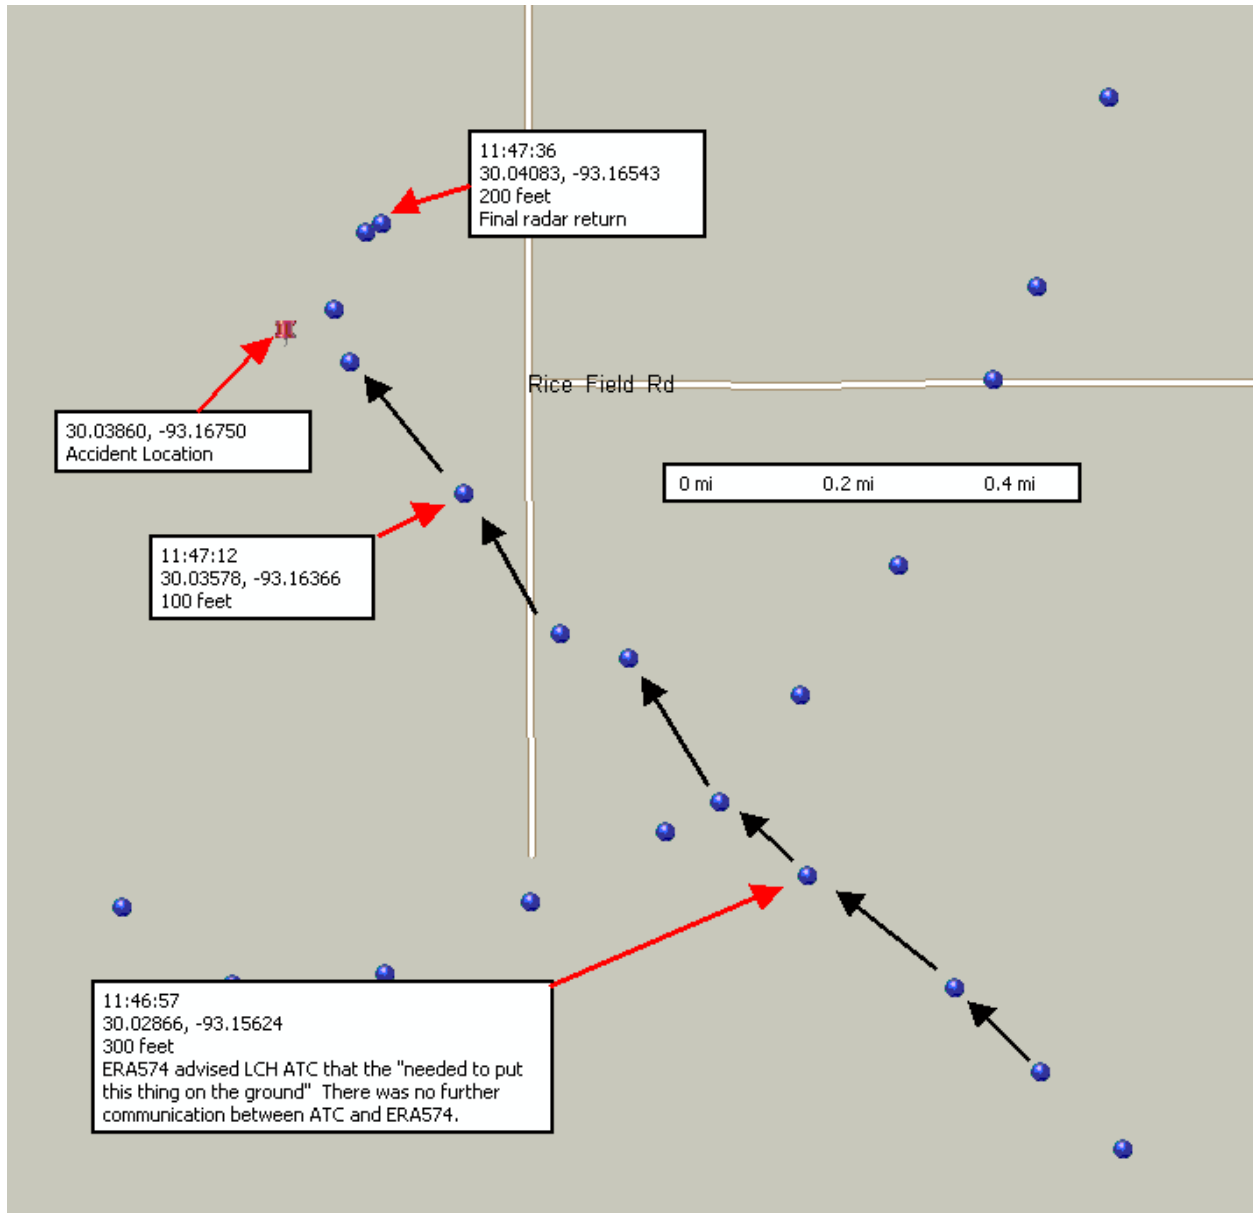
Figure 4 – ERA574 radar flight track is indicated by blue dots. The direction of flight is indicated by black arrows. The accident site is indicated by a red pushpin.
