**NATIONAL TRANSPORTATION SAFETY BOARD**  
Vehicle Recorder Division  
Washington, DC 20594

## **On-Board Image Factual Report**

Location: New York, New York  
Date: July 18, 2013  
Operator: CSXT  
NTSB Number: DCA13FR009

On July 18, 2013, at 08:29 p.m., northbound CSXT train Q 704, derailed at milepost 9.99 on the Metro-North Railroad Hudson Line. The train consisted of 2 locomotives and 24 modified flat cars. Each flat car carried 4 containers loaded with garbage. The train departed CSXT Oak Point Yard and was routed onto the Metro-North Railroad (MNCW) at Control Point (CP) 8.0 and derailed 72 feet 10 ¼ inches north of CP 10. Video files from the lead and second locomotive, CSXT 8846 and CSXT 8833, respectively, were downloaded by CSXT and sent to the National Transportation Safety Board's Image Laboratory for evaluation.

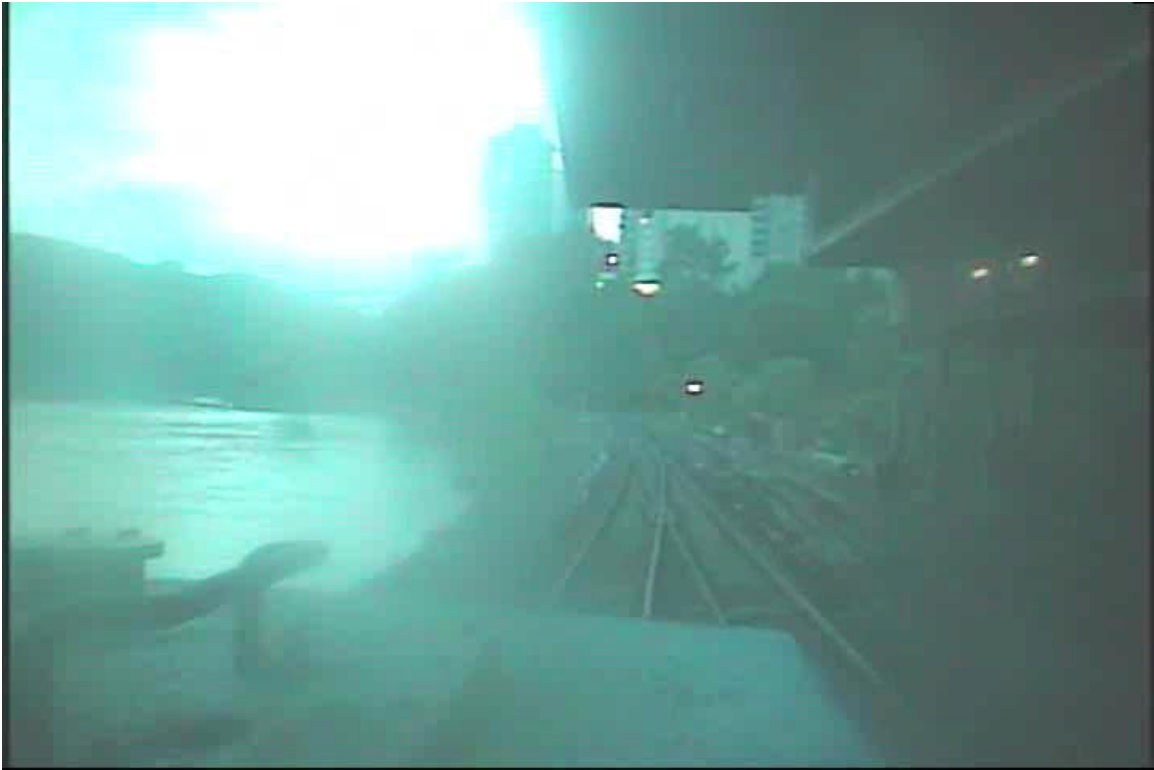
At 2027:25 EDT, the track CSXT 8846 occupied began to merge right with another track, as shown in figure 1. Shortly thereafter, CSC 8846 exited from under the Overstructure.

**Figure 1. Track merge at end of Overstructure.**

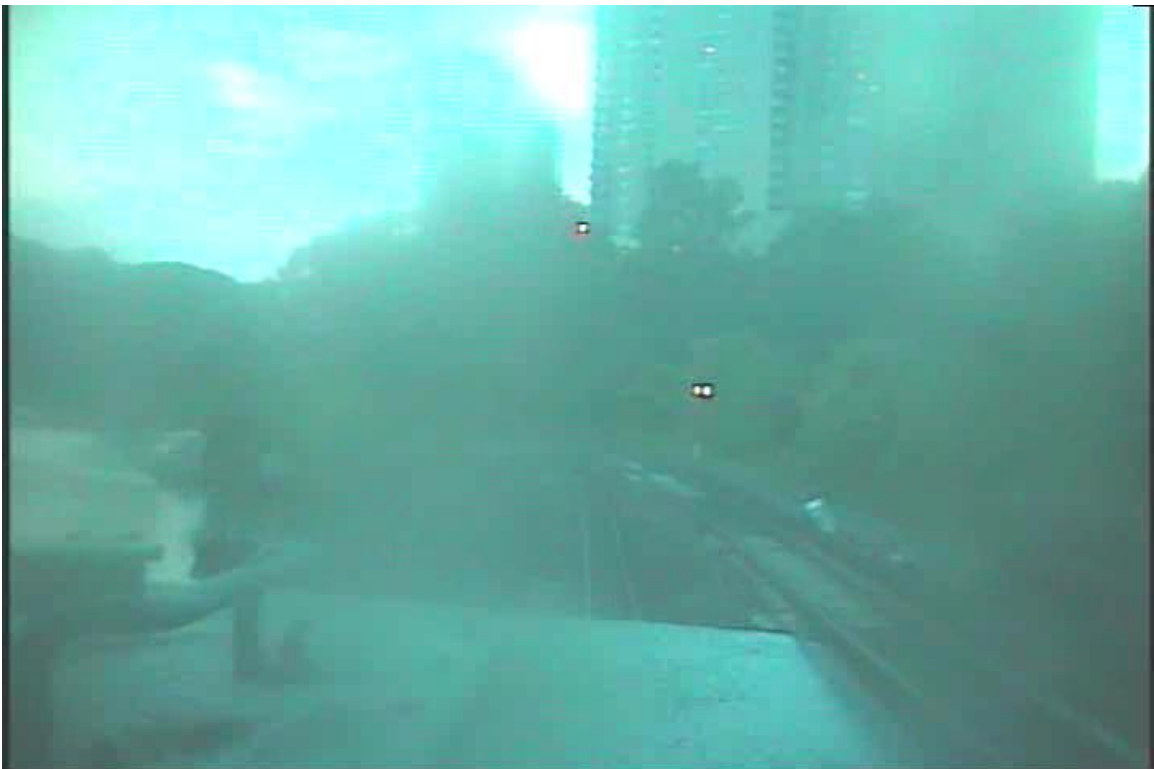
At 2027:37 EDT, CSXT 8846 approached the Point of Derailment. The adjacent track exhibited white discoloration as shown in figure 2.

**Figure 2. White discoloration of adjacent track.**

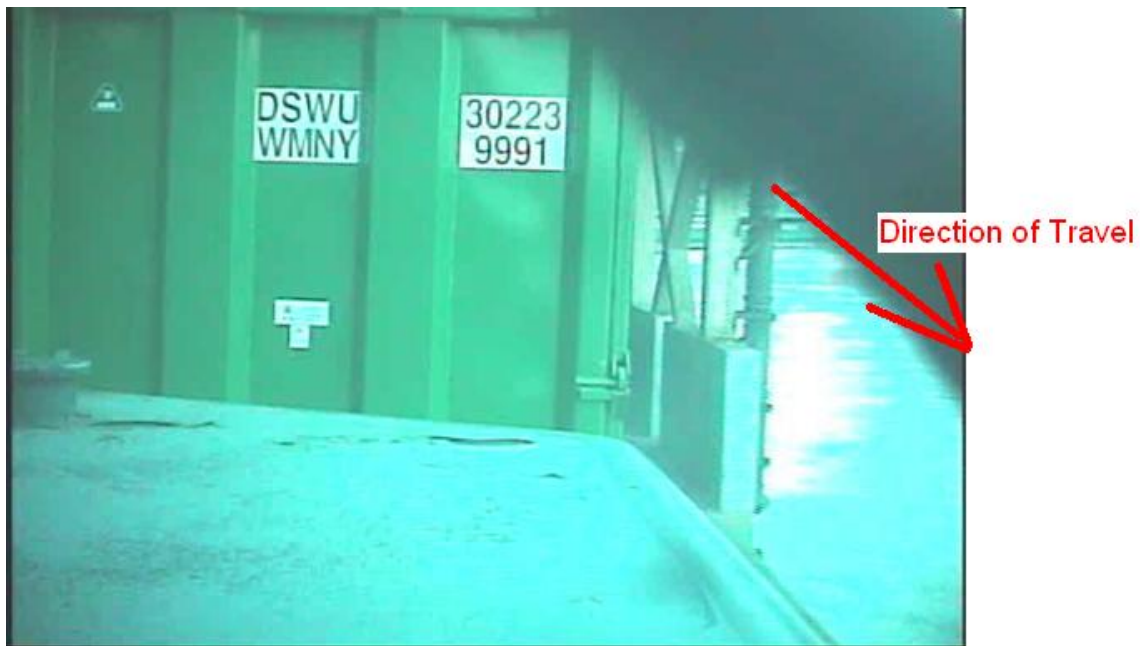
At 2027:31 EDT, CSXT 8833 exited the Overstructure, as shown in figure 3. Figure 3 also annotates the direction of travel of the train.

Figure 3. Exiting Overstructure with direction of travel annotated.

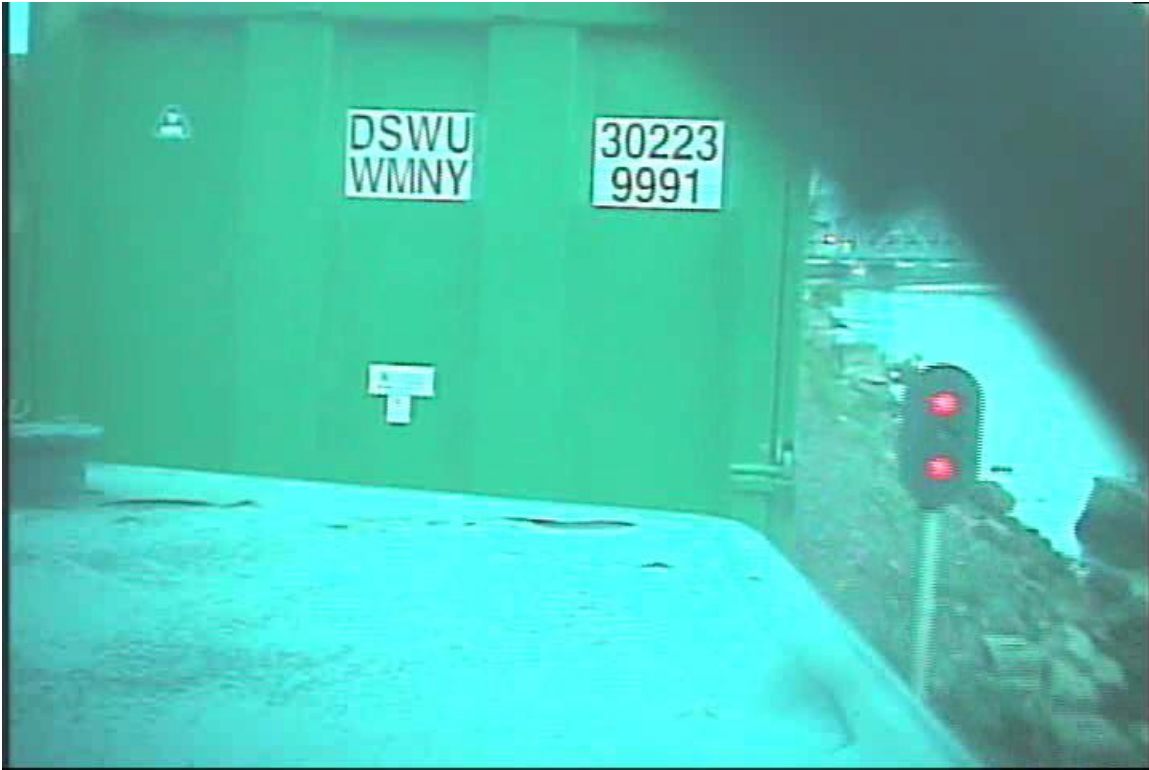
At 2027:56 EDT, CSXT 8833 passed a southbound, red signal (to the left of the train) near the Point of Derailment, as shown in figure 4. CSXT 8833 oscillated laterally and vertically until about 2028:02 EDT.

Figure 4. Passing southbound signal.
