DWG. TITLE:  
 ROWAN "JOE DOUGLAS"  
 VERMILION 376A  
 HELICOPTER APPROACH ANGLES

078-HELI-APPR-ANG      REV. B

**From:** Wendell York [REDACTED]  
**Sent:** Friday, June 22, 2012 4:14 PM  
**To:** Silliman James  
**Subject:** RE: CEN12FA250: Information Request  
**Attachments:** 078-HELI-APPR-ANG-RB HELICOPTER APPROACH ANGLES.PDF

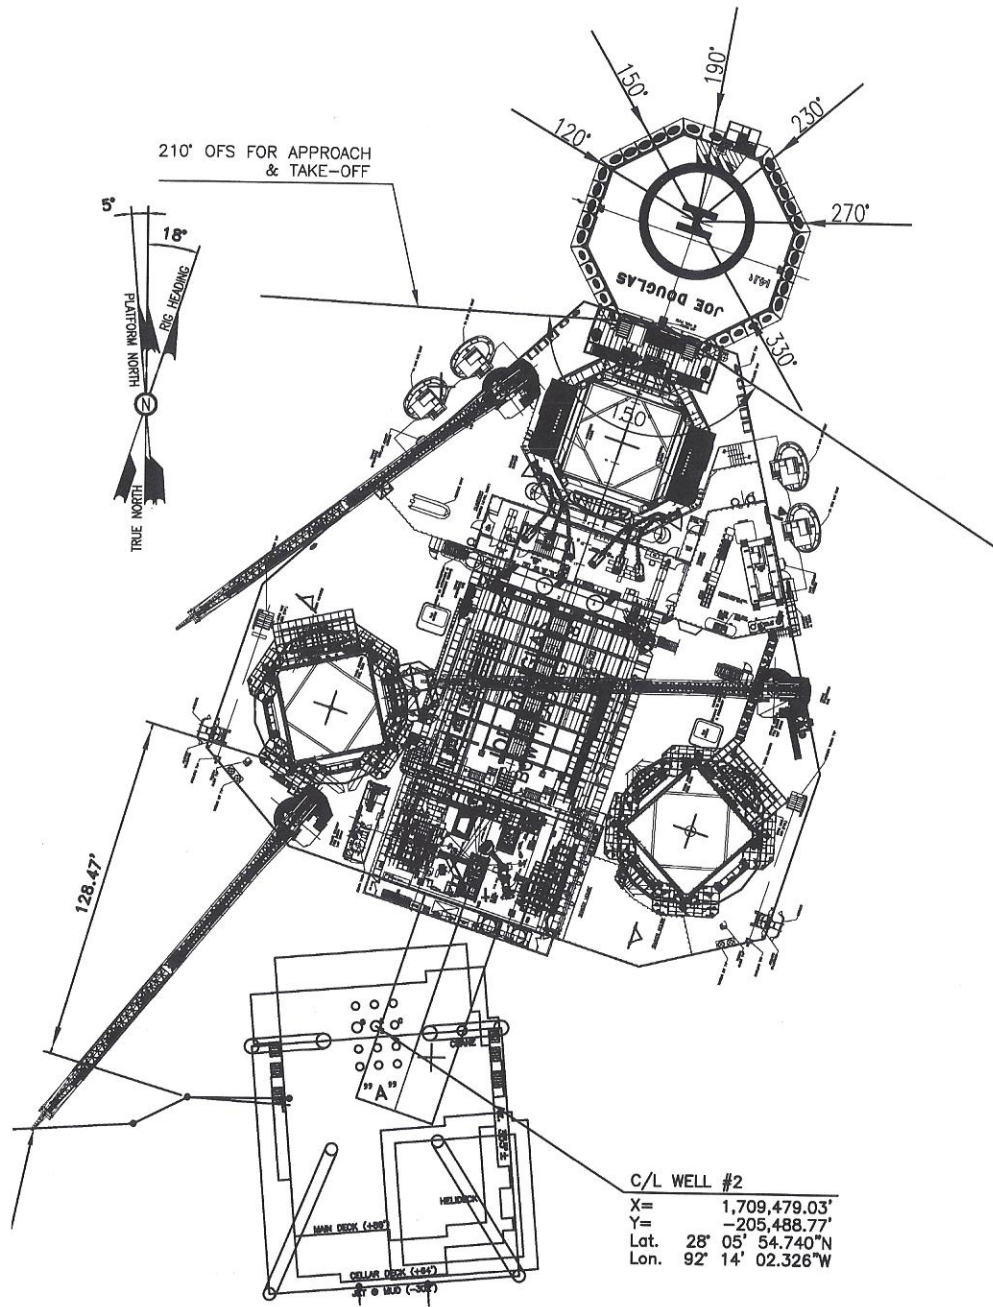
I've provided an updated two dimensional view with a bit more information. This updated drawing reflects more accurately what the cranes would look like during take-off and landing in their stowed positions. Also, I've provided answers to your questions in red below. It took me a bit of time to gather answers as the personnel onboard the rig the day of the incident are currently off rotation.

1. Is this drawing now aligned with the actual heading of the rig at the time of the accident? **(Yes, the rig is currently in the same heading it was at on April 17<sup>th</sup> and that is what the drawing reflects.)**
2. Were the cranes actually positioned as they are depicted in this drawing? If not, how were the cranes positioned at the time of the accident? **(Crane positions do not reflect actual positions at the time of incident. The crane should be in stowed position during takeoff and landing.)**
3. During takeoff and landing at the pad, do the cranes get positioned so that they are in the least restrictive positions for the landings and departures? **(See answer to #2 above)**
4. As the drawing depicts it now, it appears that a 190 degree heading is flying almost right at the middle of the rig. Am I correctly interpreting the drawing? **(Yes)**
