**NATIONAL TRANSPORTATION SAFETY BOARD**  
Vehicle Recorder Division  
Washington, DC 20594

## **On Board Image Recorder**

**Specialist's Factual Report**  
**By Bill Tuccio**

Location: Kenai, Alaska  
Date: July 14, 2012, 1515 Alaska Daylight Time (ADT)  
Aircraft: Piper PA-18-150, N7154Z  
Operator: Private  
NTSB Number: ANC12LA075

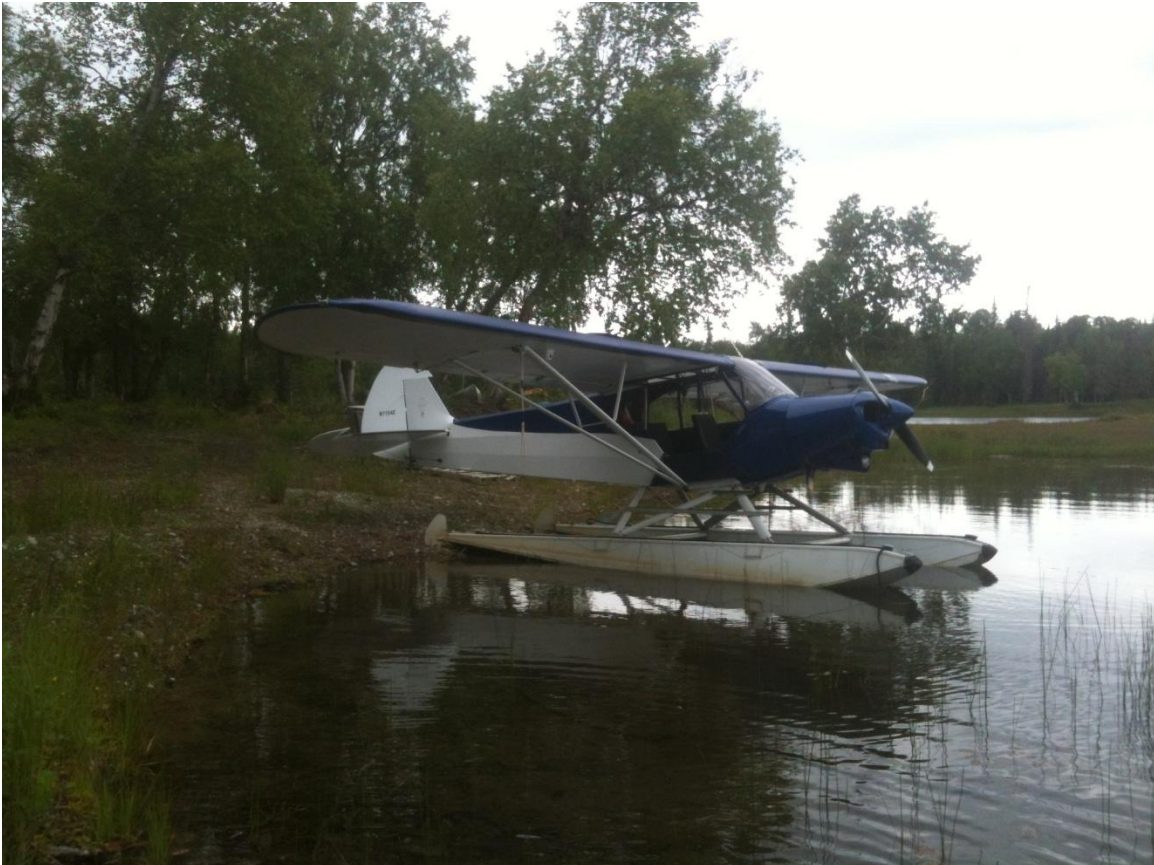
The digital photograph of the accident aircraft is shown in figure 1. The metadata of the photograph indicated the photo was taken July 14, 2012 at 15:07 ADT. The aircraft is beached at a lake shore with the engine off. Figure 2 provides increased resolution of the propeller of the accident aircraft, excerpted from the same digital photograph.

**Figure 1. Digital photograph of accident aircraft.**

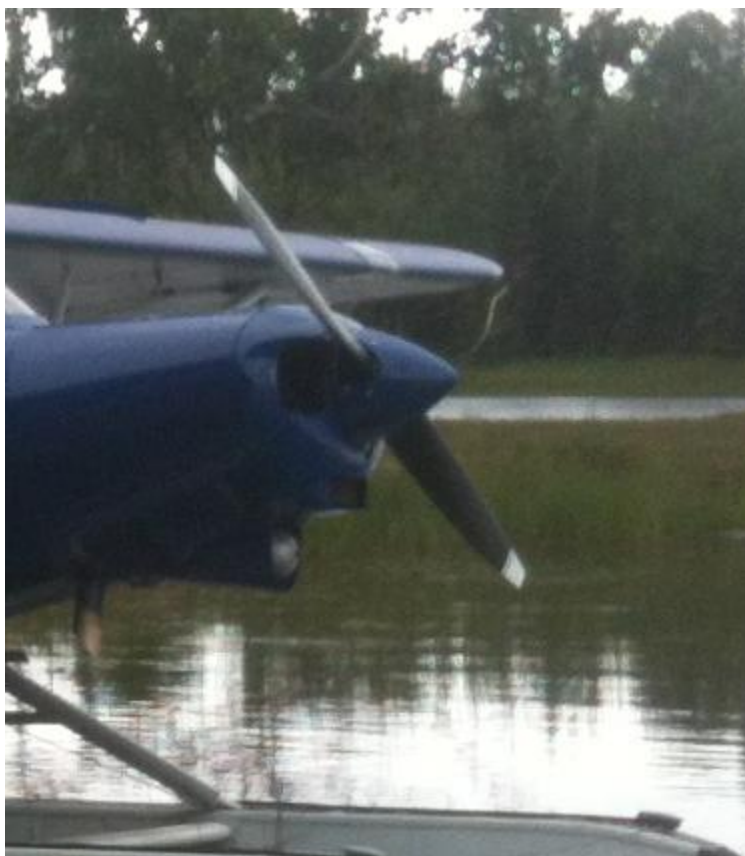
**Figure 2. Propeller excerpt.**
