Turn Coordinator Examination Notes from July 29, 2013

N5714W

NTSB Case # ERA13FA088

Parkton, North Carolina

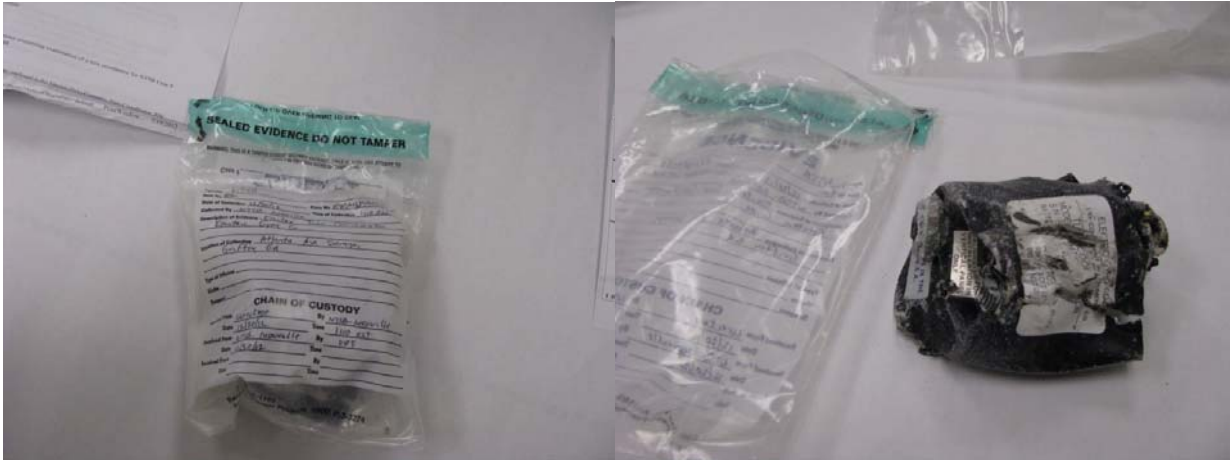
- Removed subject article from the sealed box as delivered by the FAA representative.
- The Turn Coordinator was in plastic evidence bag which was sealed.

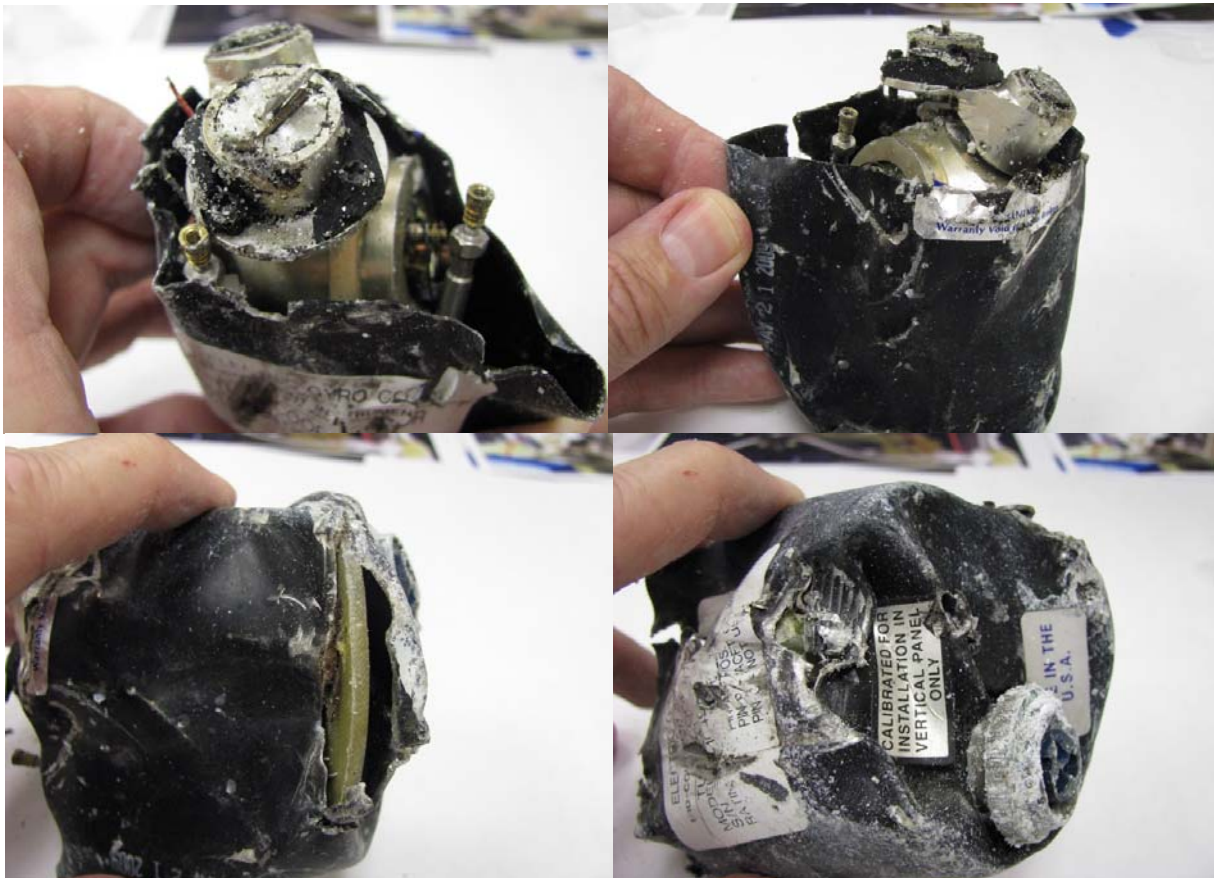
- Visual inspection of article shows significant impact damage.
- The front 1" (display) of the article was missing.

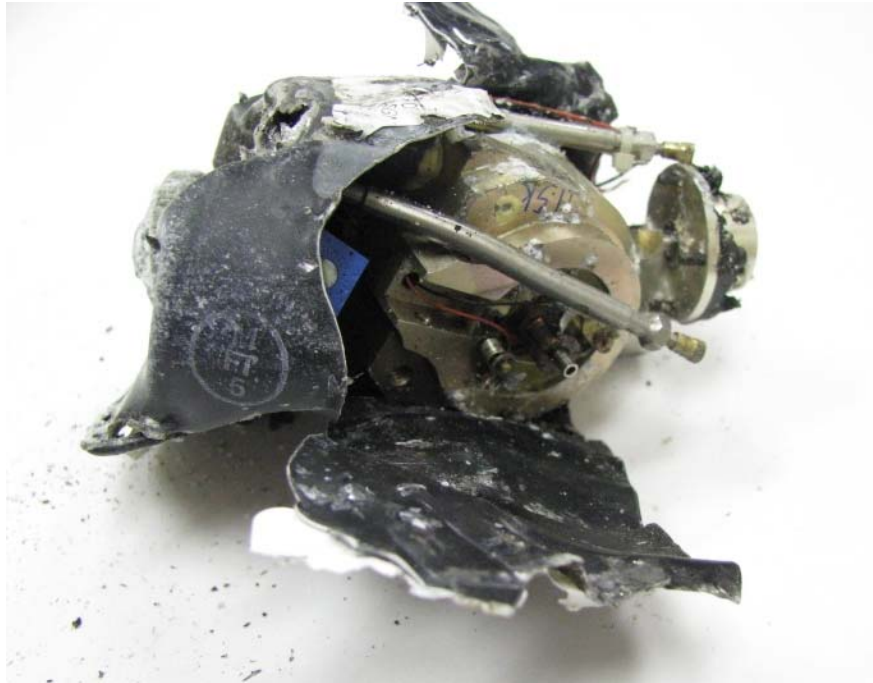
- The aluminum cover had to be cut away to gain access to the inner assembly.

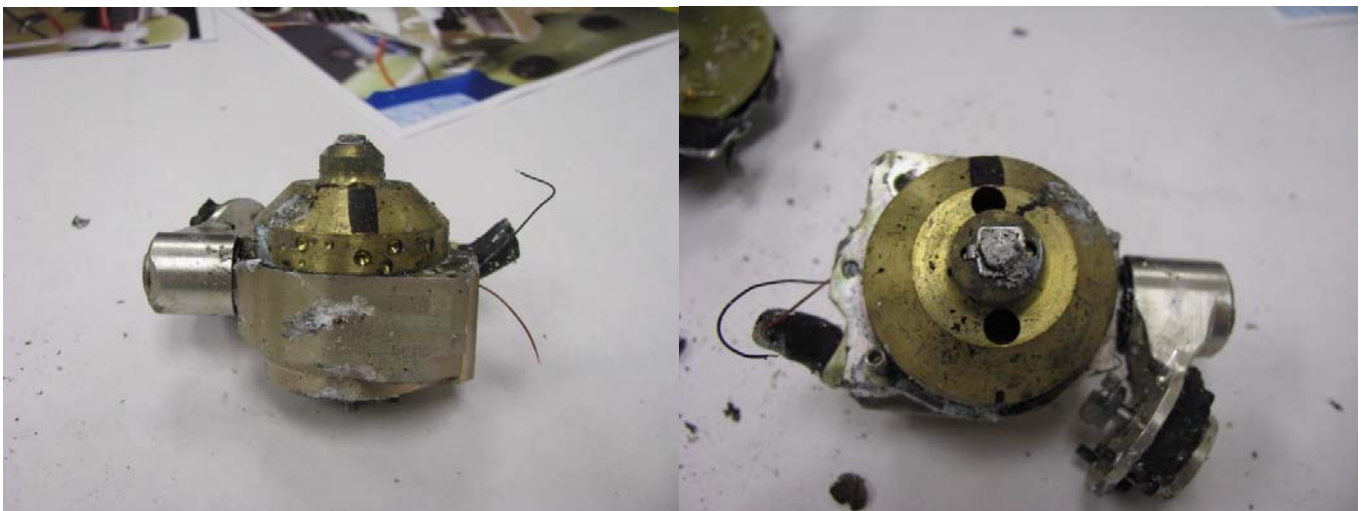
- The inner gimbal assembly was removed.
- Extensive corrosion found.

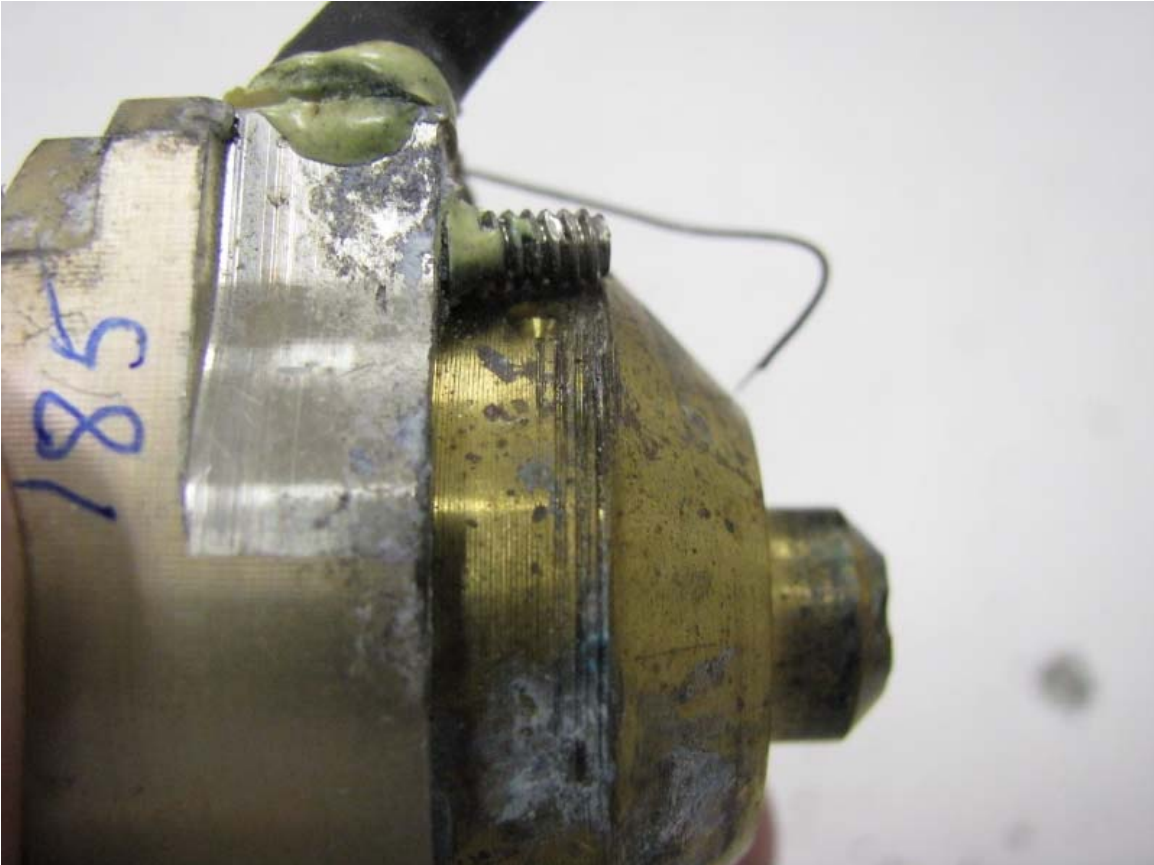
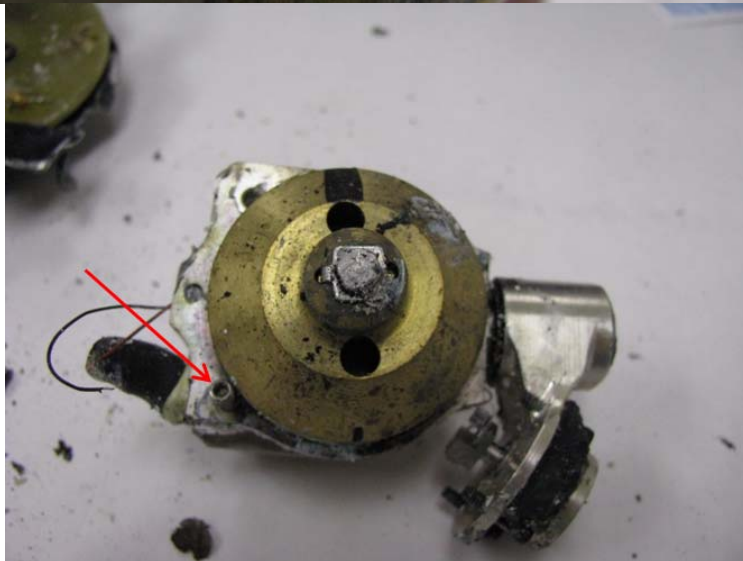
- Rotor assembly was examined for evidence of rotation at the time of the accident.
- Evidence of score marks for approximately 1.25" of the 4.5" circumference
- Score marks align with a gimbal balance weight.
- The rotor bearings were free and relatively smooth (some ball dents)

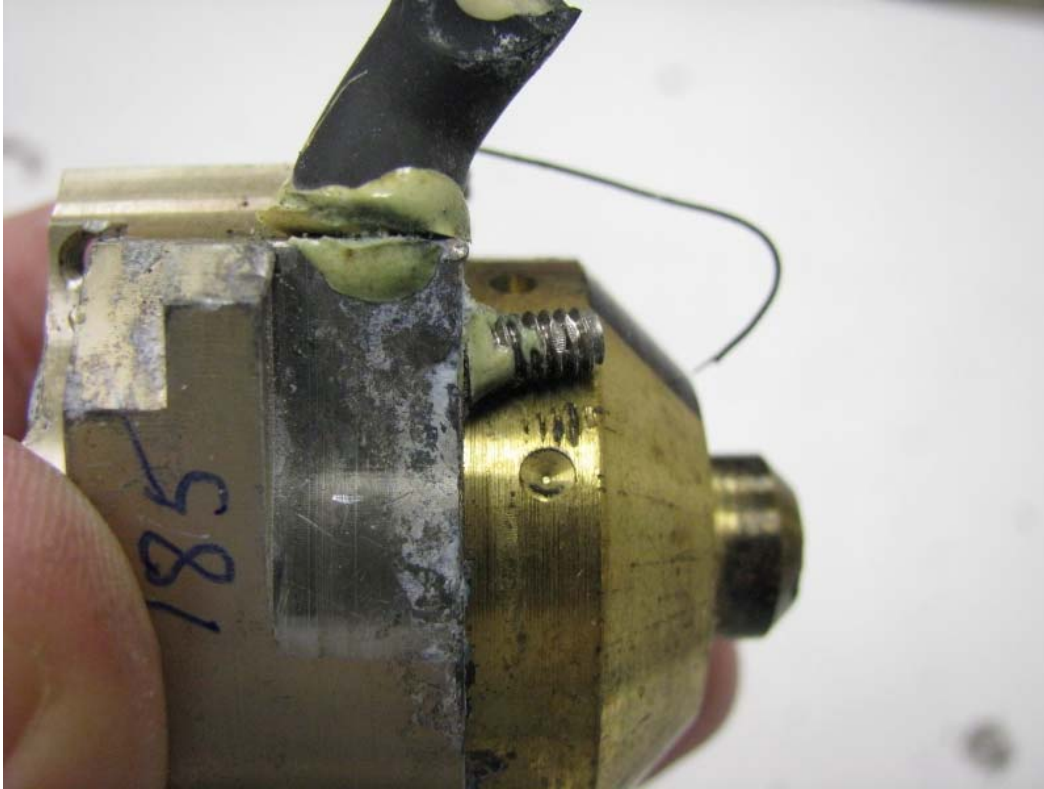
- An additional score mark was found at a different point of the rotor circumference.

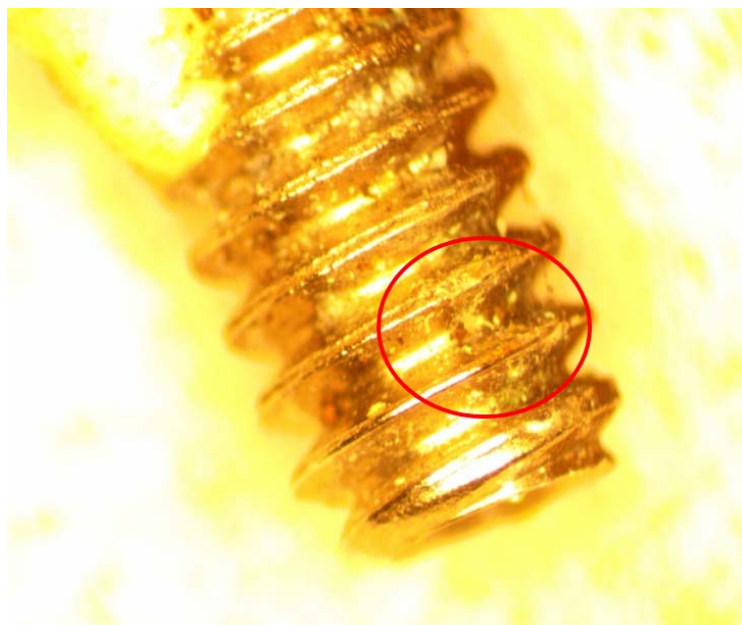
- The stainless steel balance weight/screw was inspected for signs of rotor material (brass). A minute amount of yellow/brass material was seen but photographs were unable to capture.

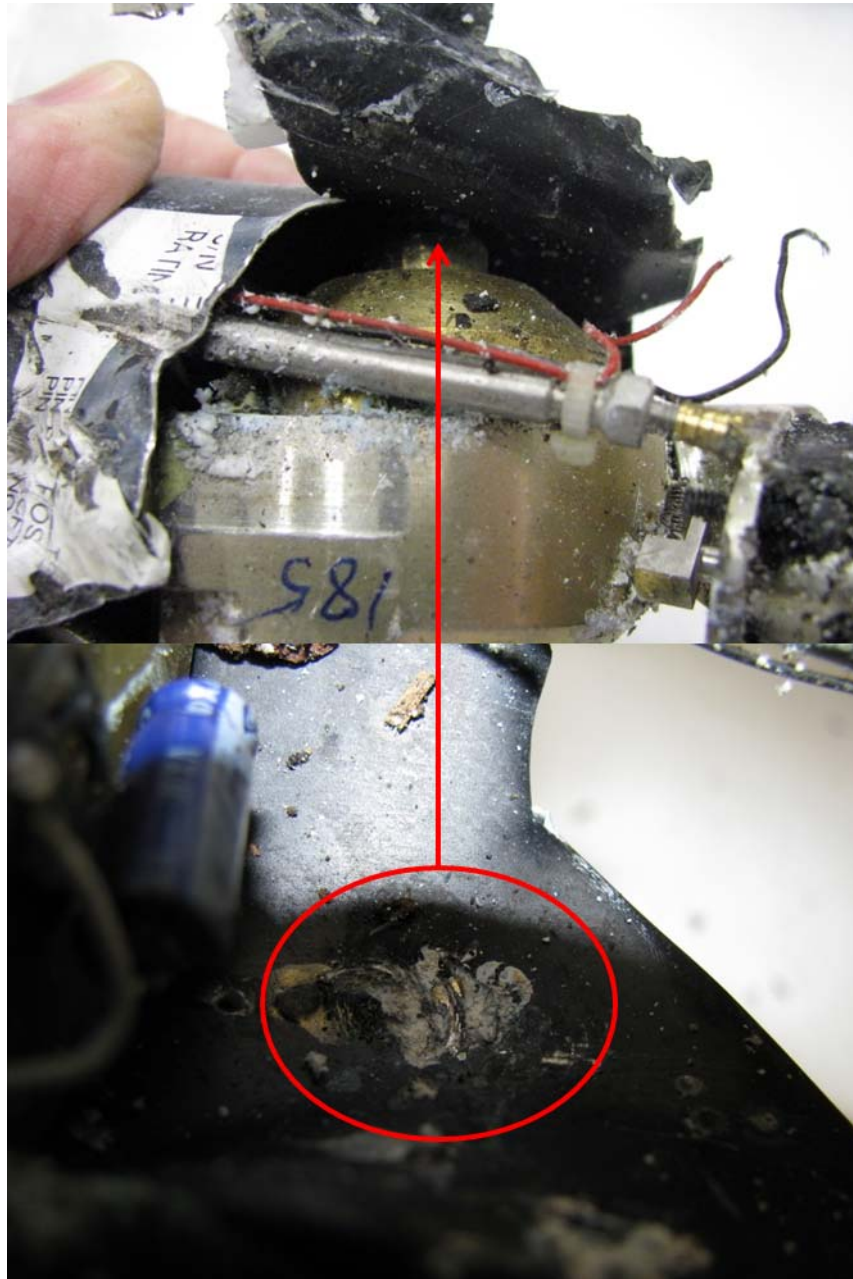
- Examined the inside of the case for evidence of rotor (brass) contact with the inside of the case housing.
- Evidence found of brass colored transfer but unable to determine if the rotor was spinning when the transfer occurred.
