NATIONAL TRANSPORTATION SAFETY BOARD

On Board Image Recorder

Specialist's Factual Report

Location: Cataldo, Idaho
Date: August 18, 2013
Aircraft: KR2, N9028Q
Operator: Private
NTSB Number: WPR13FA380

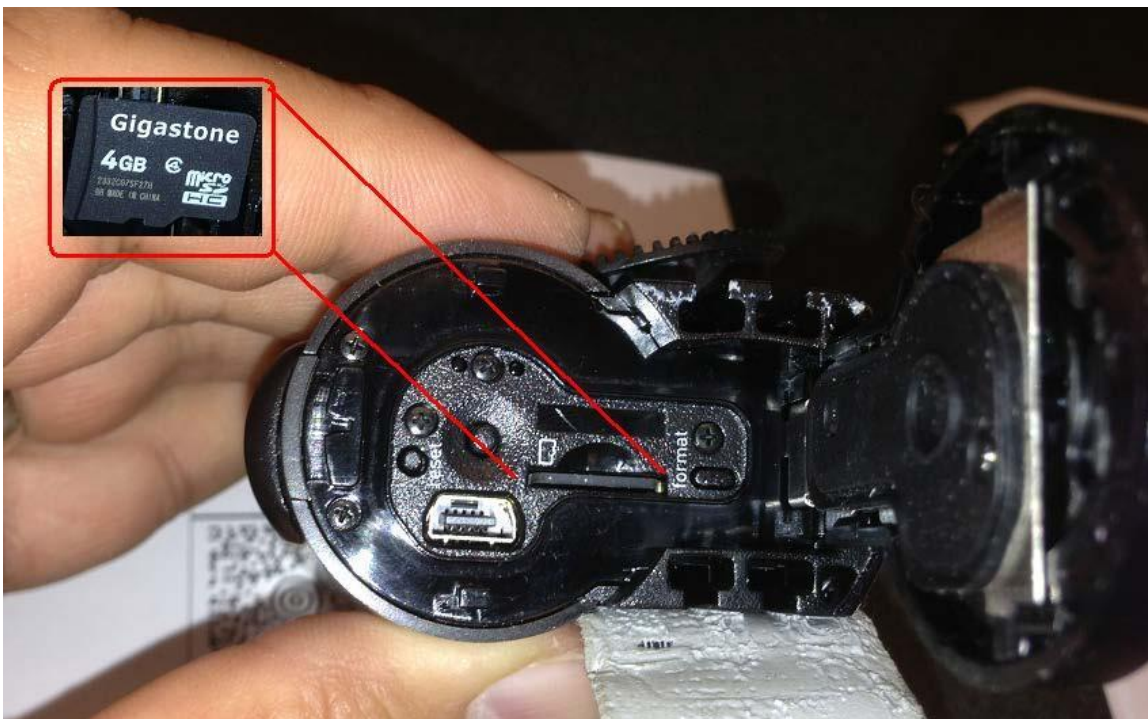
Upon arrival at the audio laboratory, it was evident that the camera had sustained only minor structural damage, as shown in figure 1. The 4GB microSD card was removed and video and audio information was extracted from the card normally, without difficulty.

Figure 1. Contour Roam 2 camera with microSD card in place.

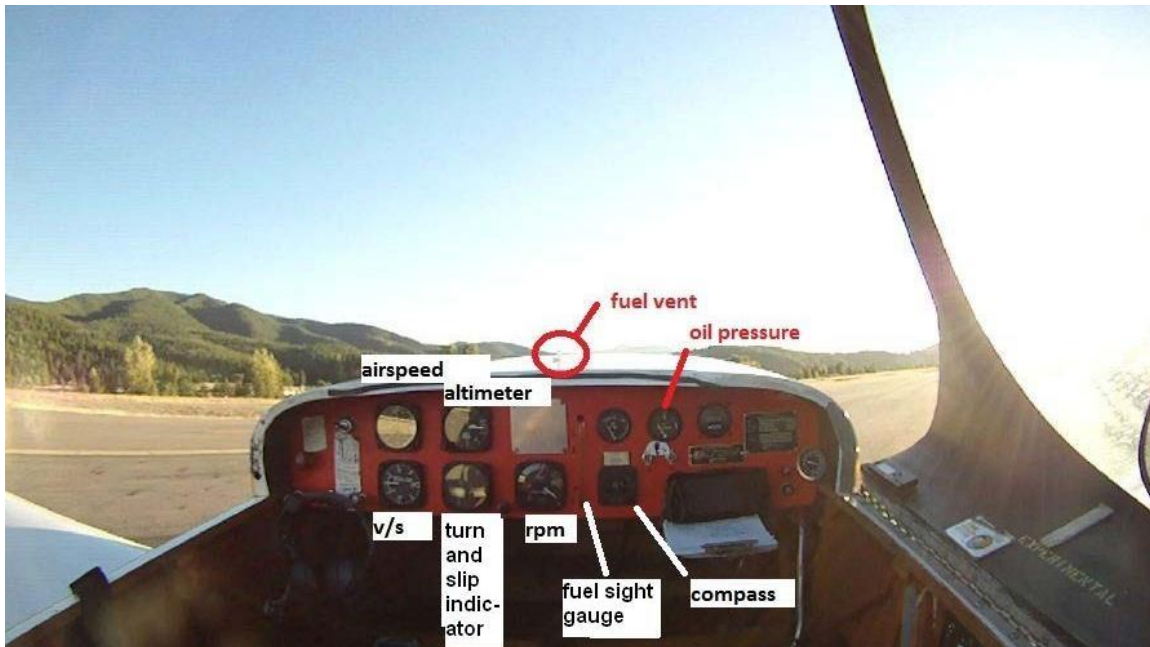
Figure 2. Accident aircraft camera view with annotated instrument panel.
