CEN131A563, ABORTED TAKE-OFF, MSN 1253

1 SUMMARY

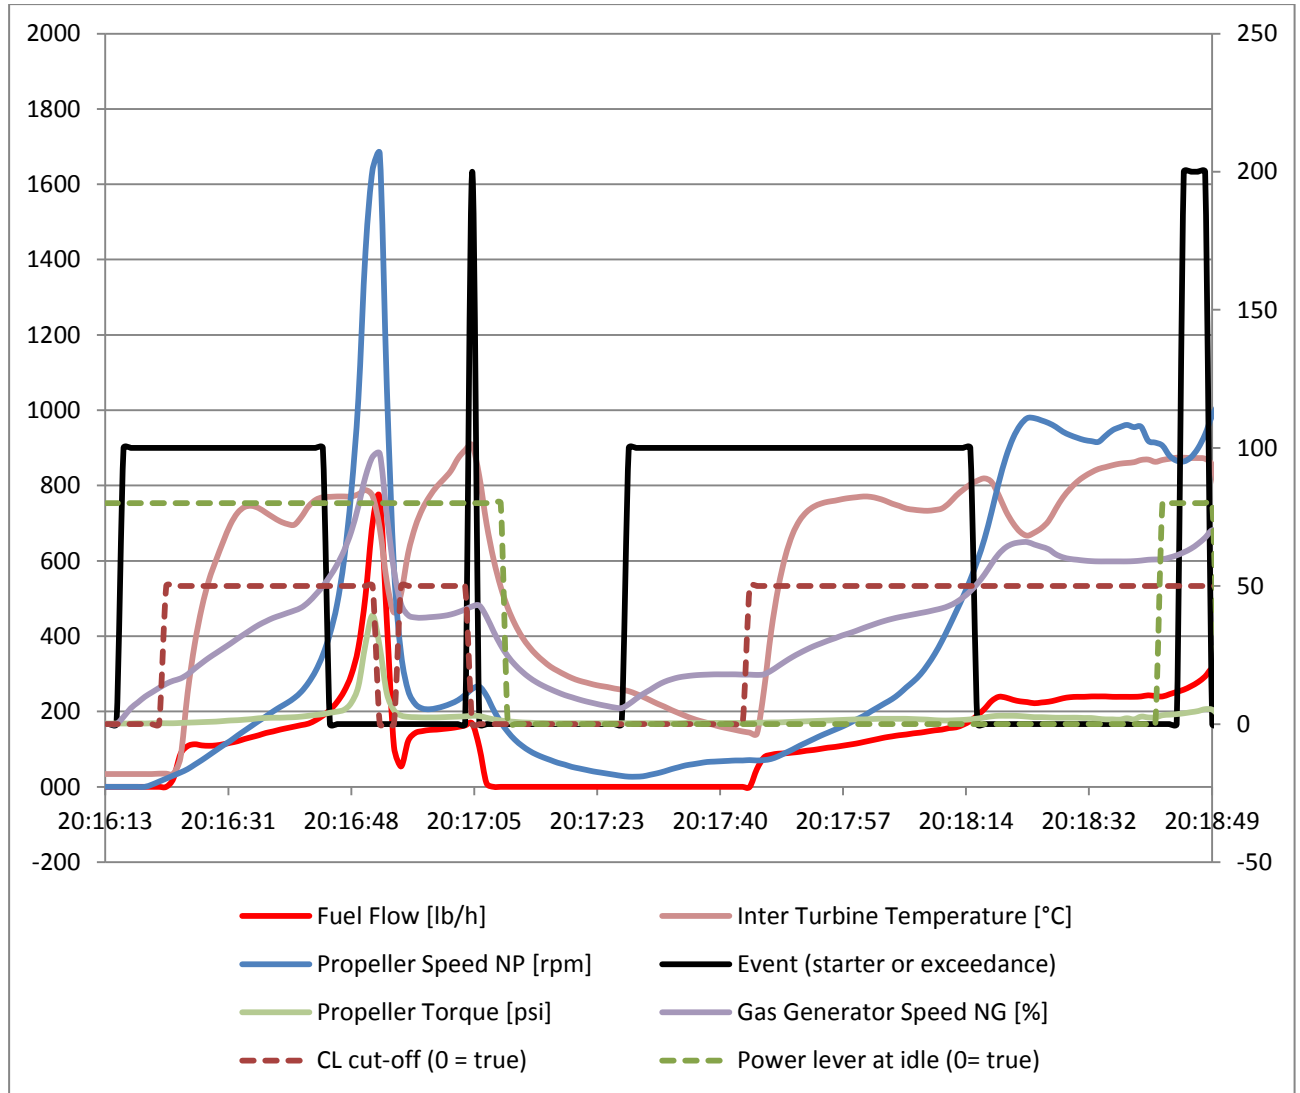
Figure 1 Engine start event

At 20:16:16 the starter is engaged. Ng rises and at 20:16:22 with an Ng of 15%, the condition lever is put out of cut-off as indicated by the change of status (brown dashed line). ITT starts to rise indicating that the engine had ignited. At 20:16:45, the start cycle is finished at an Ng of 50% (see black line dropping to 0). During the entire event, the PCL is not at the idle stop as indicated by the green dashed line. How far forward from idle it was cannot be seen on the data but Ng, FF, Np and torque now rise in one go to nearly full power. The peak in torque and Np is registered at around 20:16:52. At the same time, the CL was pulled back far enough to activate the propeller feather switch (as indicated by the sharp drop in propeller speed) and the cut-off signal but not enough to shut the fuel off (see red FF line). After three seconds, the cut-off signal changes state again indicating that the CL had moved slightly forward. The propeller remains in feather as indicated by the low propeller speed. Only at 20:17:05, the CL was brought fully back as indicated by the fuel flow which now goes to zero. However, ITT had briefly exceeded the 870° and an exceedance was

logged (see black line). The power-lever was brought back to idle 5 seconds later, at 20:17:10. At 20:17:27, the engine is restarted and iaw the AFM, the ITT was allowed to drop to approx. 140°C before the CL was brought out of cut-off. At the end of the start cycle, ITT is at approx. 800°C before dropping to 670°C. Now it is however rising again and exceeds 870°C for 6 seconds after 20:18:43. An exceedance is logged once more.

Note: No determination has been made why the ITT exceeded 870° for 6 seconds and peaked at 874°C.

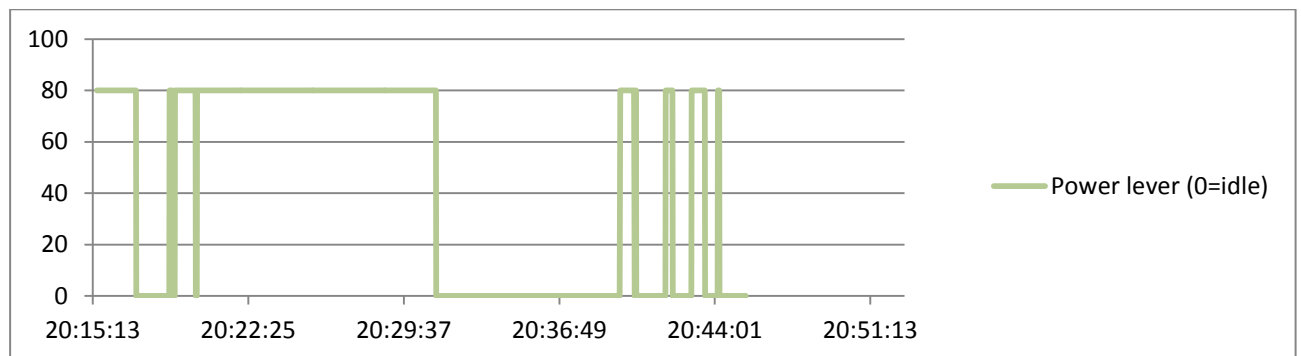
Figure 2 PCL position

The pilot mentions in the second report (Appendix B), that the power lever may have been pushed forward inadvertently by the passenger which then caused the engine to accelerate to nearly full power. FDR data confirms that the PCL was not at the idle detent during the first engine start but it also shows that the PCL was not at idle since the aircraft was powered up, see Fig. 2 below. The data also shows that initially the pilot had not fully retarded the condition lever when attempting to shut-down the engine. Although the propeller went into feather, fuel flow was still present. Since the Ng had already dropped to 40%, the engine wasn't accelerating and ITT rose rapidly. Only in the second attempt, the condition lever was brought back into the cut-off detent and fuel was shut-off.

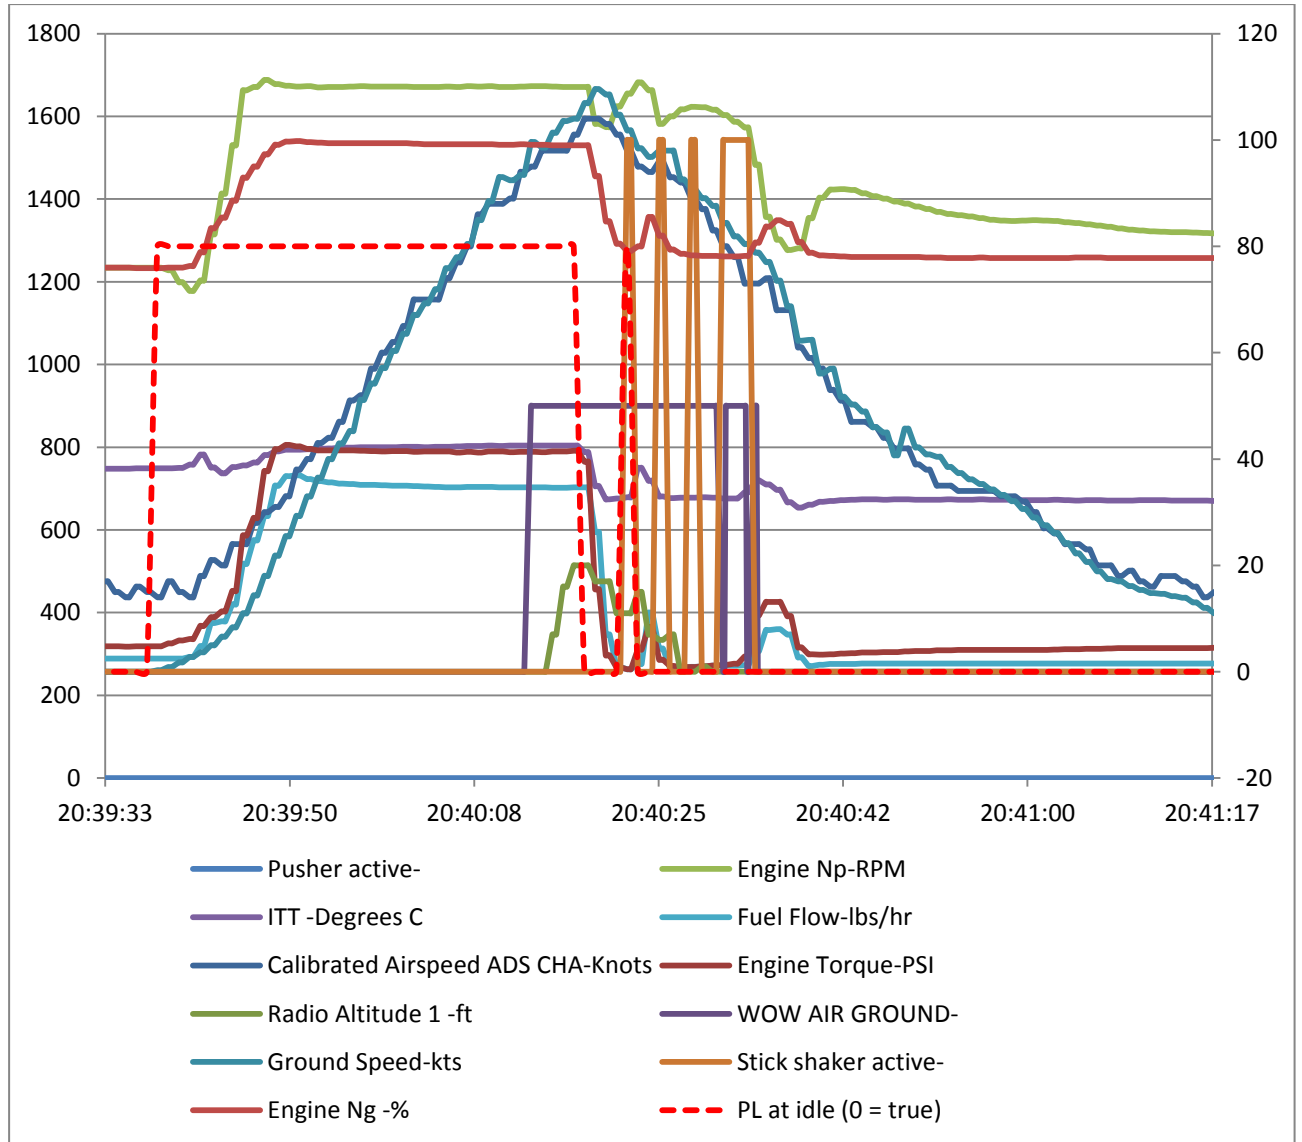
Figure 3 Take-off event

The power lever is brought out of idle at 20:39:37. The engine reaches full power of approx. 42 psi 12 seconds after power application, airspeed has reached 31 KCAS. Lift-off as indicated by the WOW air-ground signal occurs at 20:40:13 at an airspeed of 95 KCAS. At 20:40:18, at 104 KCAS and 20 ft radar altitude, the power lever is pulled back to idle, power starts to drop and is 3 seconds later at idle. Airspeed has dropped to 98 knots and the stickshaker activates for 1 second. Data shows now a brief power application to 8 psi before it goes back to idle and remains there. The shaker activates three more times, the last time while the aircraft is already on the ground. No stickpusher activation is recorded. After the aircraft has finally settled on the runway, a 3 second power increase up to 13 psi torque can be seen which is considered to be reverse power application. After that, the engine stabilizes at approx. 4 psi torque and a fuel flow of approx. 280 pph corresponding to flight idle.

The ACMS and FDR data analysis did not identify any aircraft malfunctions or inconsistencies that would explain why the take-off was aborted shortly after lift-off. It shows that the power lever was retarded to idle prior to any shaker activities. The analysis of the engine start sequence is indicative of an operation outside the procedures given in the AFM.

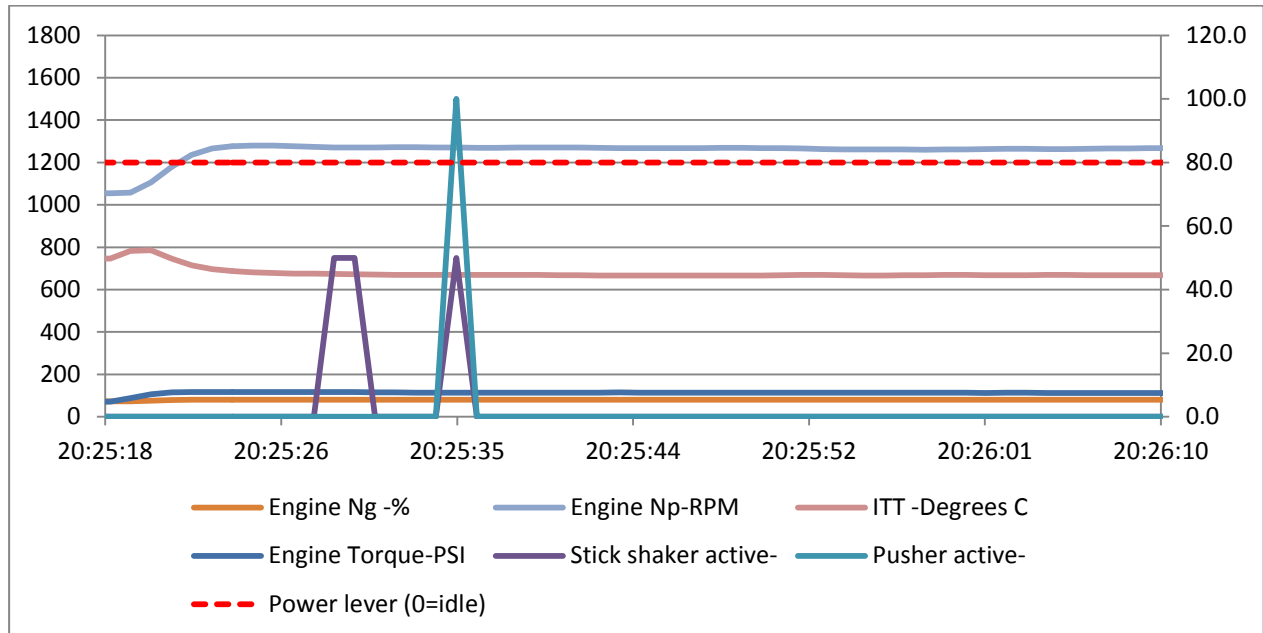
Figure 4 Shaker and Pusher activations

The above figure shows the time when the stickpusher check was done. At 20:25:18 power was increased to 7.8 psi (5 to 10 per AFM) and then the pusher test was started. From 20:25:28 to 20:25:31, the shaker activates and a few seconds later, the shaker and the pusher activate. No further pusher activities can be seen on the data.

It is noteworthy that the power lever was not in the idle position before the test nor was it brought back to idle after the initiation of the test as instructed in the AFM.
