**NATIONAL TRANSPORTATION SAFETY BOARD
Office of Research and Engineering
Vehicle Recorder Division
Washington, D.C. 20594**

GROUP CHAIRMAN'S FACTUAL REPORT OF INVESTIGATION

CEN13FA192

Location: Grand Lake, Louisiana
Date: March 15, 2013
Aircraft: Sikorsky S-76A++ , N574EH
Operator: Era Helicopters LLC, Flight ERA 574
NTSB Number: CEN13FA192

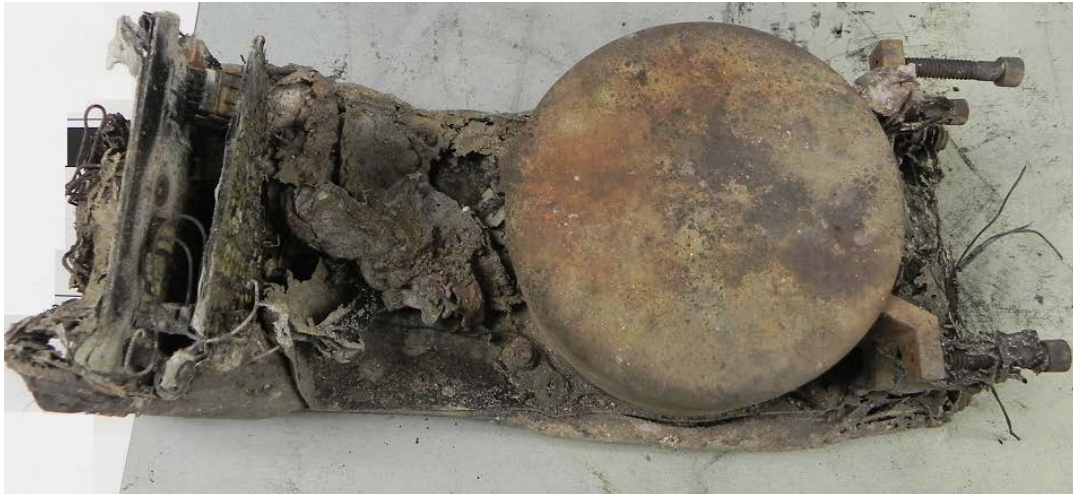
Upon arrival at the audio laboratory, it was evident that the CVR had sustained significant heat and structural damage, as shown in figure 1. The crash survivable memory unit (CSMU) was removed from the CVR assembly, as shown in figure 2. The CSMU was disassembled and the memory "puck" was

Figure 1. CVR as received.

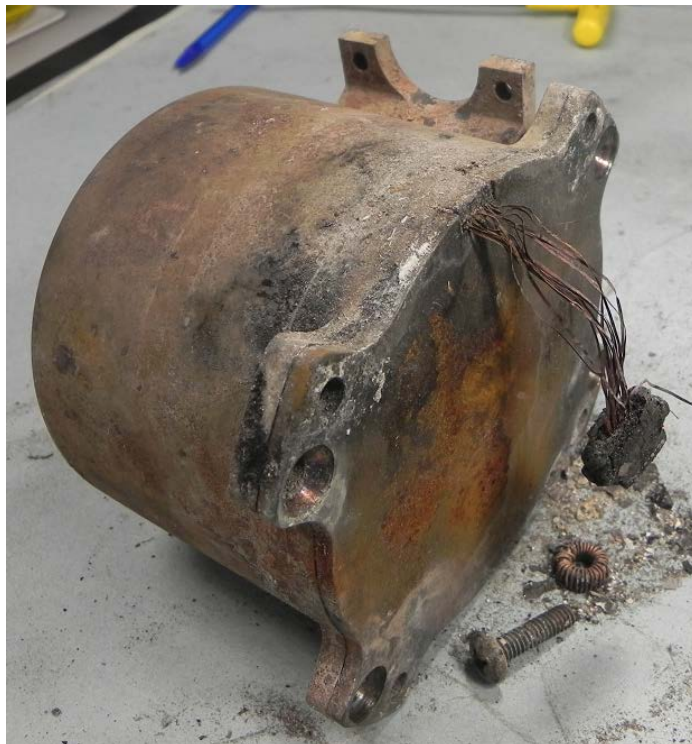
Figure 2. CSMU removed from CVR assembly.

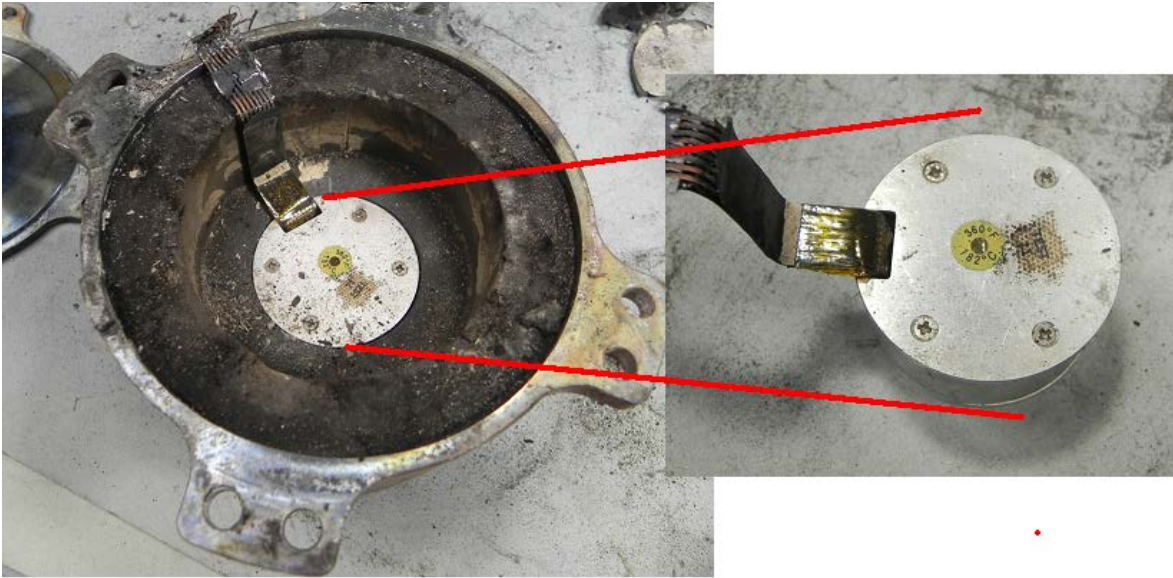
retrieved from the CSMU, as shown in figure 3. The memory puck showed signs of thermal exposure in excess of its designed limits. The memory puck was removed from its container, as shown in figure 4. The memory puck was disassembled, inspected, and reassembled as outlined in the L-3 Accident Investigator Kit. The memory was then downloaded using an NTSB surrogate recorder.

Figure 3. Memory puck retrieved from CSMU.

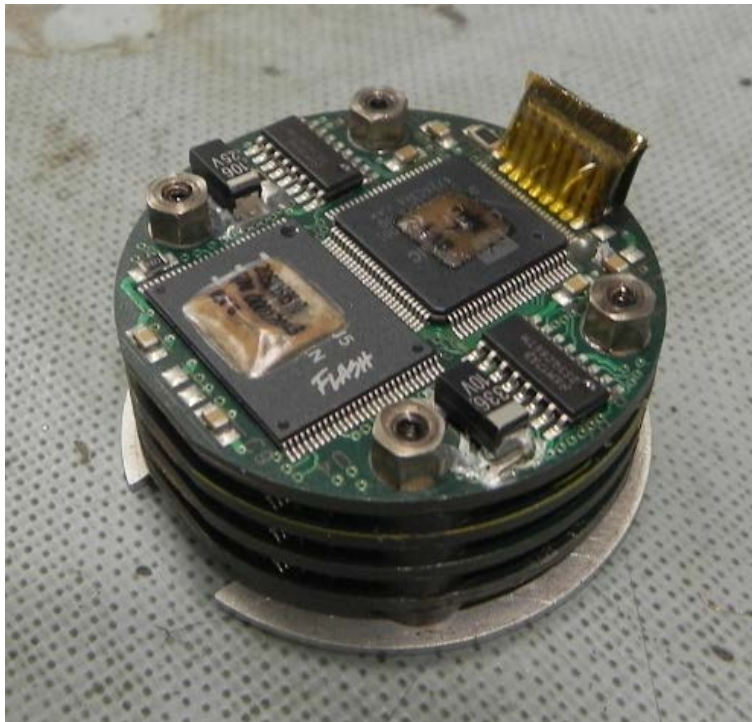
Figure 4. Memory puck removed from container.
