## **AIRWORTHINESS GROUP CHAIRMAN'S FACTUAL REPORT**

**CEN13FA192**

**Sikorsky Aircraft Corporation Tail Rotor Blade Materials Engineering  
Report No. MER-OA1308141 (16 Pages)**

SAMPLE IDENTIFICATION  Mishap A/C 760369 Tail Rotor Blade Examination	MODEL S-76A++	
	CHARGE NO. [REDACTED]	
	SUBMITTED BY NTSB	DATE 4/10/13

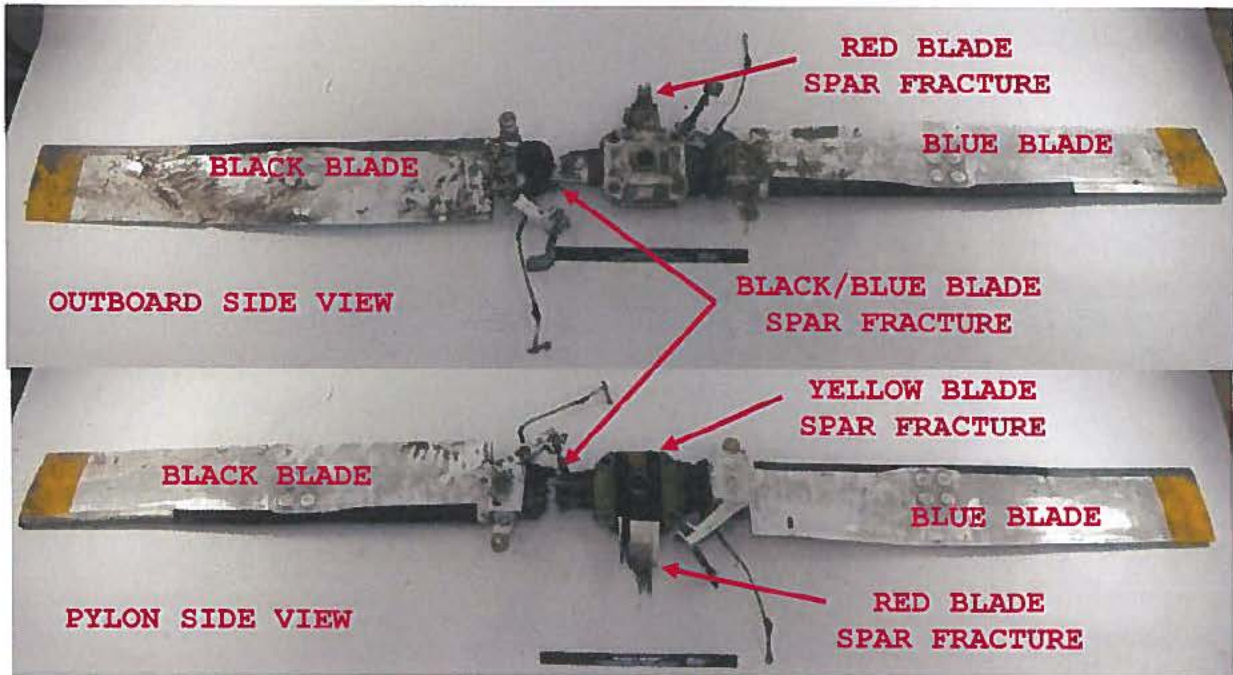
Figure 1

Figures 1 and 2 show the tail rotor blades as they were received by the laboratory in April of 2013. The blue/black blade paddles exhibited a relatively minor amount of damage, which indicates that they did not impact the ground with a significant degree rotational force. Fracture of the blue/black blade spar occurred just outboard of the boot on the black blade side. Fracture of the red/yellow blade spar occurred roughly at the pivot bearing location on the red blade side and at the edge of the retention plate assembly on the yellow side. The bonded pivot bearing retainers had separated from the pylon and outboard sides of the red blade spar half and were not recovered. The bumper plates, which are bonded to the spar at the same time as the retainer plates, remained with the spar.

Overall photographs showing the as-received condition of the subject tail rotor blade pieces with associated hardware. Locations of the spar fractures are shown. Note paddles were in generally good condition.

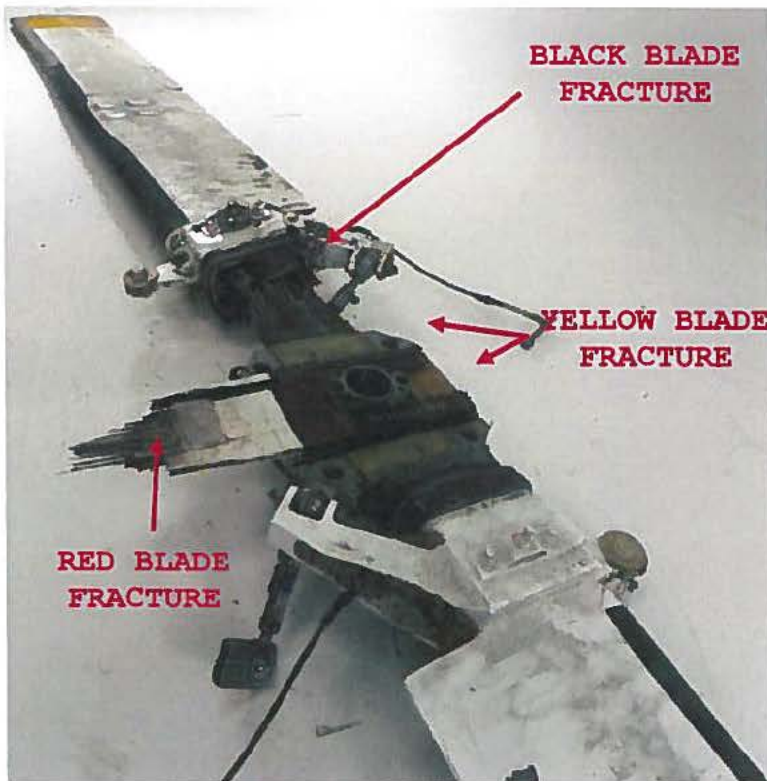
Figure 2

Close-up view of the pylon side showing the fracture locations.

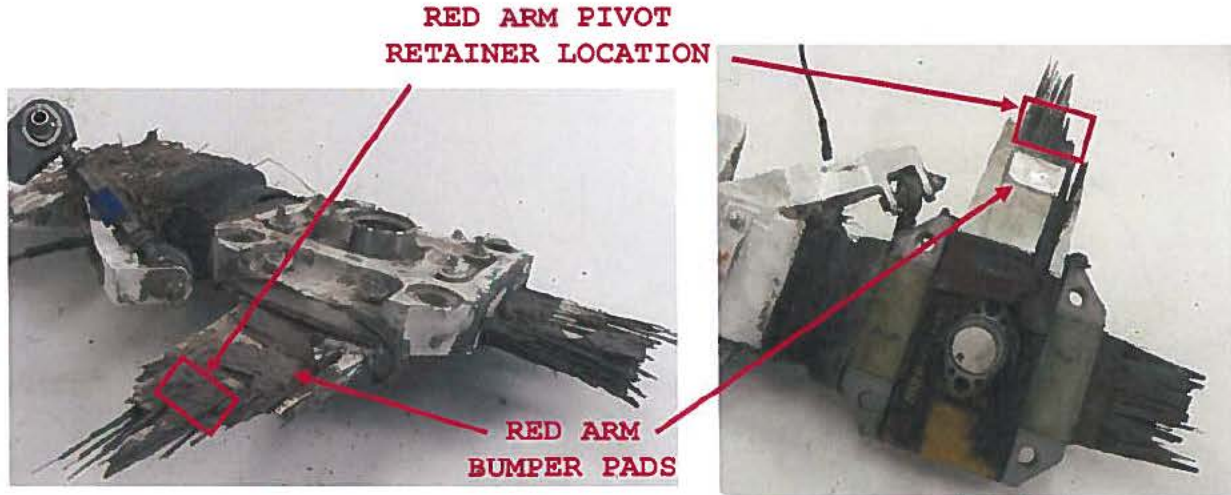
Figure 3

Overall views showing the pylon and outboard sides of the spar fractures are given in Figures 3 and close-up views showing the center section of the red/yellow blade spar are given in Figure 4. The red/yellow blade was found to have shifted in the direction of the yellow blade. This is an indication that the red paddle departed the aircraft first with the resulting centrifugal force imbalance causing the spar to be pulled in yellow blade

Another as-received view showing the outboard and pylon sides of the fractures.

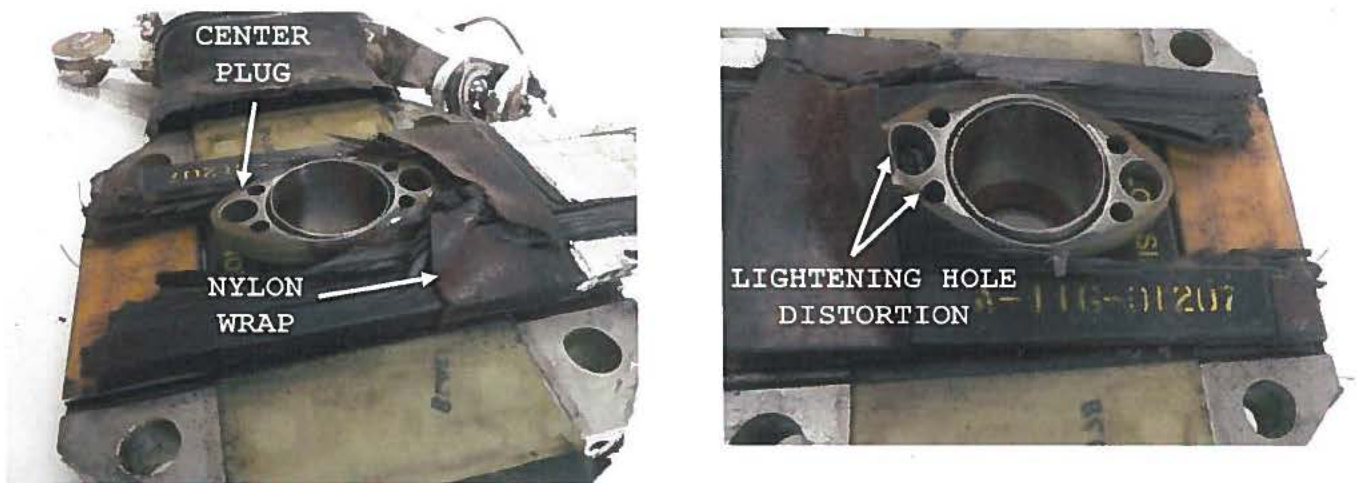
Figure 4

direction. The force of the imbalance was sufficient to yield the aluminum center plug at the lightening holes, and force graphite splinters through the lightening hole wall. Once the blade had shifted within the retention plate, the yellow blade fractured at the edge of the retention plate assembly.

4. The red paddle departed the aircraft before the yellow paddle. The resulting imbalance allowed the spar to shift in the yellow blade direction and deform the center plug.

Close-up views of the red/yellow blade spar center section showing yielding of the center plug and graphite splinters that penetrated into the lightening hole. Spar shift is indicated by the location of the nylon wrap, which is aligned with the edge of the retention plate at installation.

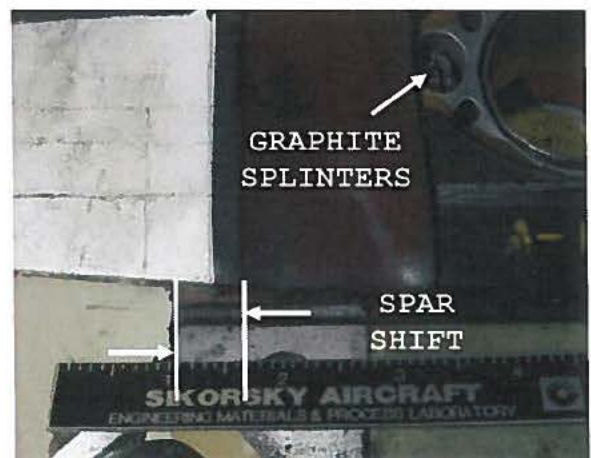
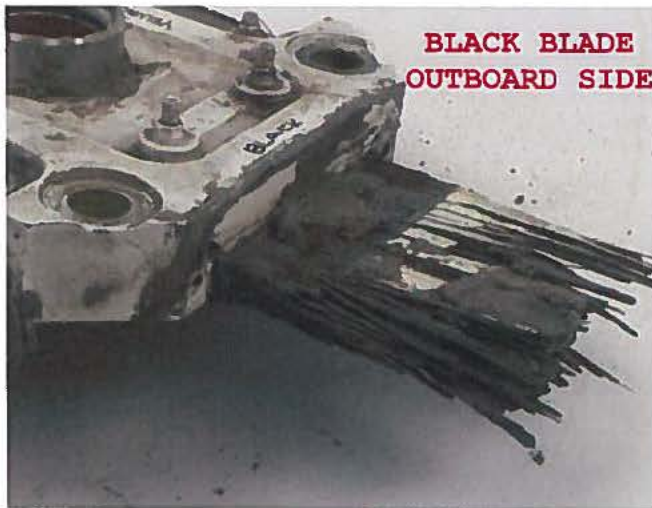
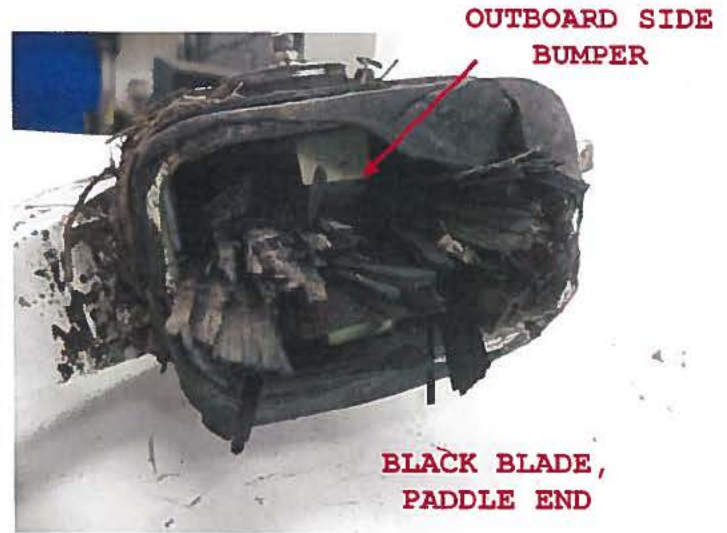
Figure 5

Close-up views of the blue/black blade spar fracture are given in Figure 5. Fracture occurred inboard of the pivot bearing at the bumper location. The fracture exhibited a broom straw appearance across the width with a flat compressive zone on the pylon side. The appearance was consistent with a flatwise bending overload fracture.

2. The blue/black blade spar had fractured at the pivot bumper location on the black blade side.
3. The black blade spar fracture exhibited a broom straw appearance and was accompanied by a thin strip of smooth, flat fracture on the pylon side. The overall appearance was consistent with a flatwise bending overload fracture.

Views of the black arm spar fracture showing broom straw appearance of the fracture and compressive fracture area on the pylon side.

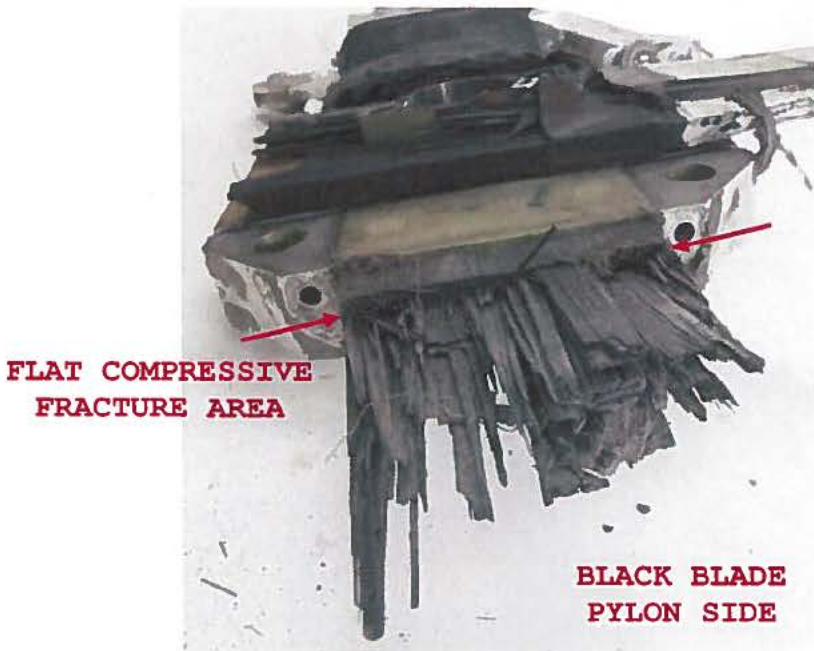
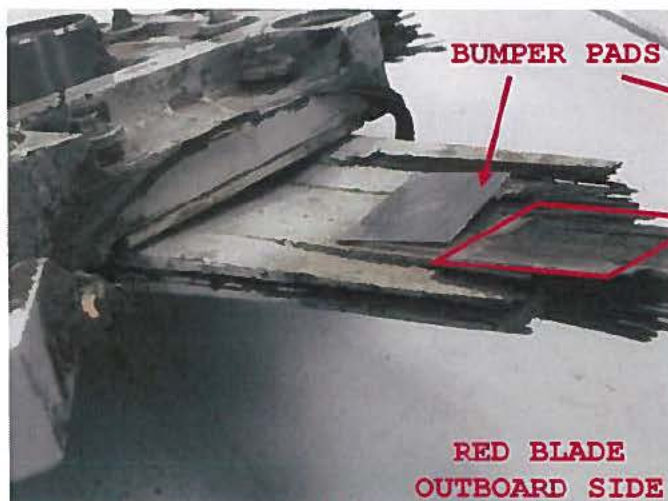
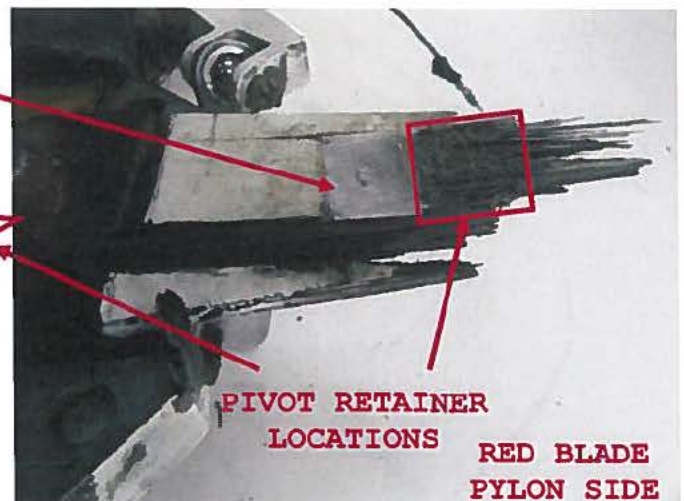
Figure 6 (below)

Close-up views of the red blade fracture are given in Figure 6. Fracture occurred outboard of the bumpers and exhibited a partial broom straw appearance with the longest broom straw strands in the center of the spar and becoming progressively shorter in the direction of the leading and trailing edge. The spar was noted to exhibit a chordwise bow and a mid-thickness delamination that extended across the width of the blade.

5. Fracture of the red arm occurred at the pivot bearing location and exhibited a partial broom straw appearance with the strands longest in the center of the spar and becoming progressively shorter toward the edges.

Views of the red arm blade spar fracture showing broom straw appearance of the center section and mid thickness delamination.

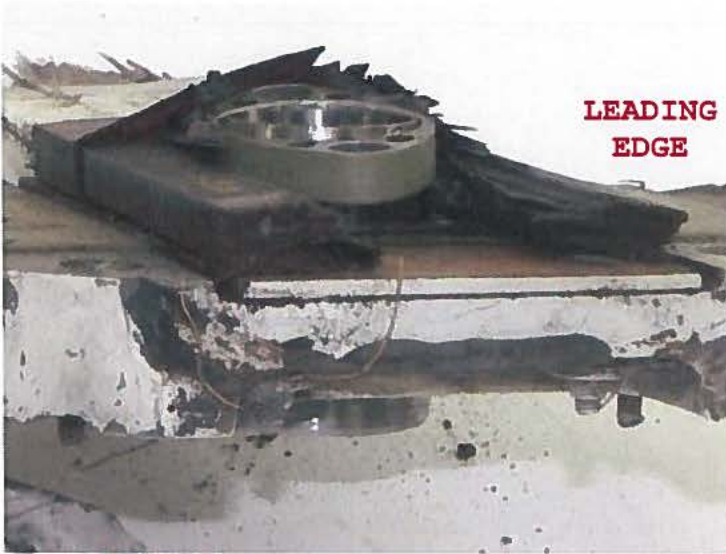
Figure 7

The yellow blade fracture is shown in Figure 7. The center portion of the spar had pulled away from the center plug and departed the aircraft with the rest of the blade. Only the leading and trailing ligaments remained. Fracture of the ligaments occurred at the edge of the retention plate. Unlike the black and red blade spar fractures, the yellow blade fracture showed no significant broom straw fracturing or inter-ply delaminations.

7. The yellow paddle departed the aircraft due to bending overload fracture at the edge of the blade retention plates.
8. The bonded pivot retainers on the red blade had separated from the spar and were not recovered. Examination of the bond surfaces showed a mixed mode of separation including adhesive disbond of the primer at the primer/rubber and primer/metal interfaces, plus cohesive fracture of the rubber. The direction of separation could not be definitively determined.

Close-up view of the yellow arm fracture. The leading and trailing ligaments of the fracture, still packed with mud in this view, exhibited a relatively flat fracture appearance with no obvious delamination or broom straw fractures.

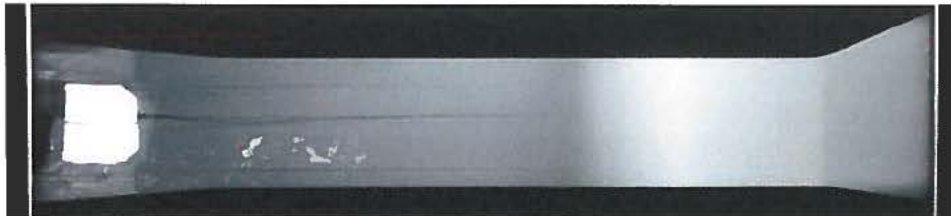
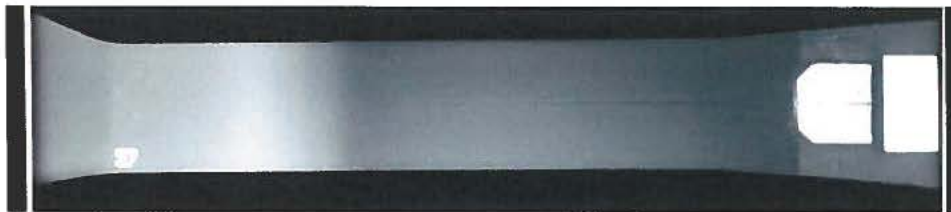
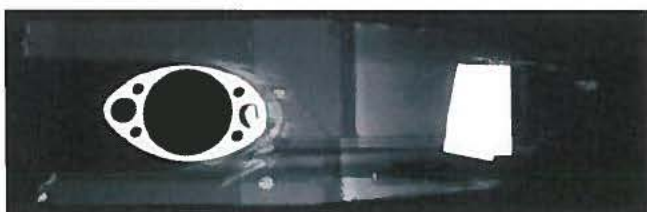
Figure 8

Following documentation of the as-received condition, the blades were removed from the retention plate and the blue/black blade spar was removed from the paddles. The spars were then x-ray inspected for evidence of ply waviness using the inspection procedure outlined in QATI 3210, Radiographic Inspection Procedure for P/N 7610-05016/76101-05017 Graphite Composite Tail Rotor Spar. No ply waviness or any other manufacturing anomaly was found; see Figure 8. This concluded the blade examination in April of 2013.

Photos documenting the radiographic inspection results.

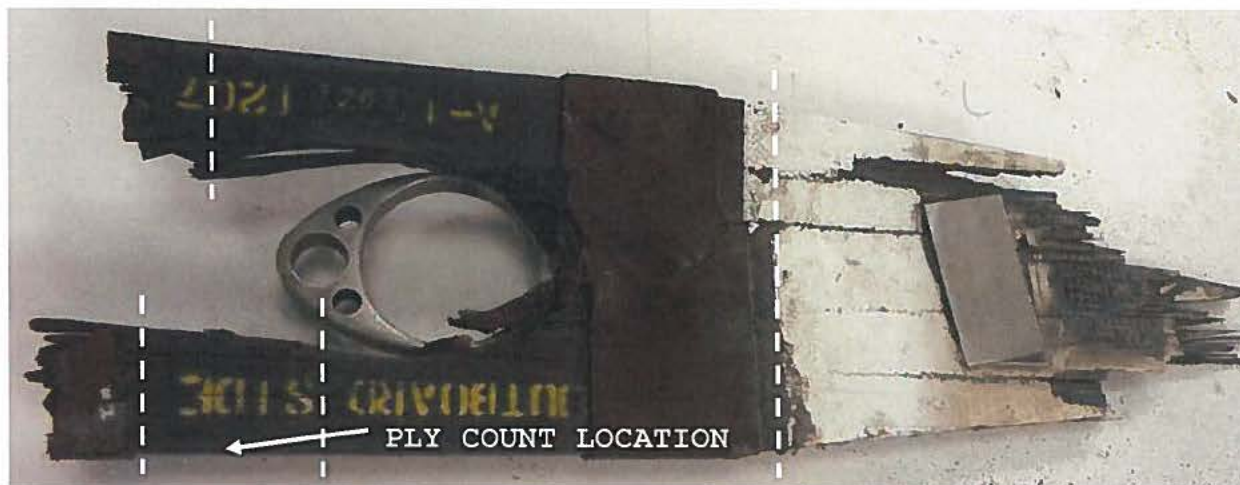
Figure 9

Outboard side of red/yellow blade spar remnants shown prior to sectioning. Dashed lines indicate saw cut locations. The center section was also used for fiber volume specimens.

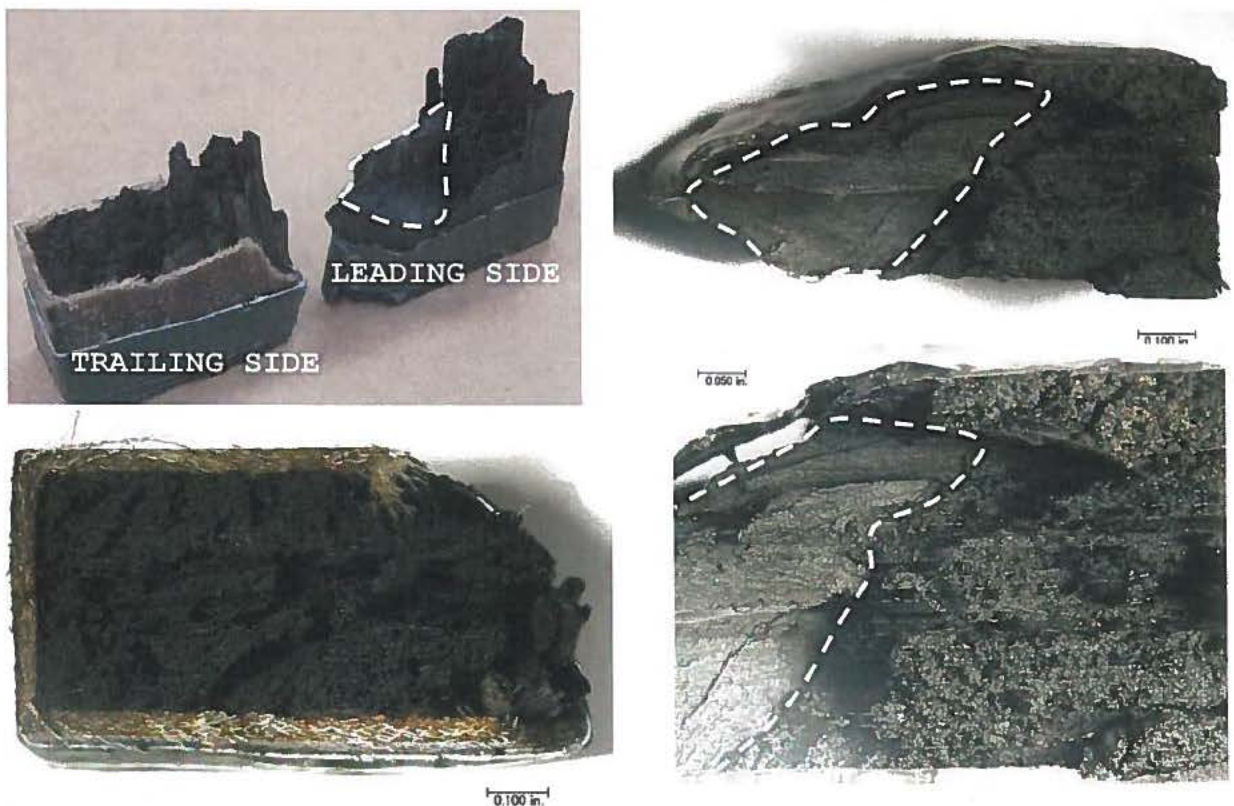
Figure 10

In August of 2013 the red/yellow spar was submitted for a more detailed examination. The spar piece was sectioned as shown in Figures 9 through 11. Close-up views of the yellow arm fracture are given in Figure 10. The fracture exhibited a predominately

tensile fracture appearance with a compressive fracture zone on the trailing side of the leading ligament.

Overall and close-up views of the yellow blade fracture showing fractured fibers. Dashed line indicates the location of the rubbed region, correlating to the compressive portion of the fracture.

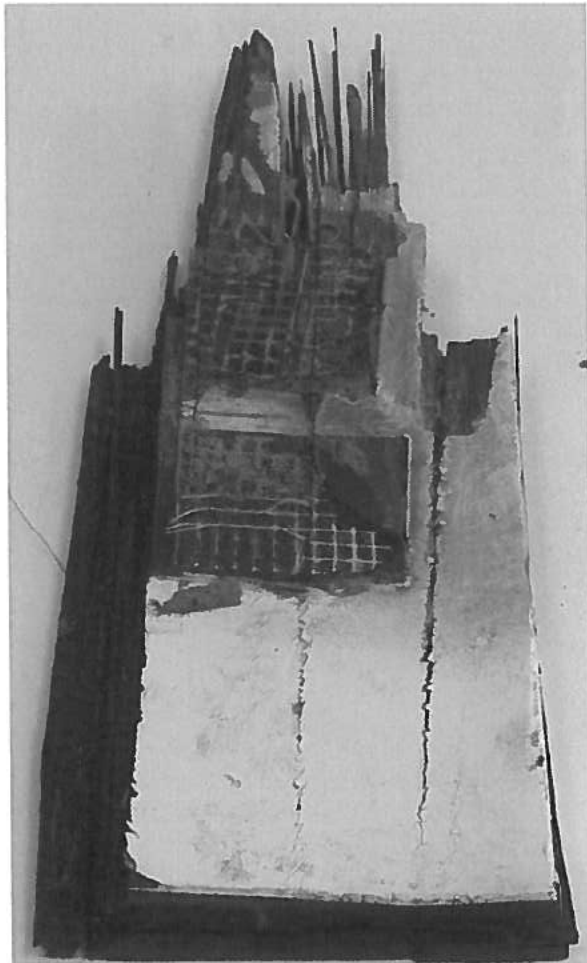
Figure 11

Close-up views of the red blade fracture after sectioning and prior to clam-shelling to expose the mid-thickness delamination surfaces. Pylon side shown.

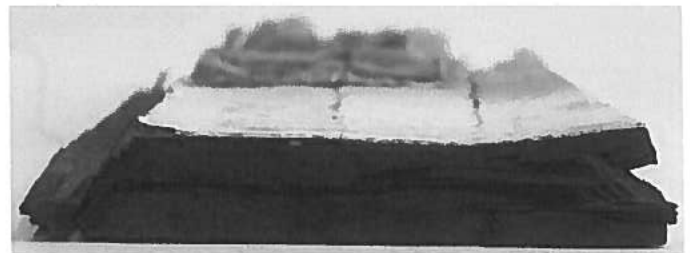
Figure 12

The red arm fracture was opened at the mid-thickness delamination and examined for evidence of a progressive fracture; see Figures 12 and 13. One area of the delamination surface exhibited a powdery appearance that was thought to possibly be caused by rubbing, so the part was examined in greater detail in a scanning electron microscope; see Figures 14 through 16.

Red blade fracture surface shown after clam-shelling. Close-up views documenting the fracture appearance are given in Figures 13 through 16.

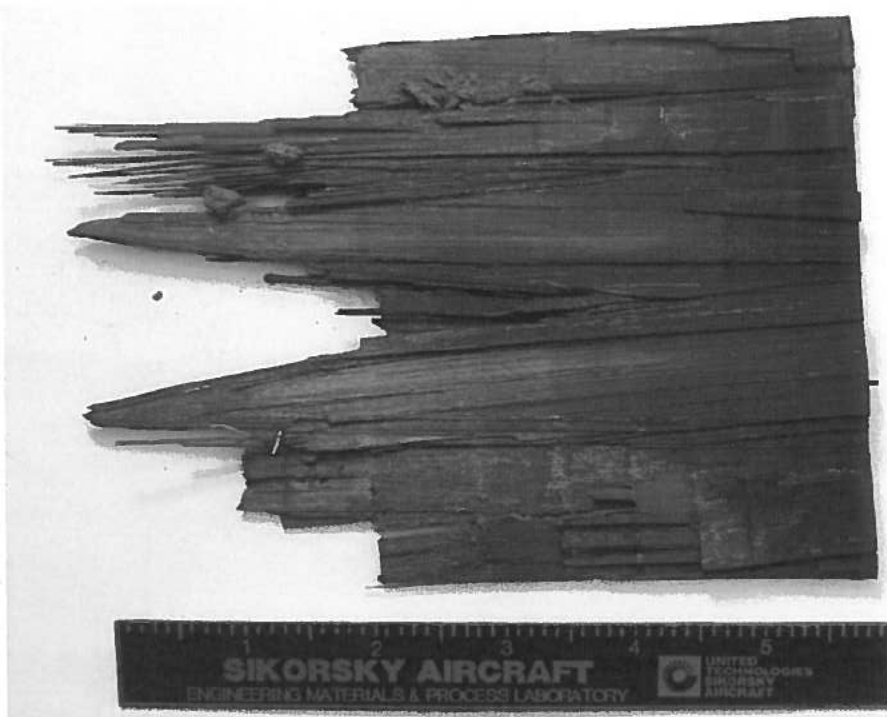
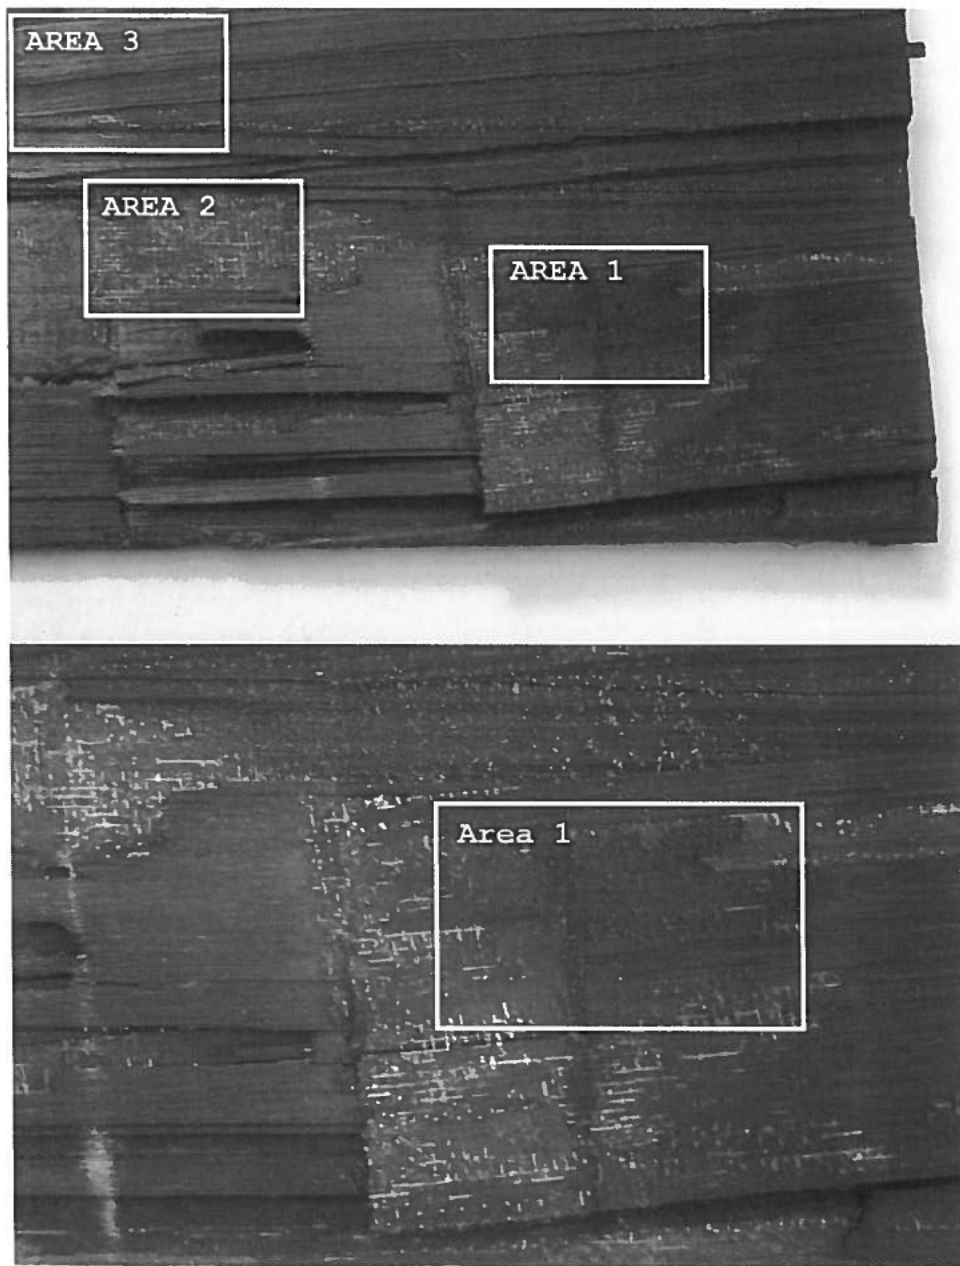
Figure 13

6. The red blade spar remnant contained a mid-thickness delamination. The delamination was opened and examined for evidence of rubbing that would indicate a progressive fracture mode. No rubbing was found.

Close-up views of the delamination surface, which generally exhibited a fresh, static fracture appearance. The 'powdery' region, designated Area 1 was examined and compared to areas 2 and 3 in a scanning electron microscope. See Figures 14 through 16 for SEM views of these areas.

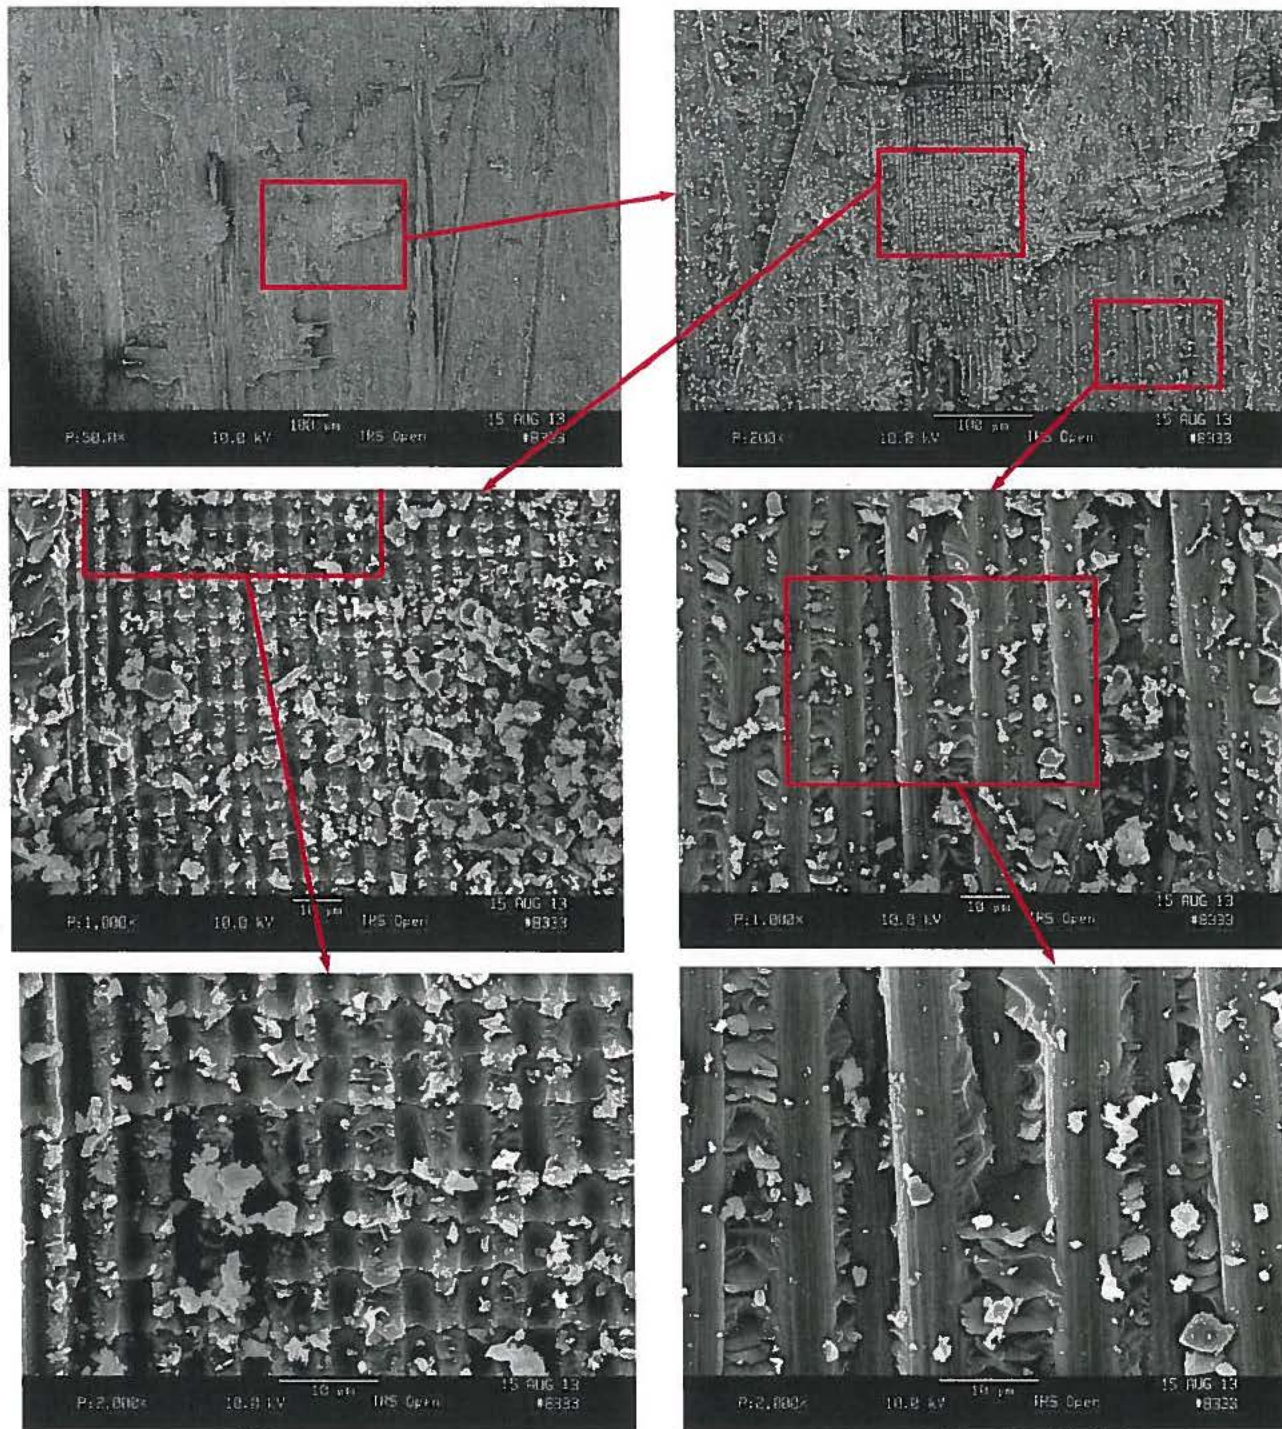
Figure 14

Examination of the delamination surface showed resin hackling, which is characteristic of shear fractures in graphite-epoxy laminates. The powdery appearance was due to the presence of numerous small particles of fractured resin that were found elsewhere on the fracture, but to a lesser degree. The fracture itself showed sharp features with no indication of the kind of rubbing damage that would be associated with a progressive fracture.

Successive magnification views of Area 1 showing the appearance of the delamination surface. Upper right view shows an impression from the fiberglass scrim (magnified views at left) and an area of graphite fibers (magnified views at right). Note thick build-up of loose resin particles on the fracture surface. At high magnification the resin fracture features are clearly defined. No rubbing is evident.

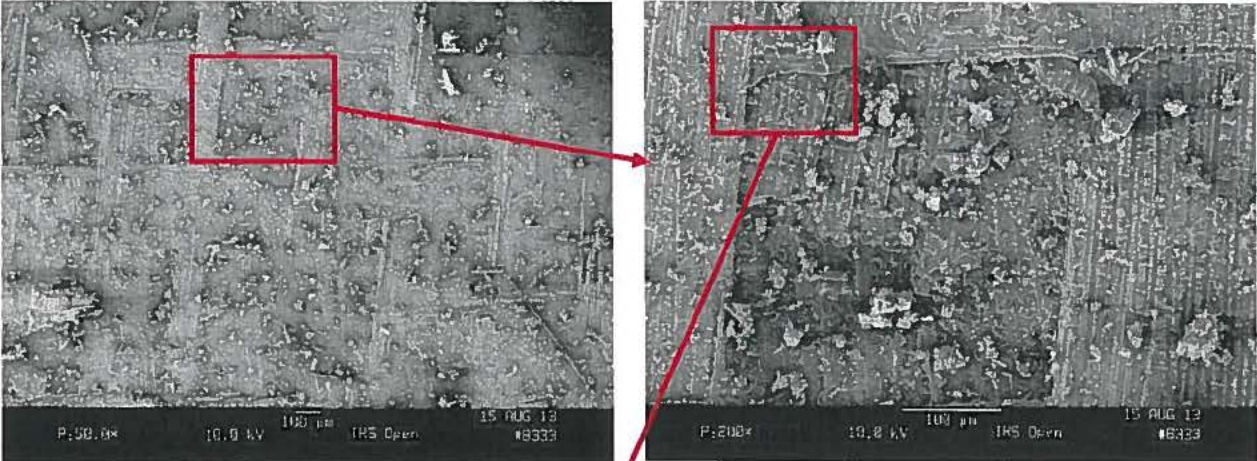
Figure 15

Successive magnification views of Area 2 showing many of the same features seen in Area 1.

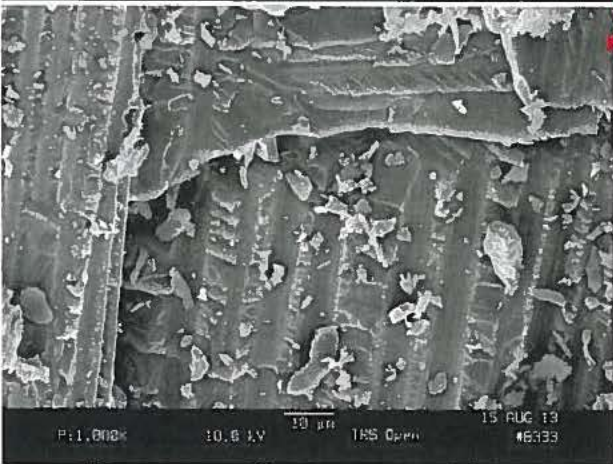
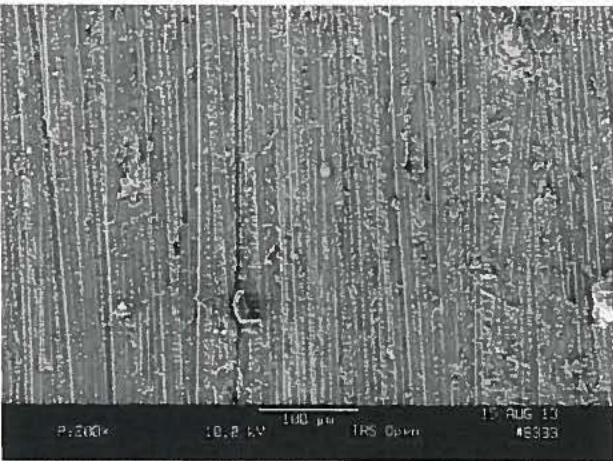
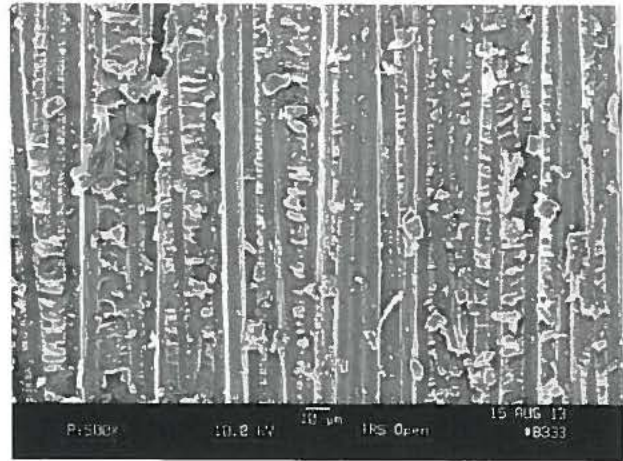
Figure 16

Successive magnification views of Area 3. Fewer particles of resin were visible on the delamination surface at this location.

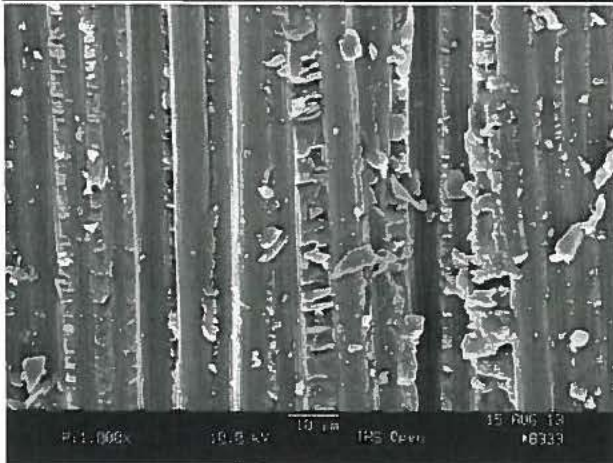
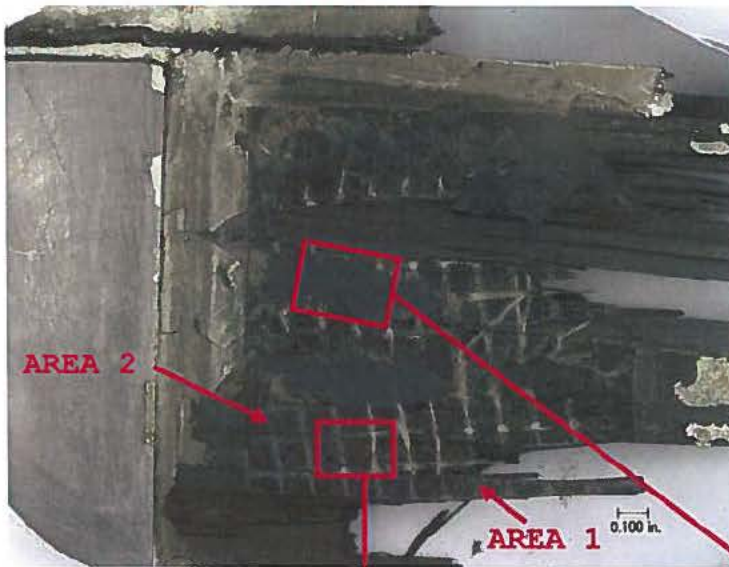
Figure 17

The pivot retainer separation surfaces exhibited a mixed mode of separation with adhesive disbond of the primer at the primer/metal interface and cohesive fracture of the rubber plus adhesive disbond of the primer at the rubber/primer interface; see Figures 17 through 19. The separation surface was examined in a scanning electron microscope in an attempt to determine the direction of separation; see Figures 20. Evidence for directionality was limited and inconsistent, so the direction of separation could not be determined.

View of the red arm outboard side pivot retainer disbond. Close-up SEM views of Areas 1 and 2 are given in Figure 20.

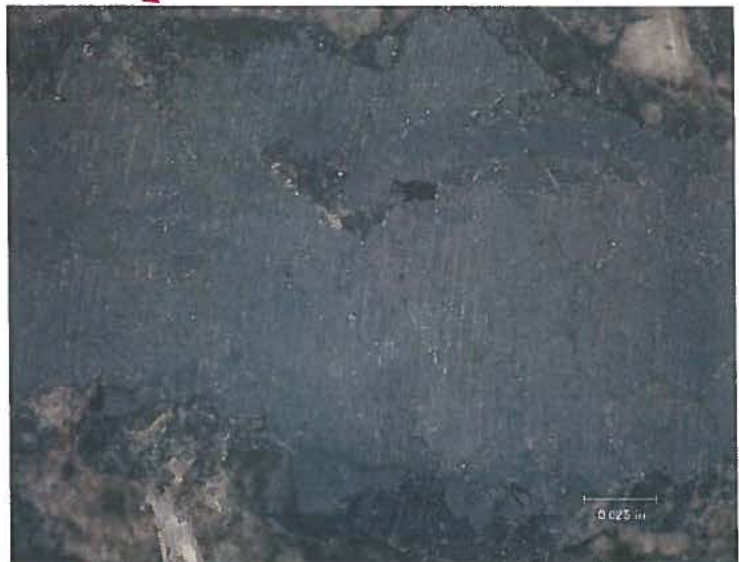
Figure 18

Close-up view of area showing adhesive disbond of the primer from the retainer surface.

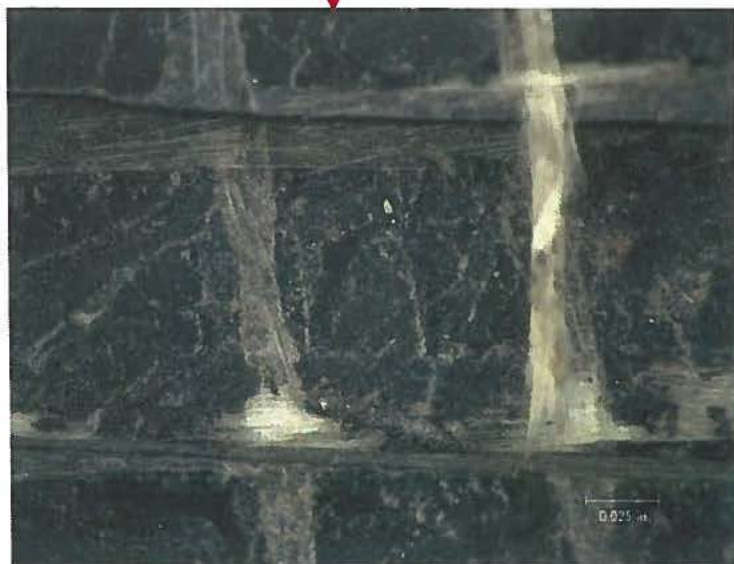
Figure 19

Close-up view of an area showing mixed adhesive and cohesive separation modes.

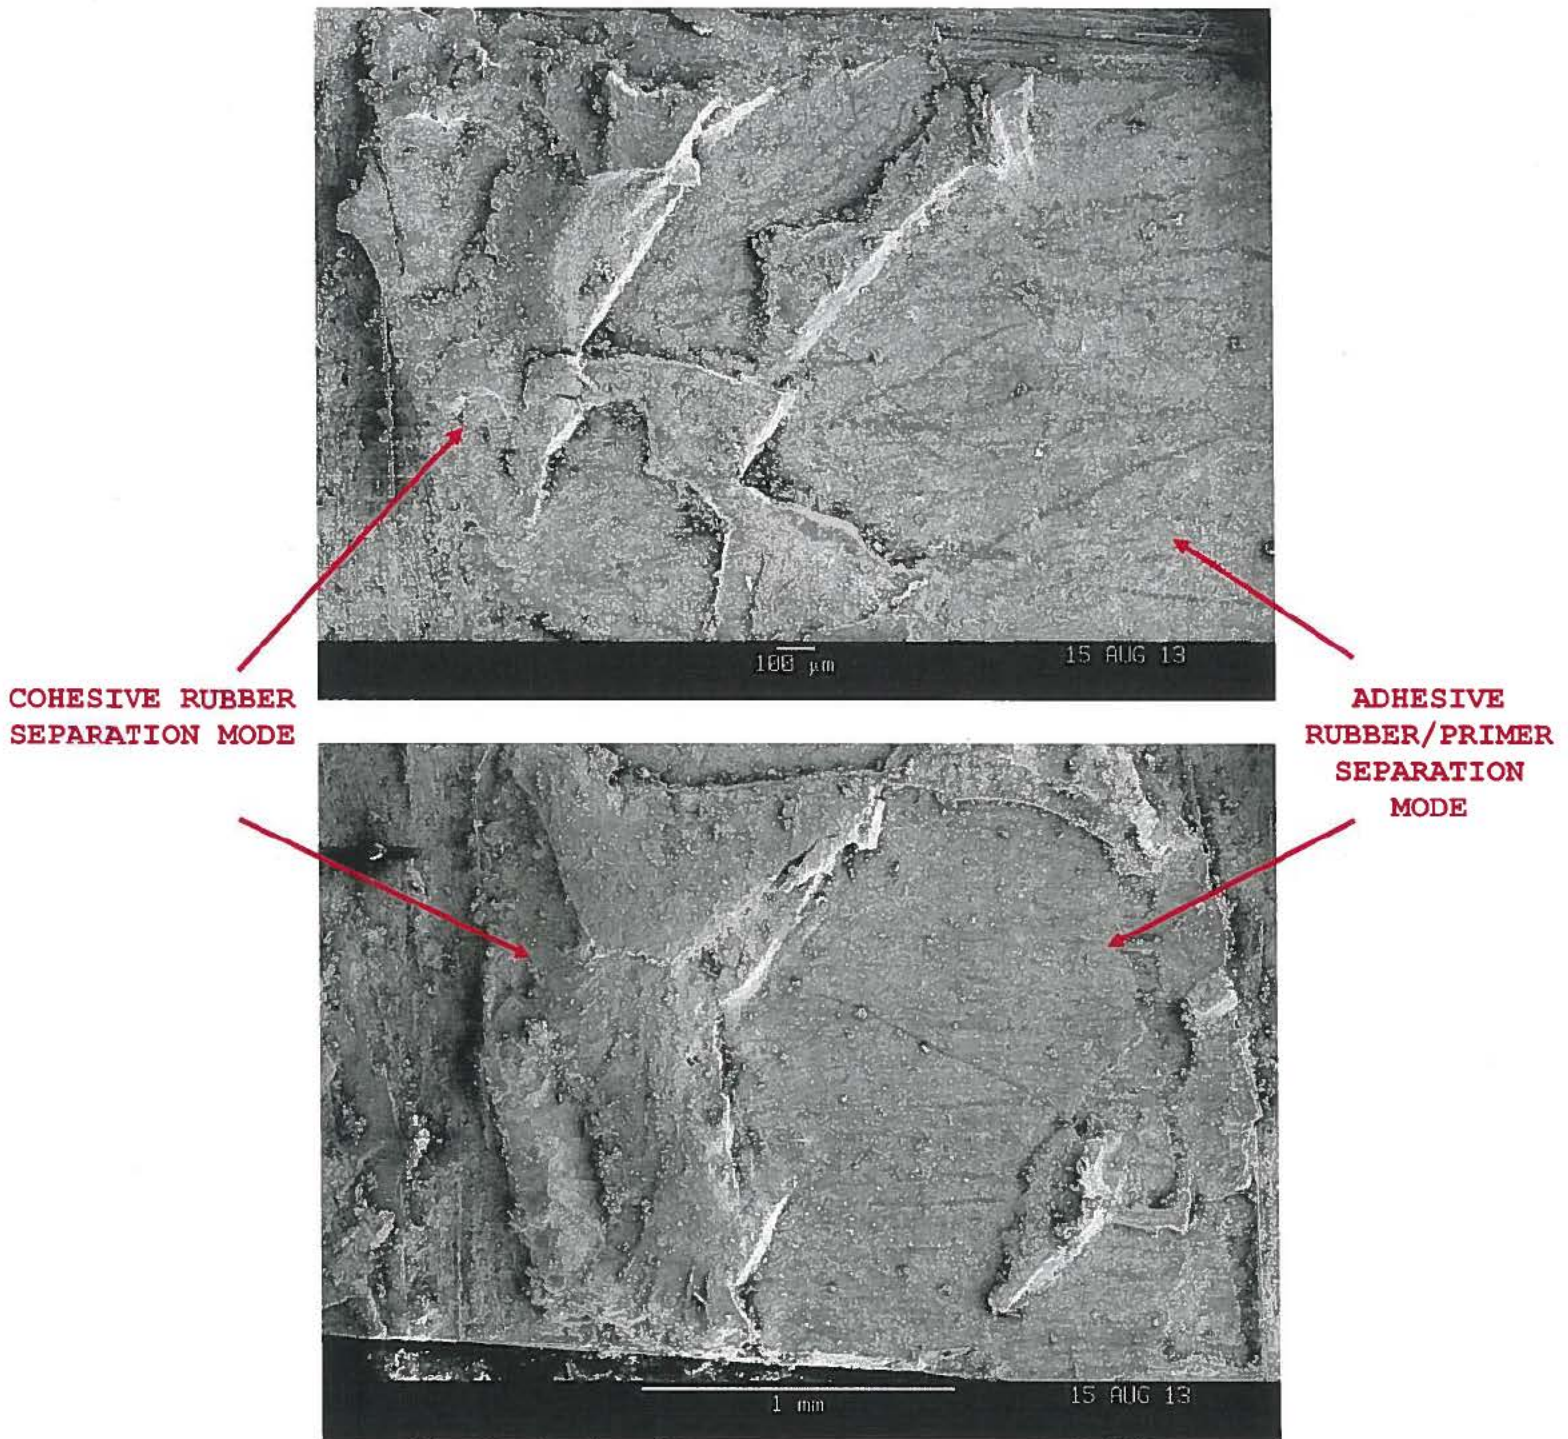
Figure 20

SEM view of Areas 1 (top) and 2 from Figure 17 showing adhesive and cohesive separation modes.

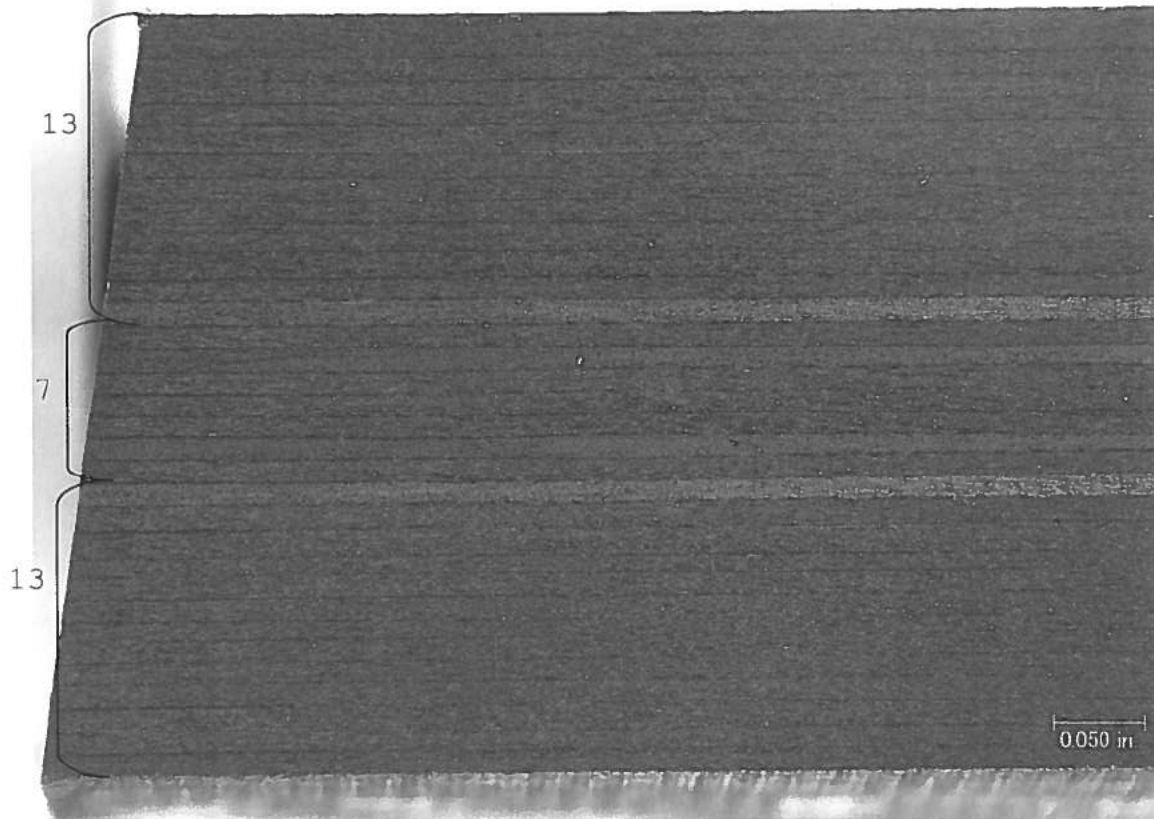
Figure 21

The trailing edge of the spar was polished in the area between STA 0 and STA 3 as shown in Figures 9, and the number of plies was counted and compared to the drawing requirement; see Figure 21. The two +20° plies were located thirteen plies in from the surface on both the pylon and outboard sides of the spar, as required by the spar assembly drawing. A total of thirty-three plies were present. The drawing specifies thirty-three plies plus four optional plies. The thickness of the spar at that location measured .402 to .404"; .377 to .422" is required.

Trailing edge shown after polishing to reveal the ply lay-up. Lighter colored laminae represent the two  $+20^\circ$  plies identified on the drawing as plies 20 and 37. Thirty-three plies were present in all. No ply waviness was apparent.
