NATIONAL TRANSPORTATION SAFETY BOARD

Group Chairman's Factual Report

AIR TRAFFIC CONTROL

ERA15FA099

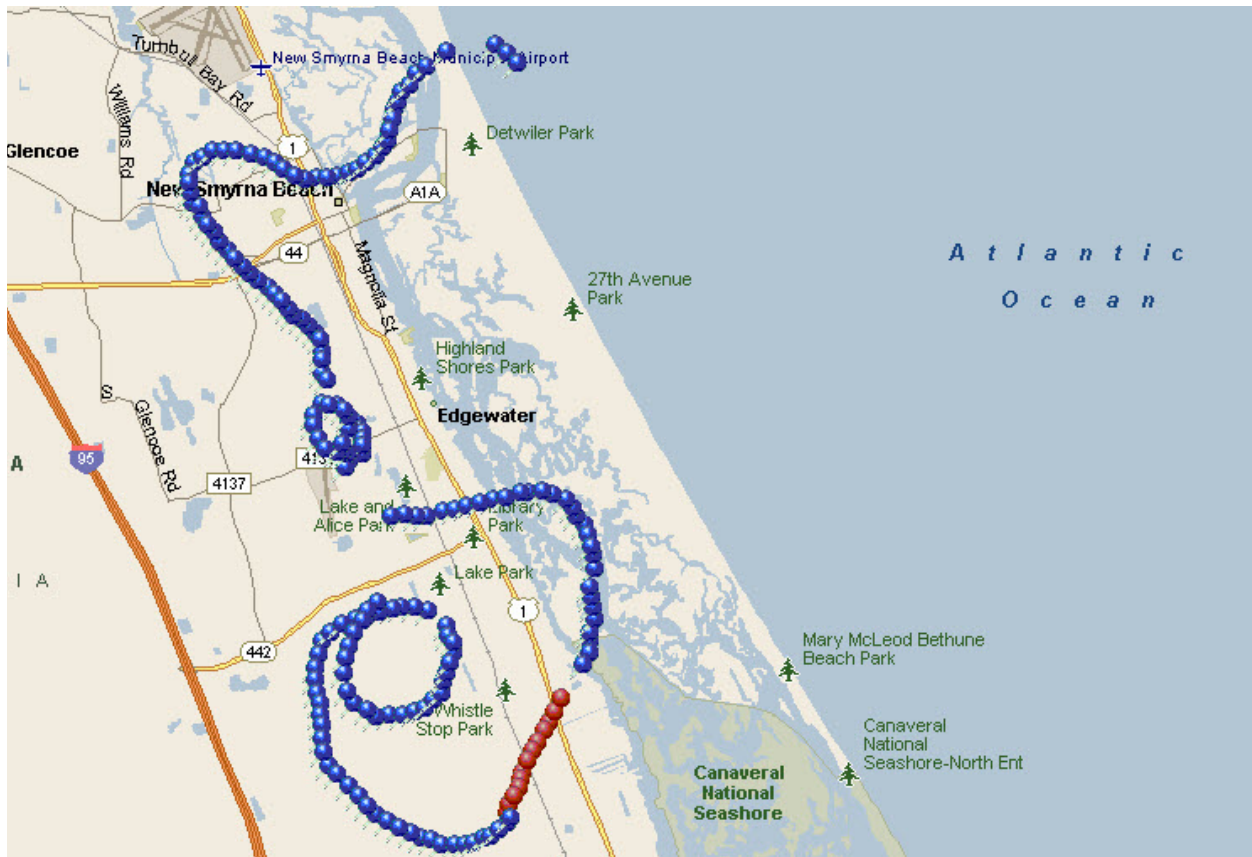
Radar data for this report was obtained from the FAA's Daytona Beach ASR-9 radar site. Figure 1 illustrates the radar plots of the aircraft as it attempted to land at Massey Ranch Airpark and New Smyrna Beach airport. Figure 2 is a close-up of the radar plots, and illustrates the accident sequence.

Figure 1 – Radar plot of the aircraft position while attempting to land at Massey Ranch Airpark and at New Smyrna Beach airport. The blue dots are the aircraft squawking 1200 and the red dots are the aircraft squawking 7700.

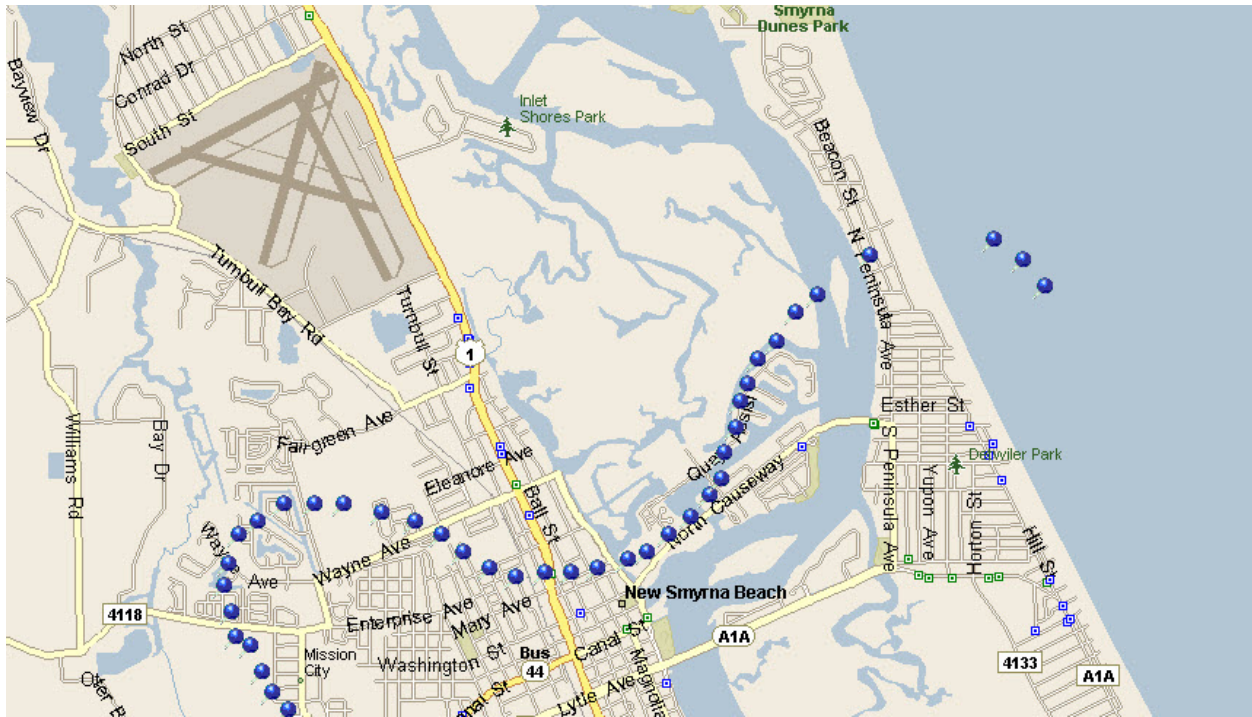
Figure 2 - The final radar plots of N757ZM.
